# NICKLE PLATE ABANDONED MINE POOL “BLOWOUT” WASHINGTON AND ALLEGHENY COUNTIES, PENNSYLVANIA<sup>1</sup>

**Abstract.** On 01/25/05, a 10,000-gpm “blowout” of the century-old Nickle Plate Mine (Pittsburgh coalbed) occurred in a public sidewalk about 12 miles southwest of downtown Pittsburgh, PA. The US Office of Surface Mining, first responder, installed diesel pumps and drain lines along public streets to control and convey the discharge to a nearby stream. On 02/22/05, the Pennsylvania Department of Environmental Protection, Bureau of Abandoned Mine Reclamation issued a 90-day emergency contract to Environmentally Innovative Solutions, LLC to provide a permanent control. With numerous partners (federal, state, local agencies; local residents and businesses), property access, stream and mine pool water quality data, historical mine mapping, and other pertinent site information were acquired.

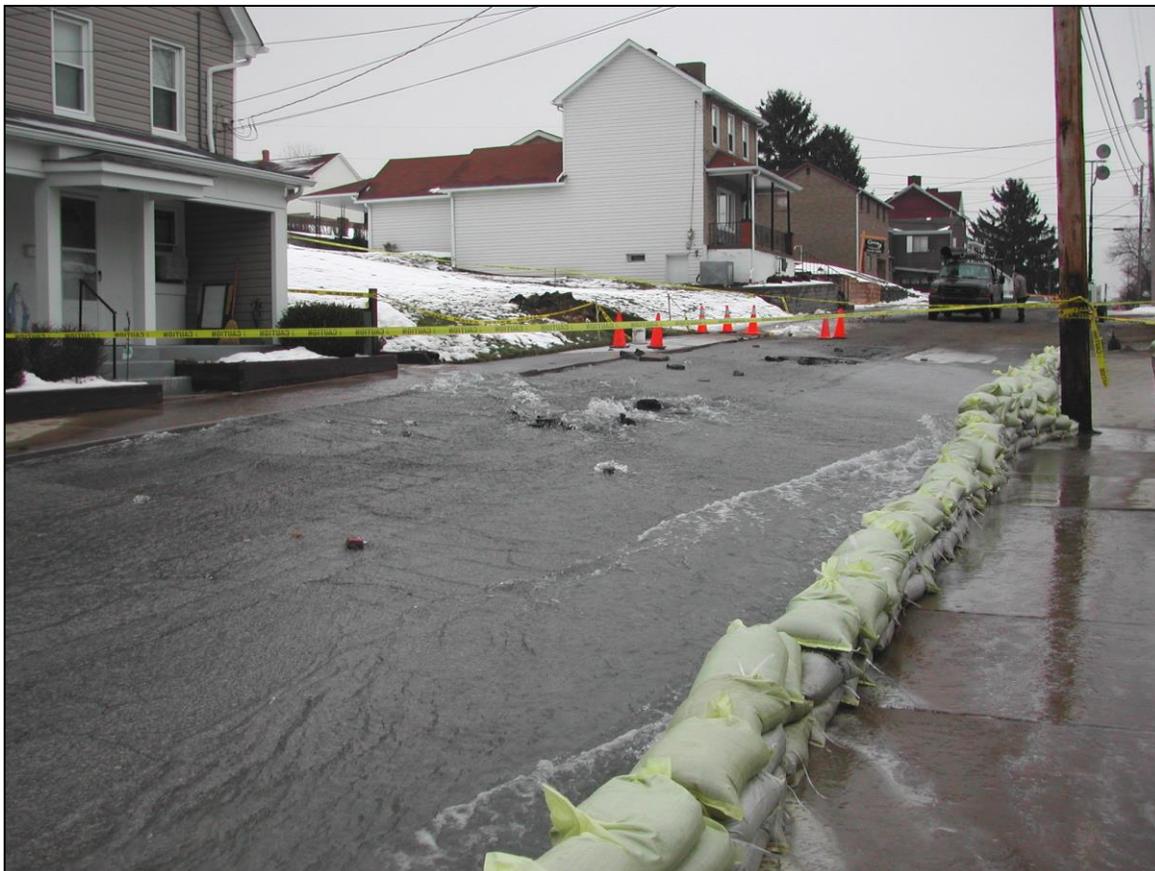
At approximately 2:00 pm (EST) on 01/25/05, while utility workers were using hand-tools to determine the location of what was thought to be a water main leak, a catastrophic “blowout” of an abandoned mine pool occurred. The confined conditions within the Nickle Plate Mine created a “geyser” with an estimated flow rate of 10,000 gpm. The “blowout” location was at 135 Liberty Street, along the sidewalk, in McDonald Borough, Washington County, PA.

Figure 1. "Blowout" of the abandoned Nickle Plate Mine pool. Note flooding of Liberty Street, McDonald, PA. (01/25/05)

Through the efforts of OSM, by 3:30 am (EST) on 1/26/05, an 8-inch and a 12-inch pump, both with about 1000 feet of discharge hose, had been installed to convey the degraded mine drainage to the nearest watercourse of adequate size. (The watercourse then enters Robinson Run, a stream devoid of aquatic life with total Fe and Al content generally exceeding 40 mg/l and 20 mg/l, respectively.) By 2/15/05, the 12-inch pump was removed as the estimated flow rate decreased to ~4,000 gpm. By 2/18/05, OSM had installed two piezometers to monitor the mine pool.

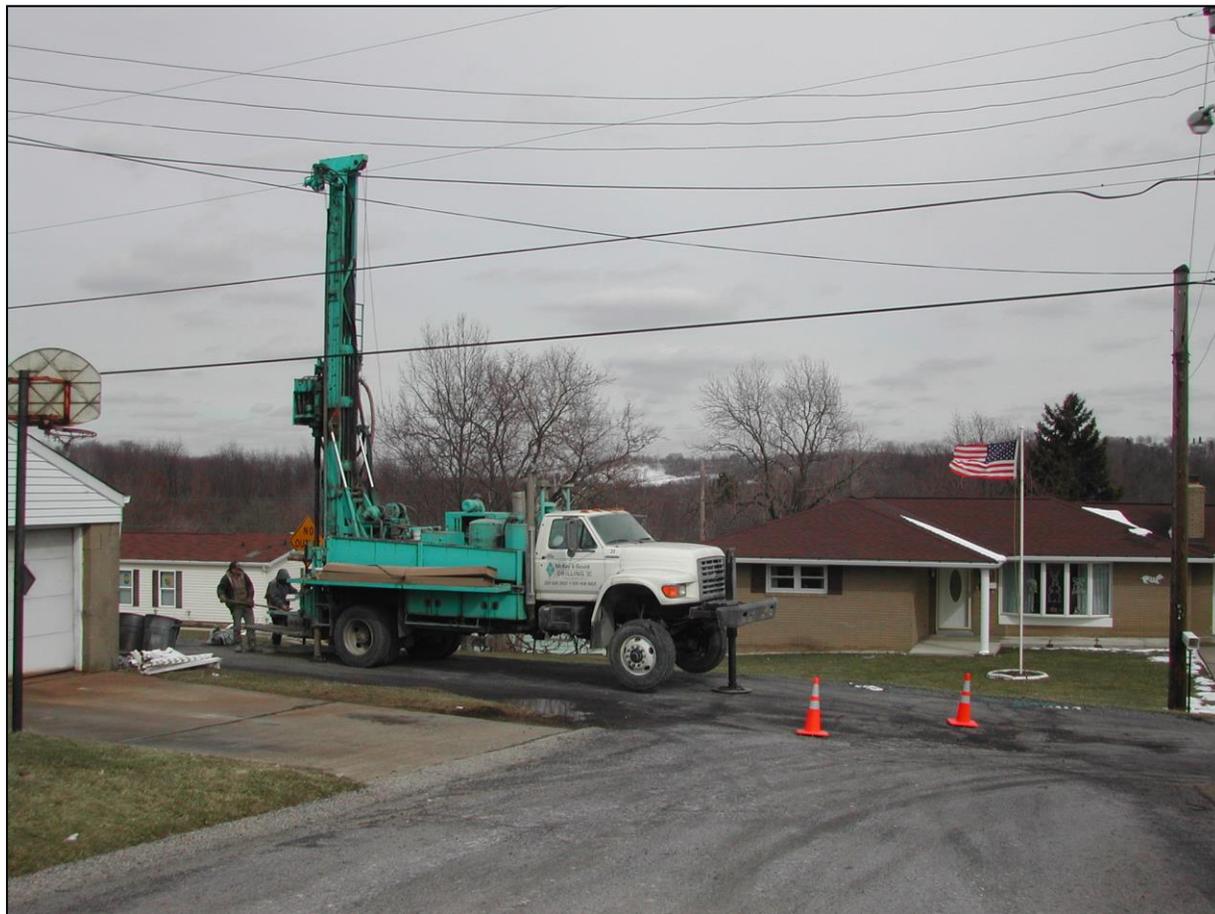
Figure 2. Piezometers installed as part of hydrogeologic investigation. (03/10/05-photo by Rich Beam, BAMR)

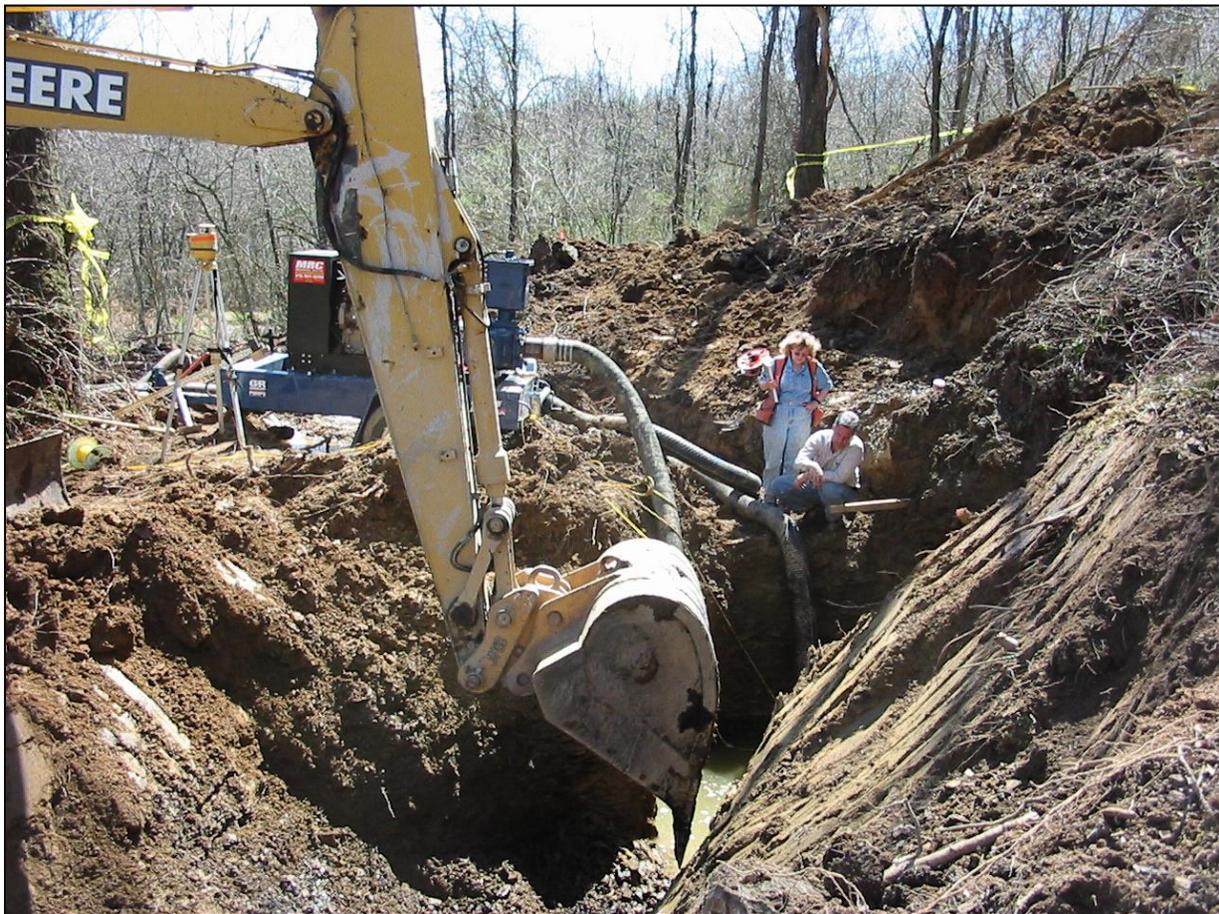
Landowner permission was received to install and monitor piezometers and test pits and to construct the necessary facilities, if the option was deemed feasible. On 04/01/05 and 04/05/05, thirteen boreholes were drilled with five additional piezometers installed (3 in voids) which were located by the BAMR survey crew. The site was inspected for subsidence features and siphons were installed to drain existing impounded degraded surface water. On 04/08/05, four test pits were excavated and pumping at the “blowout” was suspended. On 04/09/05, pumping was conducted and then a temporary gravity drain was installed at Test Pit 1. Subsequent monitoring of the piezometers, Test Pit 2 and the “blowout”, indicated successful control of the elevation of the mine pool at the “blowout”. (See Fig. 3.) Monitoring on 04/09/06 and 04/13/06, a period without precipitation events, indicated the difference in elevation of the mine pool at the “blowout” and at Test Pit 1 was 1.6 to 1.3 feet, respectively.

Figure 3. Test pits excavated with pumping conducted to determine favorable locations for Primary and Secondary Drains. (04/08/05)

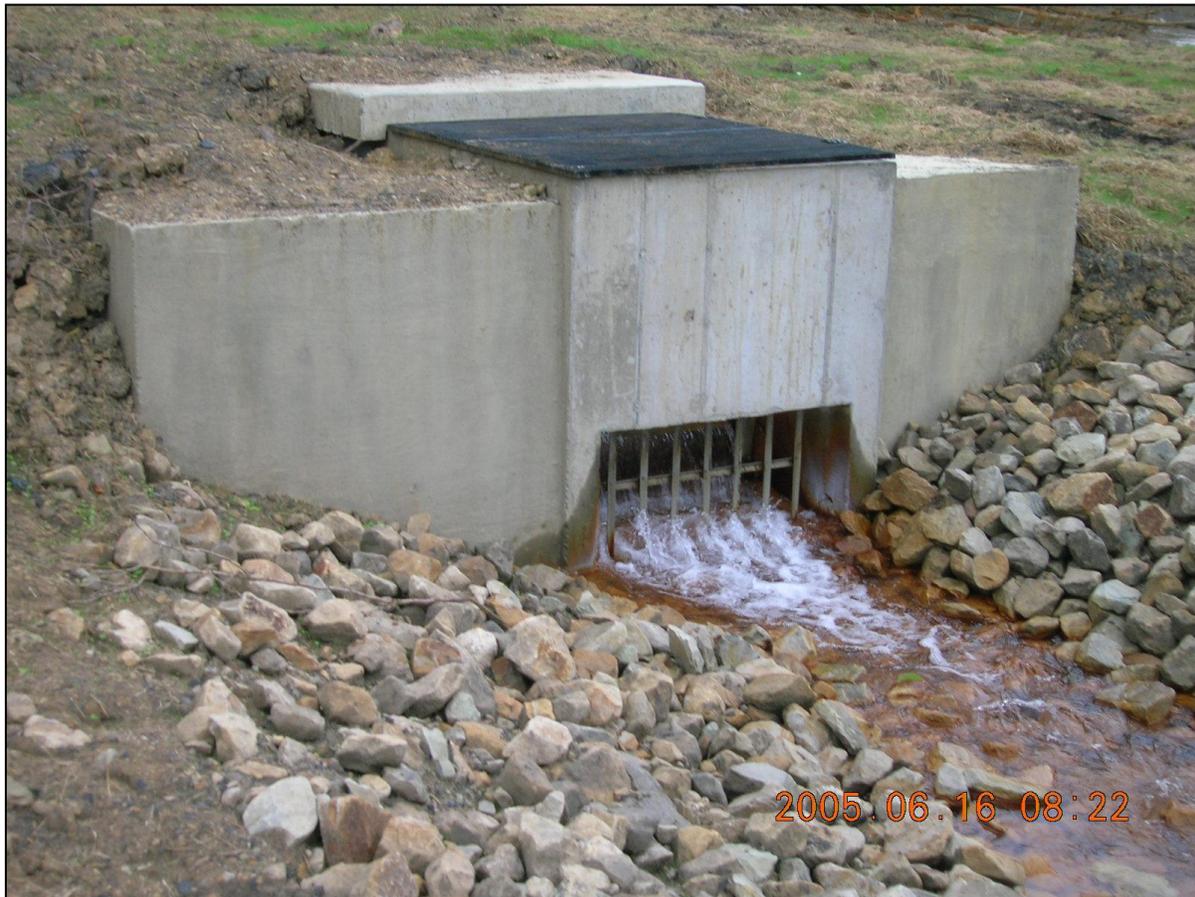
Figure 4. Primary Drain online May 20, 2005. (06/16/05)

At the inlet, flow is intercepted and conveyed by the following three components: (1) three, 8” perforated pipes placed about 26 feet into the mine void, (2) an 18” perforated vertical riser with 18” perforated barrel, and (3) a non-calcareous, R-4, (6” average diameter) rock drain. The vertical riser allows monitoring and access for future pumping, if needed, and is protected by a concrete manhole with a bolted access cover, having a single 1” perforation to allow for manual water level measurements and venting of gases, if present. The inlet area was backfilled with R-4 rock with geotextile fabric used for layer separation of select onsite fill. Where appropriate, the area was graded and revegetated.

At the outlet, a rectangular concrete structure (4’W x 5’H x 13’L) set on two concrete footers with wing-walls to function as “anti-seep” features, included a “weir-like” water level control feature to facilitate limited mine pool elevation manipulation (maximum ~5’) as well as relatively accurate flow rate estimations. A concrete lid (6’W x 9’L) deters unauthorized entry. Locking and hinged grating was placed immediately above the weir for access to manipulate the mine pool, if needed, as well as continued monitoring. A stilling well with datalogger facilitates water level measurements and a riprap-lined (R-4) channel conveys the discharge to a previously degraded stream. (See Fig. 4.)

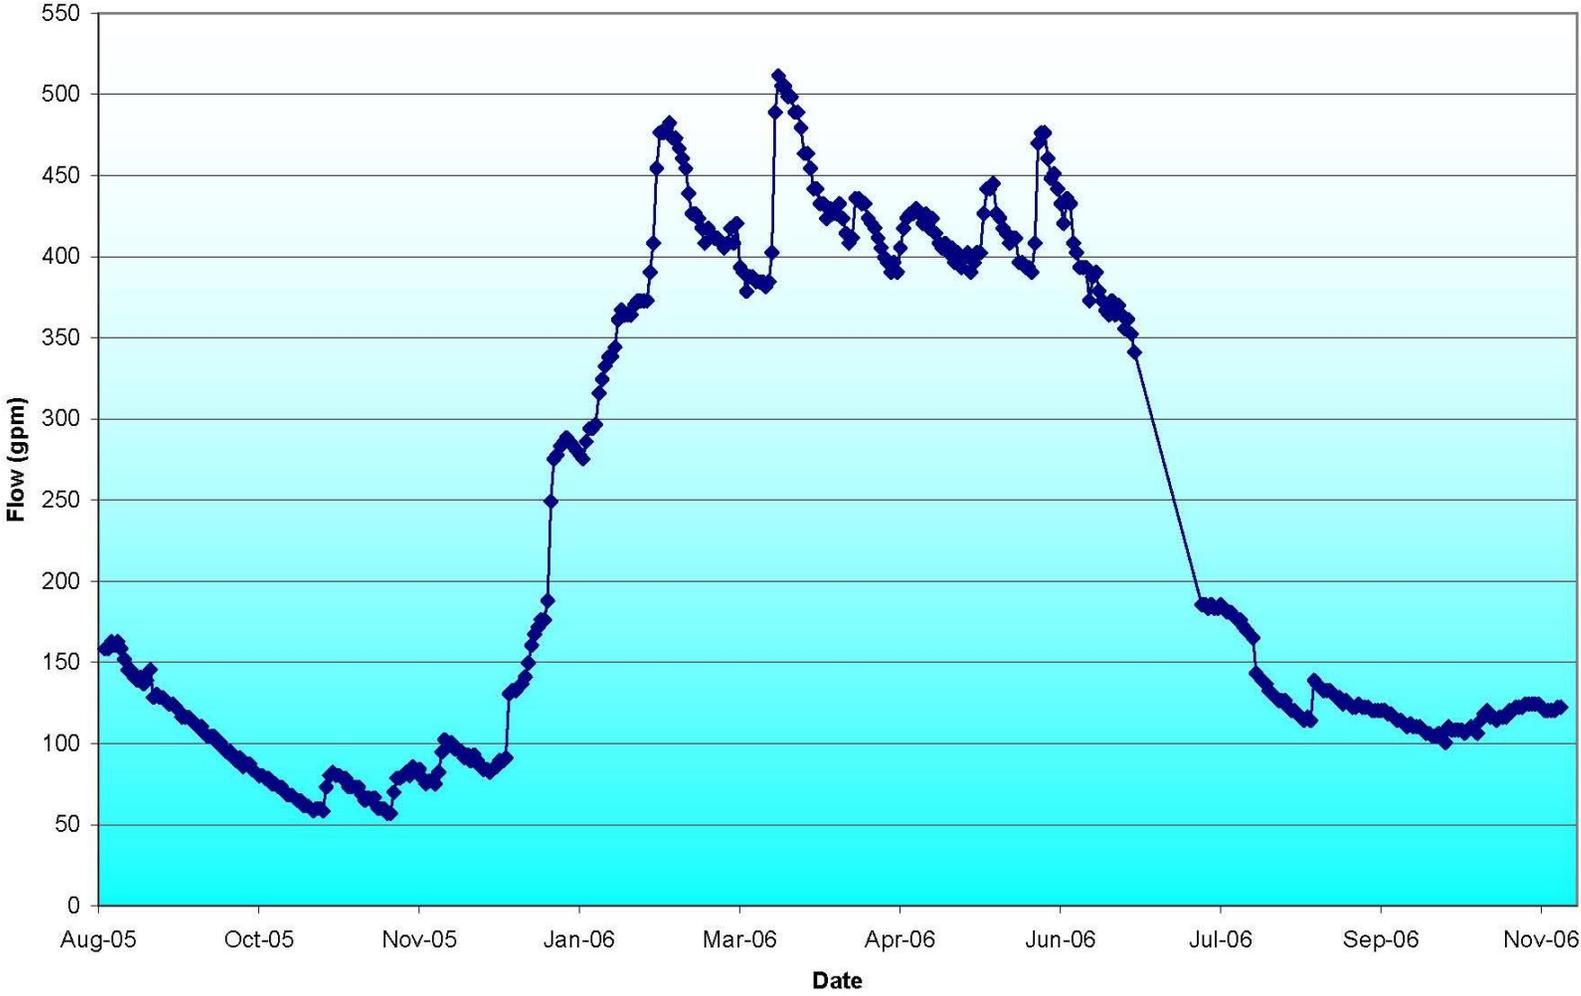
Figure 5. Primary Drain Discharge Monitoring

The weir notch was cut into ½-inch Tivar installed on the upstream face of stainless-steel stoplogs, and, by using the 1,000-gpm design flow and calculated required head for the targeted mine pool elevation at 1046.2' at the "blowout", the crest of the weir was set at 1044.5'. (Note: With insertion of all stoplogs, the crest of the weir would be about 1047.5'. The Secondary Drain with an overflow pipe invert at about 1048' would discharge prior to flowing from the "blowout".) The weir has a total maximum measurable depth of 1.3' for a maximum measurable flow rate of ~6,000 gpm. Flows in excess will be above the weir and additional calculations would be needed to estimate flow rate. Monitoring of the flow rate at the Primary Drain is ongoing. Figure 5 depicts the variations in flow rates.

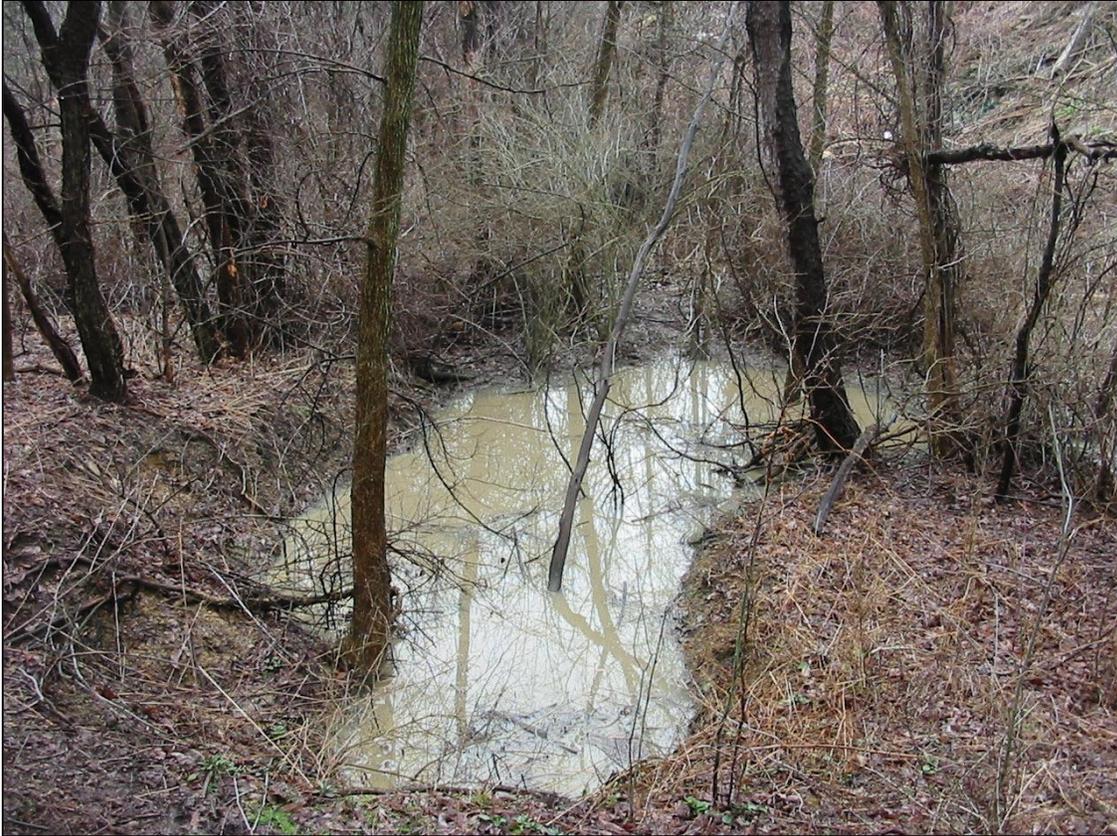
Design. The Secondary Drain, constructed in Test Pit 3 which was located in a subsidence depression that actively conveyed surface water into the mine, not only allows access for monitoring of the mine pool and for future pumping, if needed, but also provides an outlet for mine pool drainage should the Primary Drain be compromised or other significant hydrologic changes occur within the mine. The top of the riser is protected by a concrete manhole with an access cover secured by bolts. The cover has a single 1” perforation at the center to allow manual water level measurements and venting of gases, if present. (See Fig. 6.)

Figure 6. Subsidence depression intercepting “Miller Run” prior to Test Pit 3 excavation. (03/03/05)

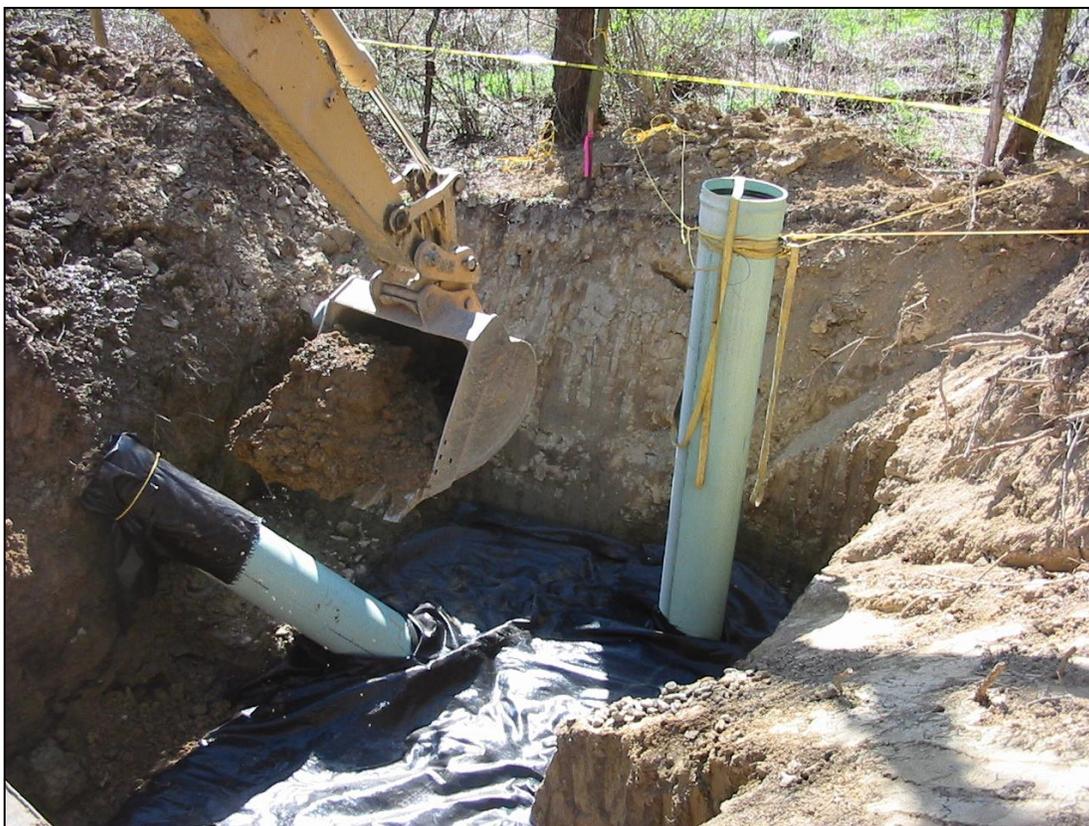
Figure 7. Construction of Secondary Drain. Geotextile used for layer separation of aggregate and backfill. (04/13/05)

A riser pipe with an 18” diameter was selected in order to facilitate a typical intake basket (~12 inches in diameter) for an 8” diesel pump suction line and to allow a reasonable annulus for flow within the riser. An 18” overflow pipe was included in the design to provide a “safety relief” for the mine pool. From a 45° WYE installed near the bottom of the riser, the 18” overflow pipe with 45° elbow was then installed in order to direct overflow to a constructed channel and eventually to “Miller Run”, a stream historically degraded by AMD. (See Fig. 7.)

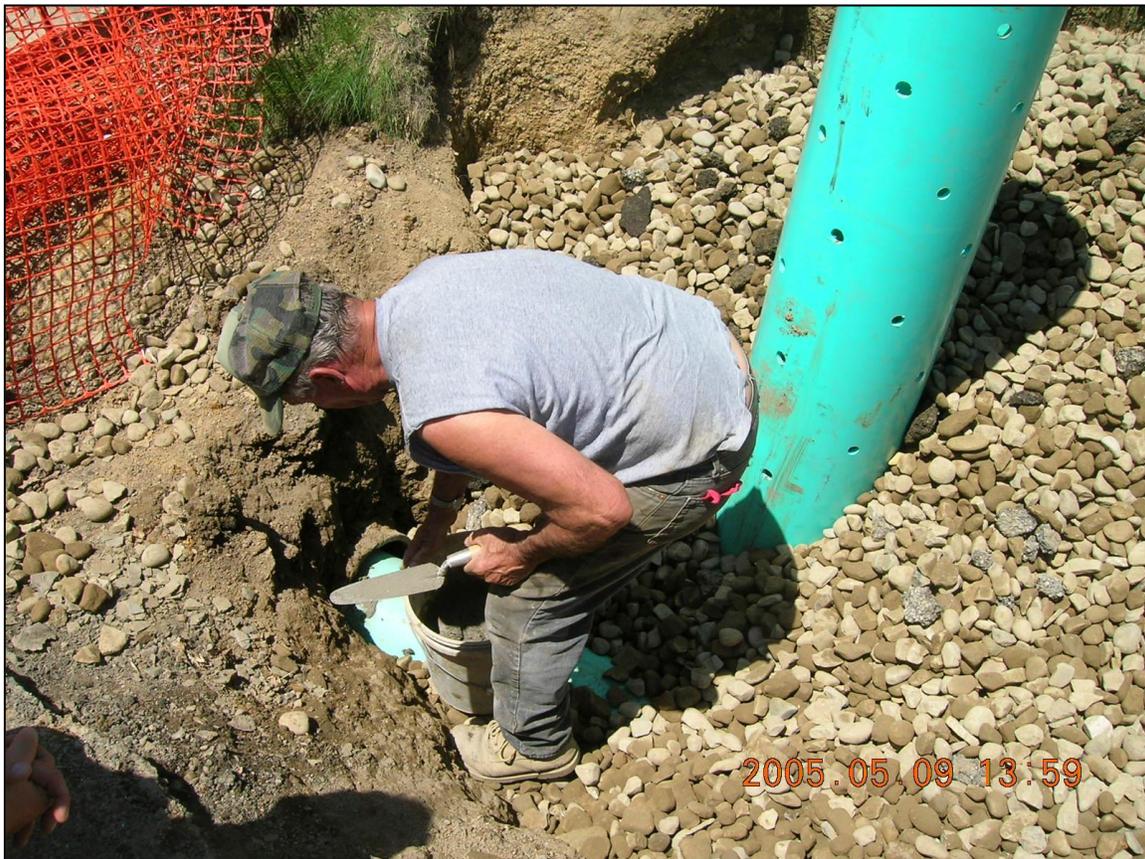
Figure 8. Local resident and subcontractor Dave Menke assists in the installation of the Early Warning System at the “blowout”. (05/09/05)

discharge in the unlikely event that the mine pool elevation rises to ground level. After removing debris to the extent practicable with a rubber-tired backhoe, a 15” SDR35 riser, with 1” and 1<sup>1</sup>/<sub>8</sub>” perforations (about 50% of each) on 6” centers spaced both vertically and horizontally, was set into the void. A short section (~6’L) of 6” SDR35 pipe perforated with five, 5/8” holes every 6” was inserted “back into” the mine void as feasible and connected to the 15” riser below design water elevation. PADOT #3, non-calcareous, aggregate was placed around the pipe to grade and the sidewalk was reconstructed. The top of the riser is protected with a cast-iron manhole access cover set in concrete with bolted lid. The lid was perforated with seven 1” holes to allow manual water level measurements. In addition to monitoring, this perforated cover will allow water to discharge in a highly visible area of a residential section of McDonald Borough. If this were to occur, local residents would be able to alert the proper authorities to implement corrective measures. (See Fig. 8 and 9.)

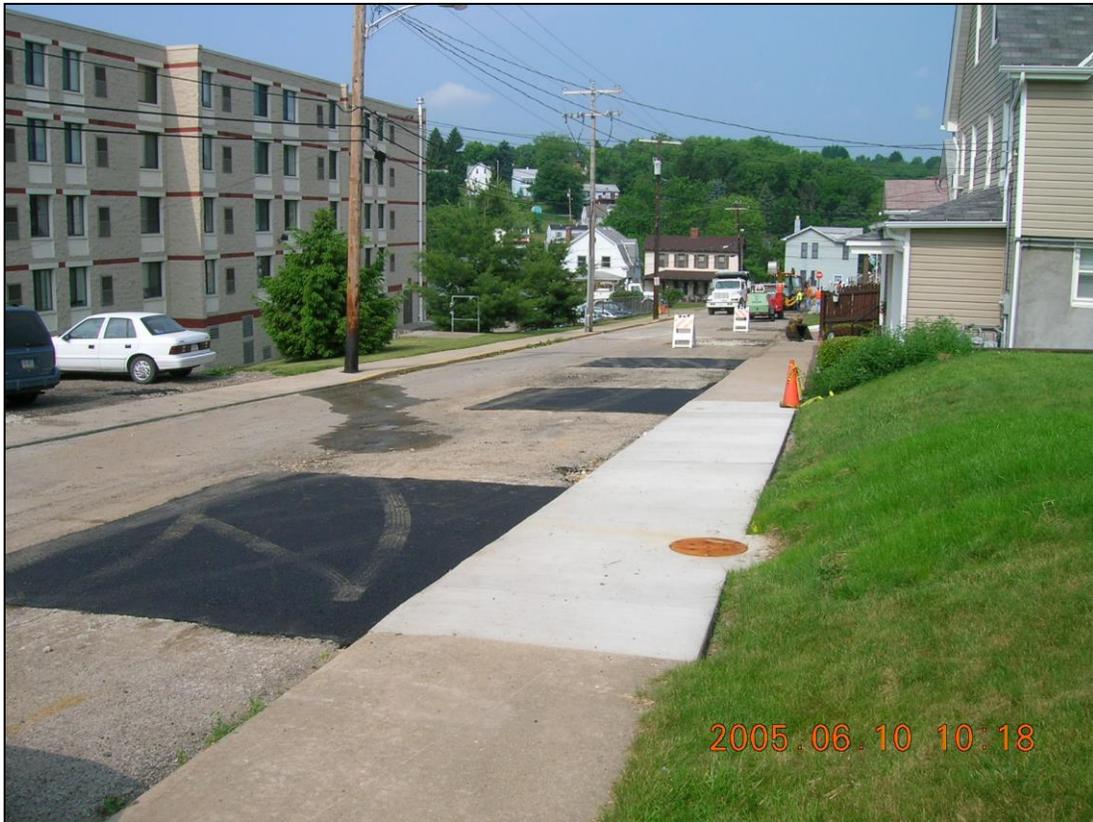
Figure 9. View of the manhole cover of the Early Warning System in the repaired sidewalk.  
(06/10/05)

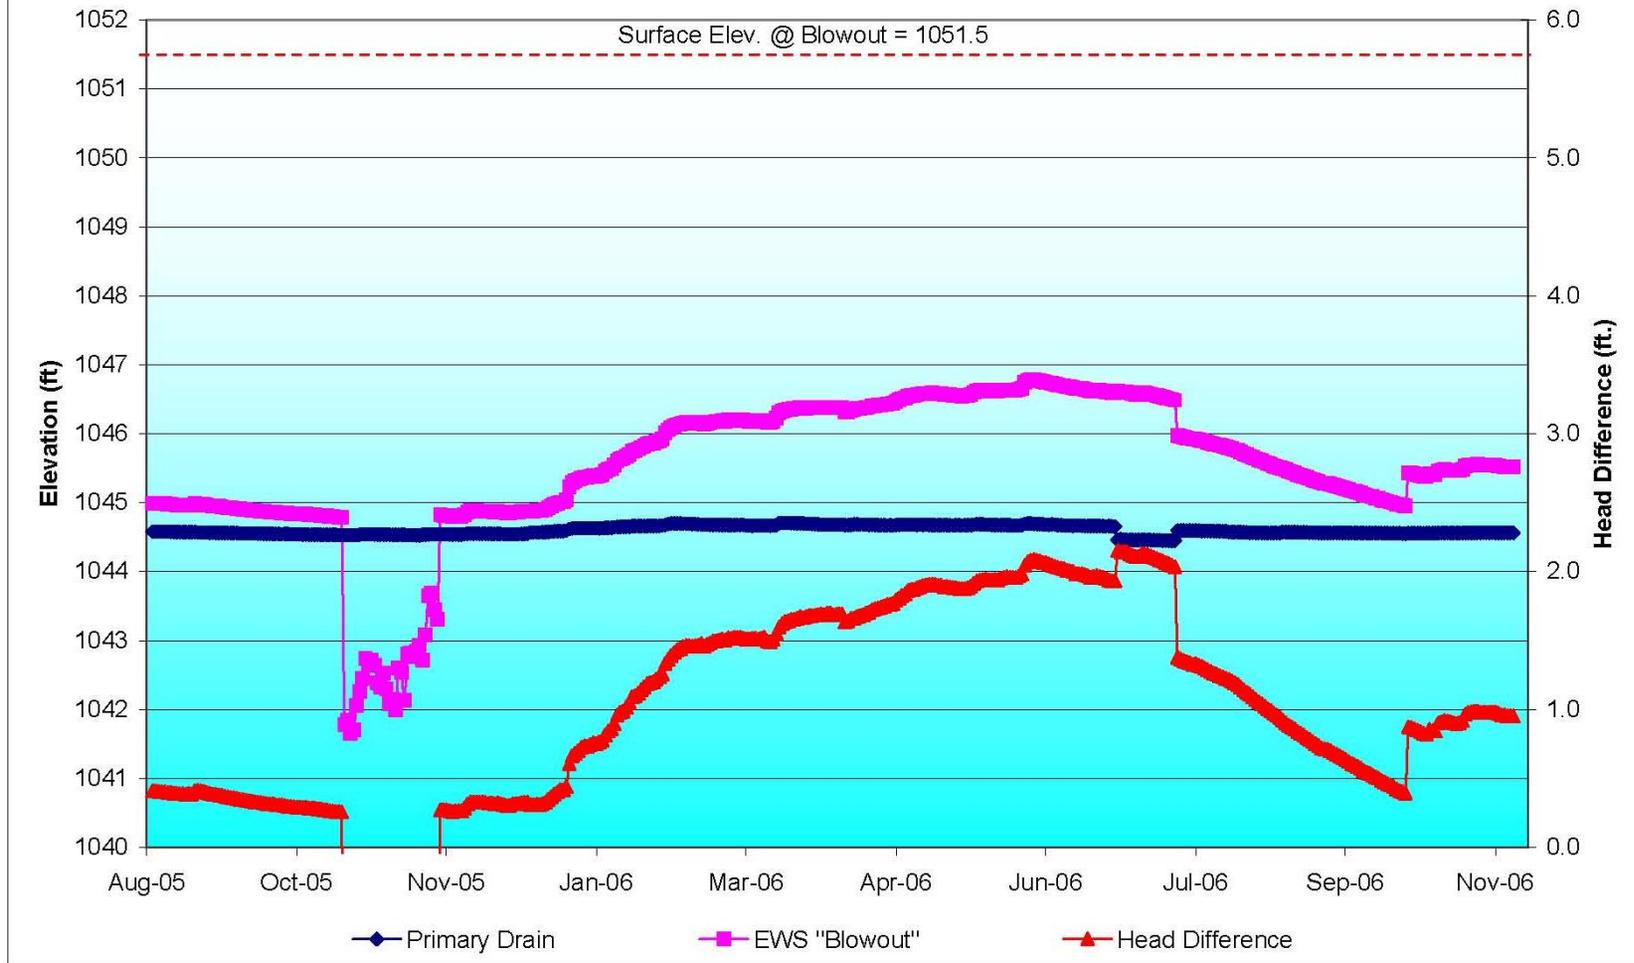
Figure 10. McDonald Mine Pool Elevation Monitoring

The cause of the “blowout” at McDonald is unknown; however, Hurricane Ivan (09/2004) is expected to have been an influence. Since implementation (over 2 years), all systems appear to be functioning. (See Fig. 10.) The contract cost for project completion including compilation of historic data, installation of piezometers, mine pool response tests, community outreach, and “design-build” of facilities was about \$400,000. Monitoring by BAMR is continuing. To date, no maintenance has been required at the Primary Drain or the “blowout”. The only maintenance was the removal of sediment (shoveled by hand) washed from upland areas that had accumulated at the pipe outlet of the Secondary Drain in 06/2006. Passive treatment is planned for the abandoned mine discharge in 2008/2009.
