REHABILITATION OF FIRE SUPPRESSION IMPACTS
ON THE
NORTH FORK FIRE
IN
YELLOWSTONE NATIONAL PARK¹
by
Eleanor D. Williams and Steven C. Smith²

Abstract: The North Fork Fire, which totalled more than 400,000 acres, was one of the largest of the 1988 fires in Yellowstone National Park. Because this fire was human-caused, it was aggressively suppressed, resulting in the construction of approximately 30 miles of bulldozer firelines and 320 miles of hand firelines in backcountry areas. National Park Service (NPS) policy requires rehabilitation of land disturbances within parks. The potential for successful post-fire rehabilitation was significantly improved by the utilization of impact-reducing methods such as curvilinear fireline routing, implementation of techniques to minimize soil disturbance, and reclamation of disturbed topsoil and organic debris before winter. Rehabilitation techniques performed by a rubber-tired excavator at bulldozer sites included scarification, topsoil replacement, and large slash and boulder replacement. Soil raking, small slash replacement, and stump cutting on bulldozed firelines was completed by hand crews. Hand fireline rehabilitation included soil and sla

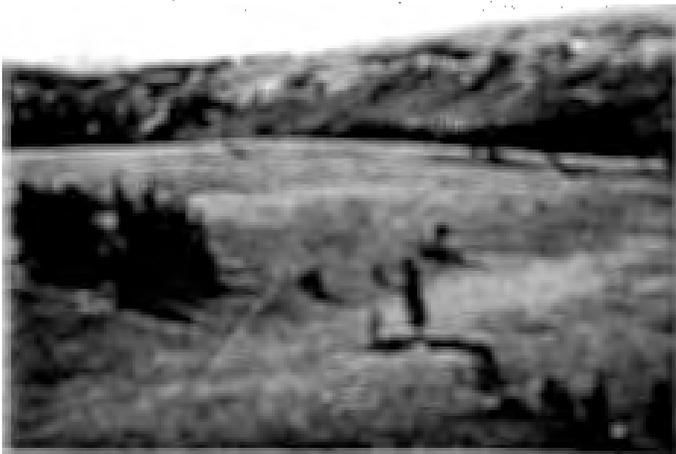
Fire crews, using hand tools including chainsaws, shovels, McClouds, and Pulaskies, constructed over 300 mi of hand fireline on the North Fork Fire. Using helicopter transport, these crews were able to reach even the most remote portions of Yellowstone National Park. Construction of hand fireline began with the removal of trees and shrubs by a chainsaw crew. The second step was removal of duff, sod, and organic soil layers with hand tools. This left a windrow of materials on one side away from the approaching flame. When completed, handlines were from 2-4 ft wide, with a wider, cleared corridor extending along fire perimeters. Figure 4 illustrates constructed hand fireline.

Figure 4. Constructed hand fireline. (Williams)

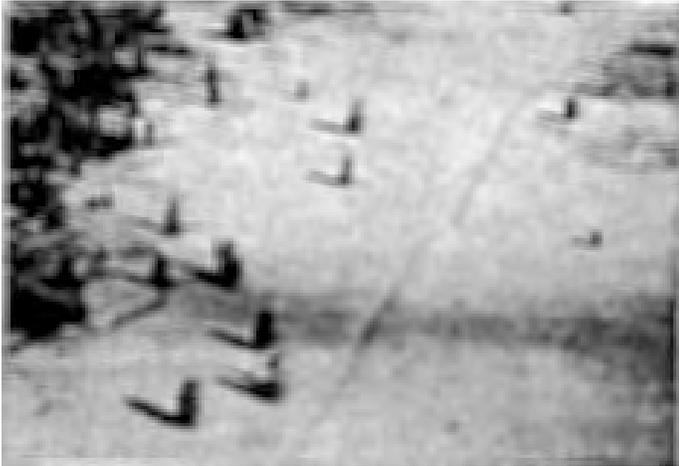
ticularly detrimental. Because much of the organic material in the fireline was removed through the explosion, rehabilitation was very difficult. Figure 5 illustrates an explosive fireline.

Figure 5. Constructed explosive fire line. (Williams)

Successful rehabilitation of explosive firelines was difficult because organic materials removed upon detonation were nearly impossible to recover. Surfaces and edges of lines were hand raked to incorporate seed sources into the area. Firelines were covered with loose, shrubby material to create microclimates that provide shade and shelter for re-growth.

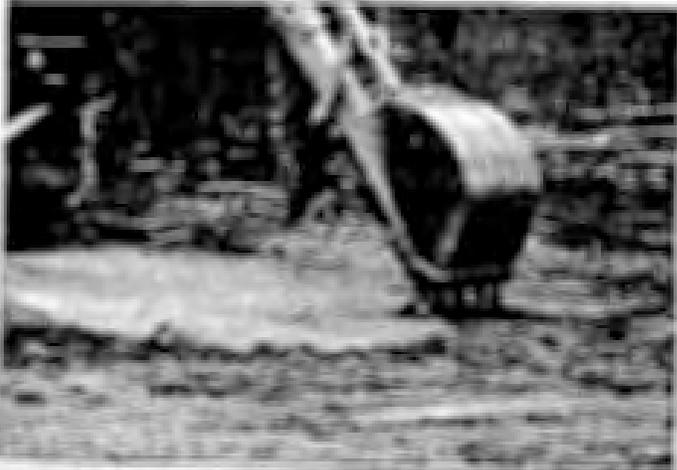
Figure 7. Illustration of scarification. (Williams)

2) Using the excavator bucket teeth (see Figure 7), mechanically rip and scarify the surface 6 in deep where compaction has occurred.

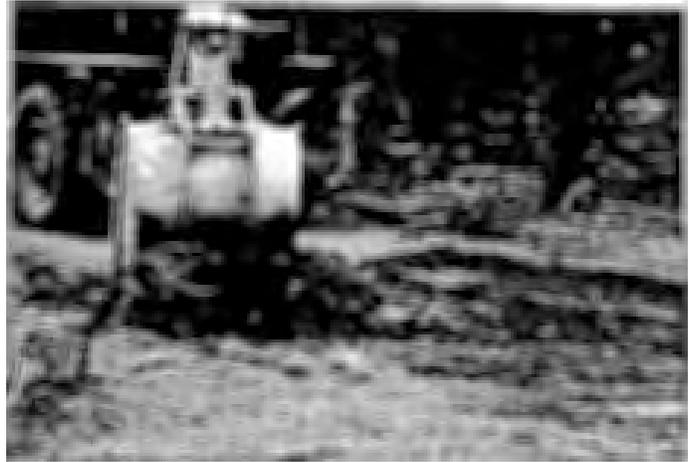
Figure 8. Illustration of topsoil replacement. (Williams)

3) Replace topsoil, duff, and seedbearing organic material over the scarified surface (see Figure 8). Replacement of this material is critical to revegetation and mixing of layers should be avoided.

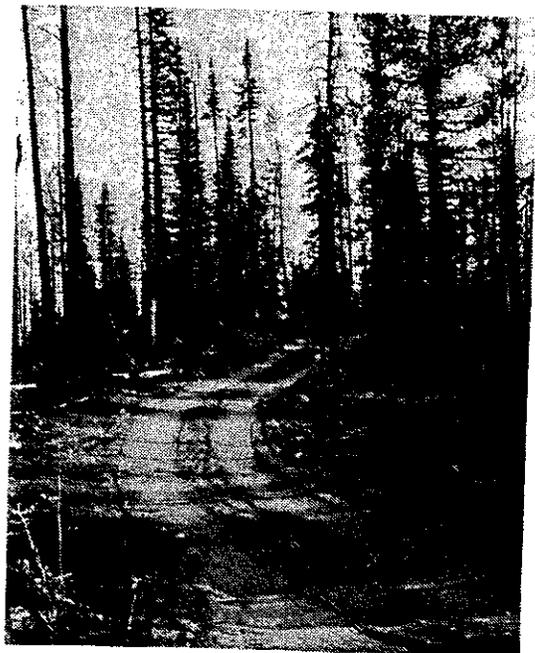
Figure 11. Bulldozer fireline prior to rehabilitation. (Bundros)

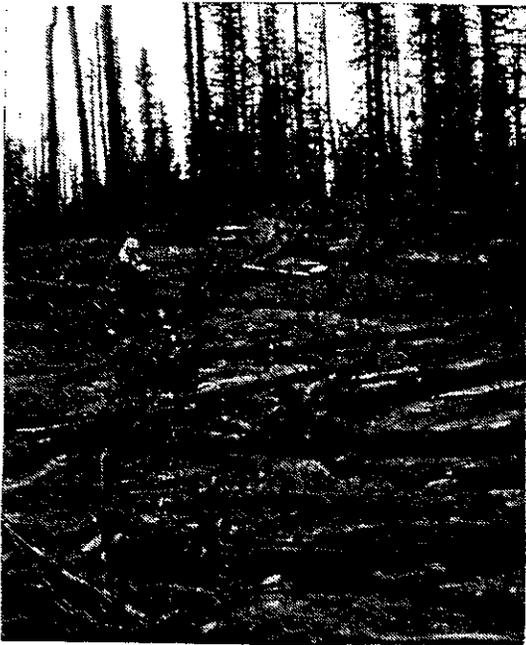
Figure 12. Bulldozer fireline following rehabilitation. (Bundros)

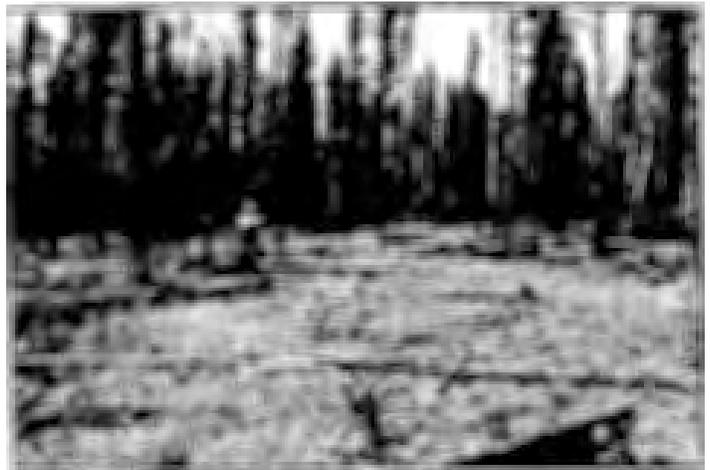
Figure 14. Bulldozer fireline following rehabilitation. (Eggers)

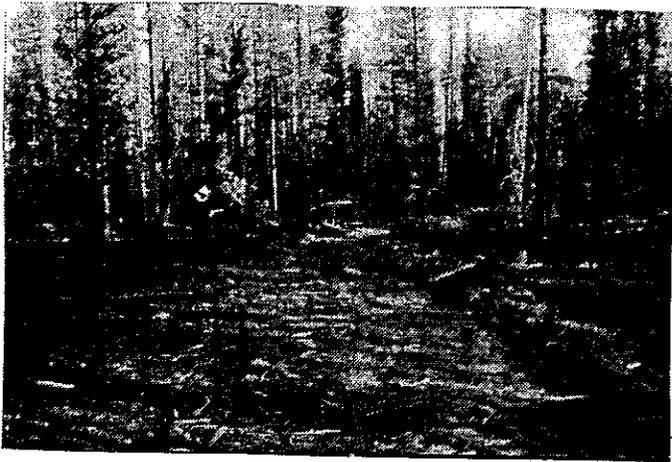
Figure 13. Bulldozer fireline prior to rehabilitation. (Bundros)

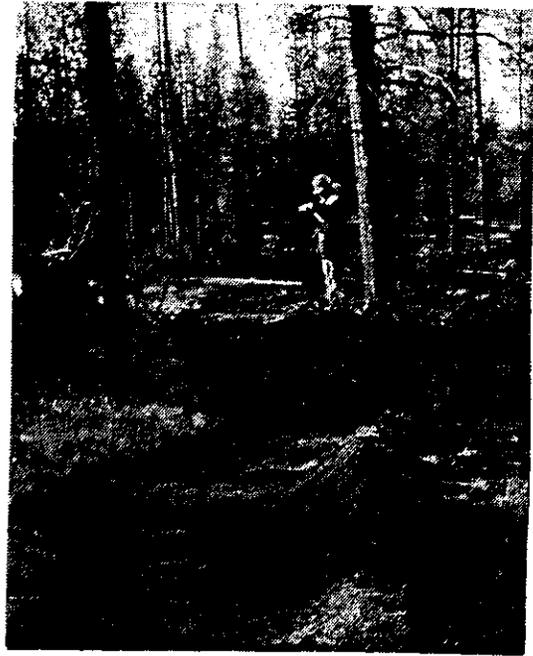
Figure 17. Hand fireline prior to rehabilitation. (Bundros)

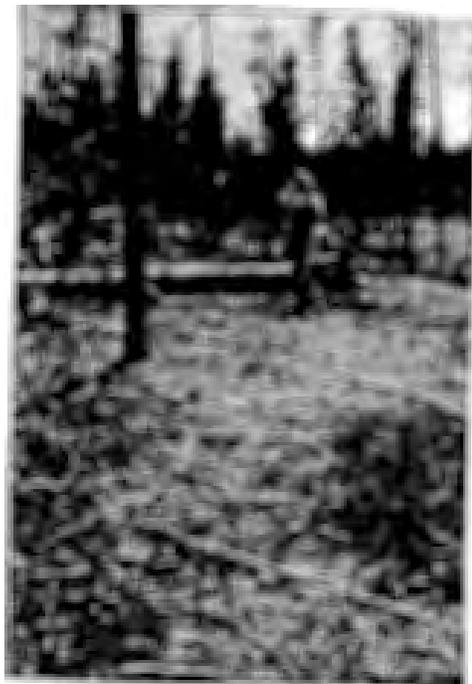
Figure 18. Hand fireline following rehabilitation. (Ruchman)

Hand fireline rehabilitation proceeded in a progression similar to bulldozer fireline. Flush-cutting stumps and water bar construction were performed as the first steps when possible. Performing these early minimized the disturbance of replaced topsoil. Topsoil replacement was completed by crews using hand tools. In most cases, some scarification of the compacted subsoil layer occurred as the topsoil was being re-applied. Sod, duff, and organic debris were returned to near original positions. Mixing was avoided. Following topsoil replacement, slash was scattered over the surface to protect the disturbed area from wind and water erosion. This also enhanced the microclimatic conditions. Figures 17 and 18 illustrate examples.

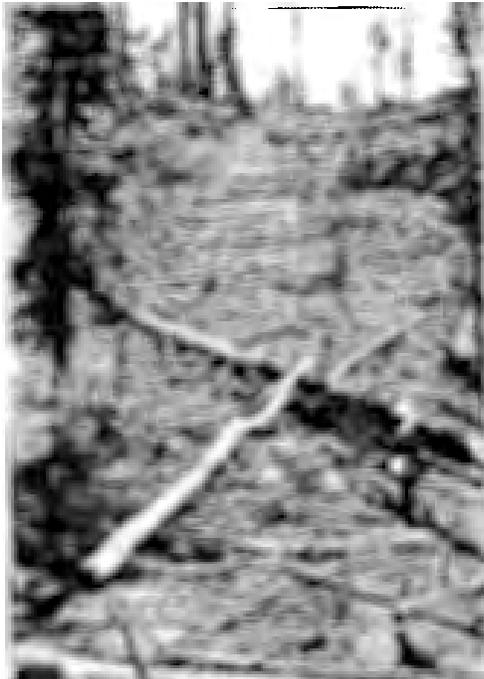
Figure 20. Black Bear Canyon Photo Point following rehabilitation, 10/88 (Eggers)

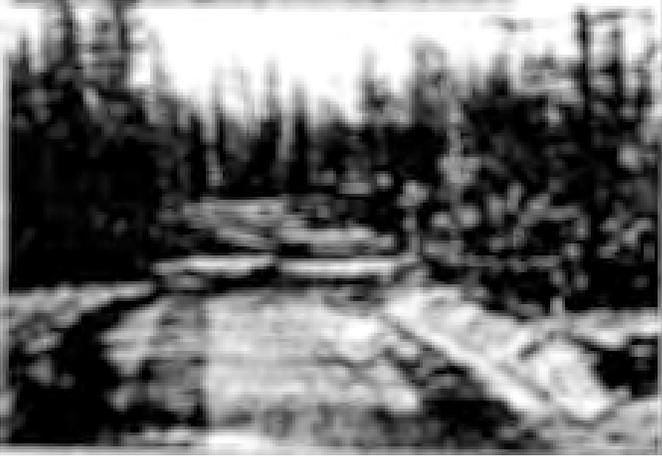
Cougar Creek, north of West Yellowstone, Montana, was the location of approximately 7 mi of bulldozer firelines. These firelines were located on a stream terrace between the Cougar Creek and Duck Creek floodplains. Terrain at this site was generally level and sloping towards the river. Vegetation was mostly lodgepole pine forest with intermixed grassy meadows. Being adjacent to an active floodplain, the soils were mostly alluvial. Three photo points were installed at this site. The one illustrated in Figures 23 through 26, is representative of the site.

Figure 23. Cougar Creek Photo Point prior to rehabilitation, 9/88. (Bundros)

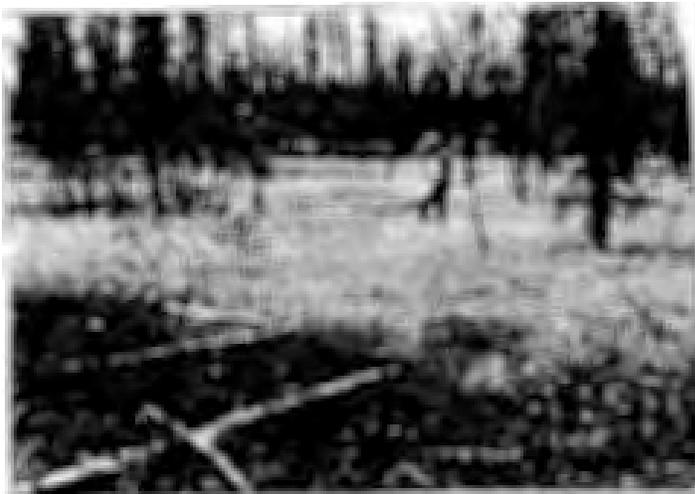
Figure 24. Cougar Creek Photo Point following rehabilitation, 10/88. (Eggers)

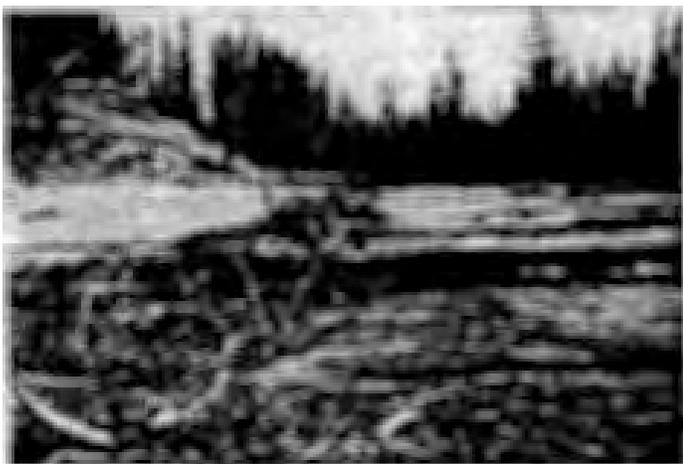
Figure 28. Sage Meadows Photo Point following rehabilitation, 10/88. (Eggers)
