# MINE SUBSIDENCE EVENT AT WASHINGTON WEST APARTMENTS<sup>1</sup>

David B. Wilson<sup>2</sup>, Mitchell W. Weber,<sup>2</sup> John Purdy,<sup>2</sup> and Patricia Acker<sup>3</sup>

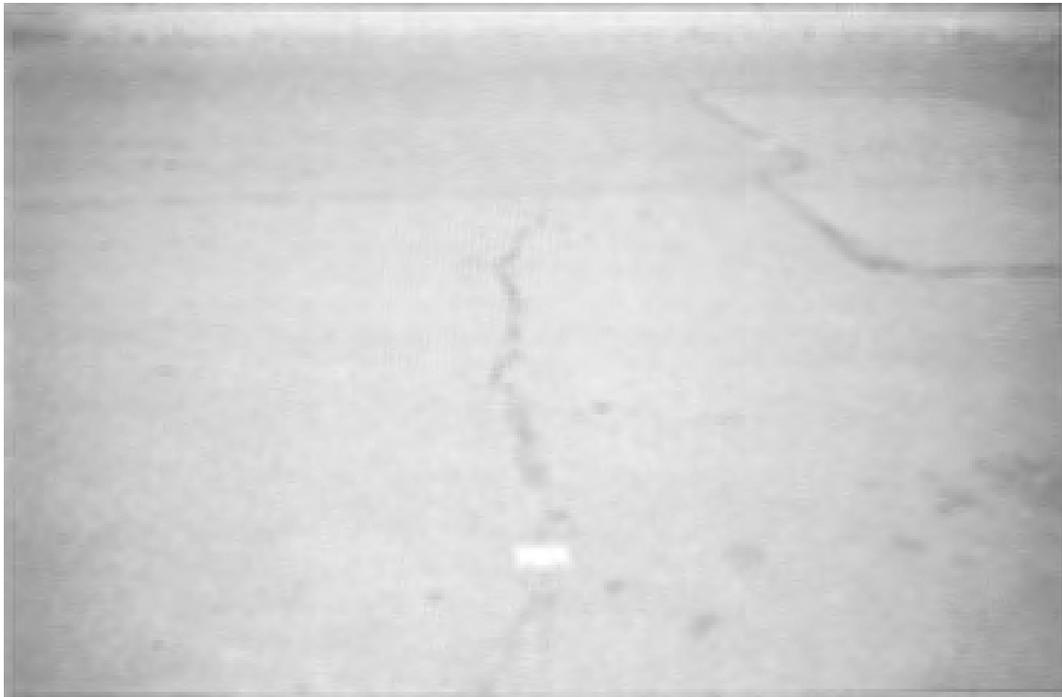
A walk-through visual survey of the building and grounds revealed several indications of lateral and vertical movements. Inspection personnel recorded 3/4-in lateral movement at the expansion joint. About 200 cracks were observed in the walls and floors of the public areas of the building, including hallways, stairwells, storage areas, the boiler room, the day room, and office spaces. Dilation of the cracks ranged from tight to several millimeters. Some of the previously repaired cracks had reopened. Vertical or torsional movement of the building was not determinable during the site visit. Exterior evidence of ground movements included observations of tension cracks in the pavement of Washington Avenue, lateral displacement of street curbs and sidewalks, and broken gas and water lines in the immediate vicinity of the apartment building. Fig. 2 shows a tension crack in the pavement of Washington Avenue along the front of the apartment building.

Figure 2. Typical tension crack in the pavement of the streets surrounding the Washington West Apartment building.

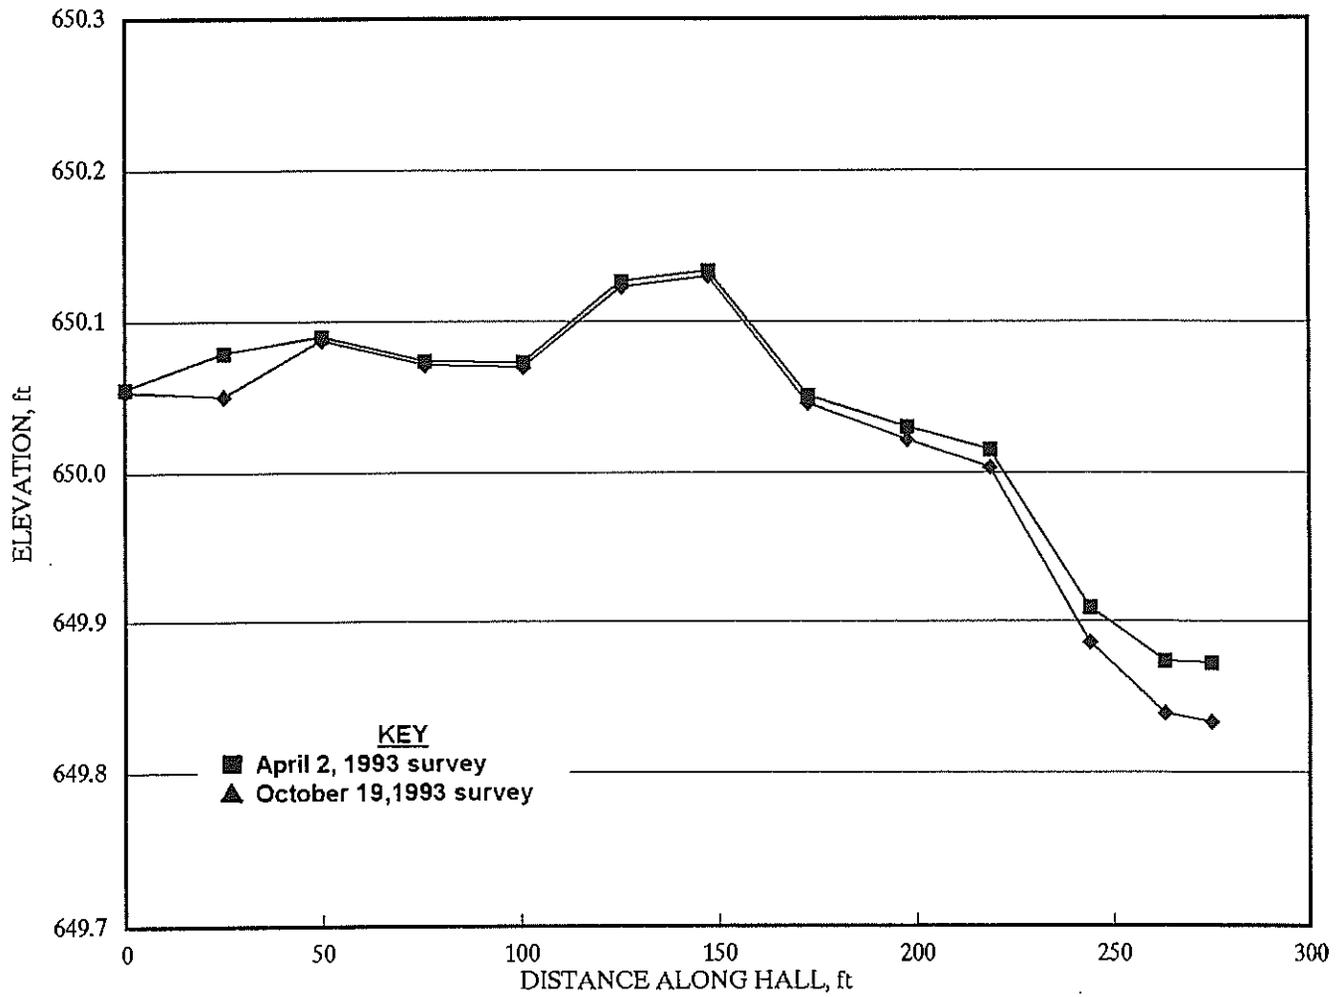
Typical movements along the hallway centerline are presented on fig. 3. This figure shows that most of the settlement typically occurs within the northernmost 60 ft of the building. The apparent total settlement is 3.36 in along the north-south axis of the building and 1.0 in along the transverse direction, with the northeastern corner of the building having settled more than the northwestern corner. A one-month downward movement of 0.1 in was recorded during April 1993. Additional downward movements of 0.36 in vertical and 0.3 in transverse occurred between April and October 1993.

Figure 3. Plot of centerline profile showing typical vertical settlement in the northern portion of the apartment building.

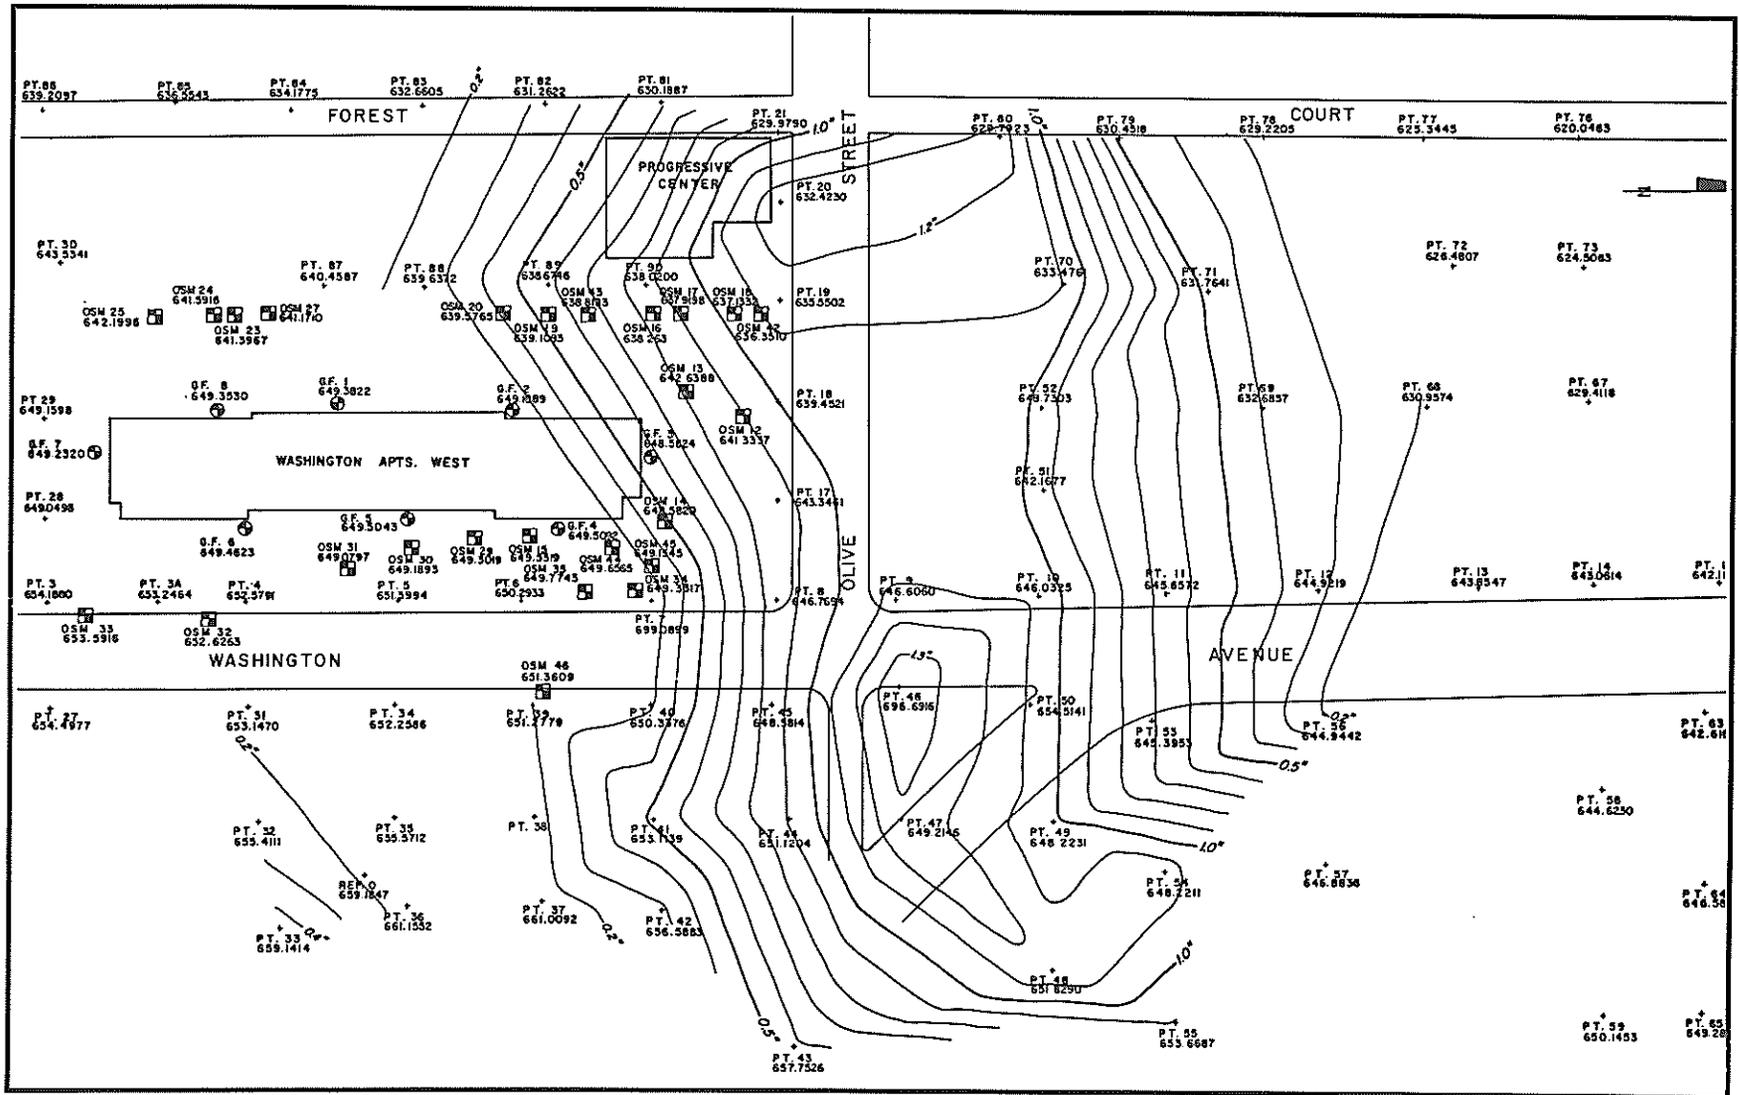
Ninety vertical survey points were established outside the building. Fig. 4 is a plot of the measured settlement at each survey point indicates a trough pattern of subsidence in the area to the northeast of the apartment building. The maximum settlement of about 1.4 in occurred in the April to October 1993 monitoring period. This settlement pattern is in agreement with the observed tension cracks that have developed in this area and the deformed shape of the building, according to the interior survey and crack gage monitoring analysis.

Figure 4. Settlement contour plan of the areas around the Washington West Apartments.
