**ABANDONED DEEP MINE SUBSIDENCE INVESTIGATION
AND REMEDIAL DESIGN,
INTERSTATE 70, GUERNSEY COUNTY, OHIO**

Abstract. A two thousand linear foot, undermined section of Interstate 70 in Guernsey County, Ohio experienced settlements due to pothole type subsidence events within the travel lanes, shoulders and adjacent right-of-way areas. Potholes measured approximately ten feet in depth and width. The subsidence occurred after the dewatering of the abandoned deep mine during auger mining operations west of the site. A two-phase emergency investigation was undertaken by the Ohio Department of Transportation (ODOT) and Gannett Fleming Corddry & Carpenter (GF). The purpose of the investigation was to assess the immediate danger of potholes occurring in the traveled lanes and paved shoulders, to identify the subsidence mechanisms, and to design a remediation program. Phase one investigations involved the review of existing subsurface data, the advancement of shallow borings and the performance of multiple geophysical surveys including ground penetrating radar, seismic refraction and electromagnetic terrain conductivity. The Phase one investigations did not reveal the presence of subsidenc

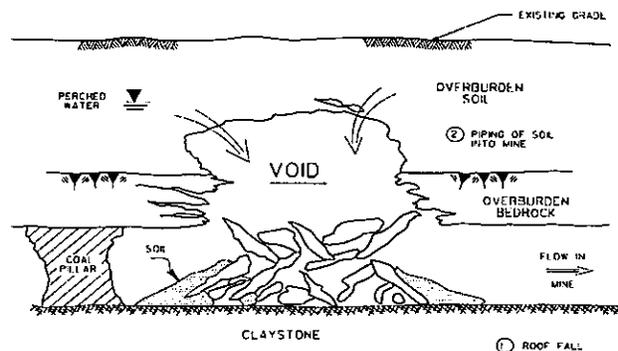
FIGURE 8: SUBSIDENCE MECHANISMS

Based upon the data collected, two main mechanisms were identified as the most likely sources of the ground settlements, or subsidence features, observed at the project site. These mechanisms are mine roof failure and piping of soil into the mine void.

Dewatering of the mined interval and the reduction of static water levels in overburden soils, due to the adjacent auger mining operations, is suspected to be the direct cause of the mine roof failures. In addition to the removal of buoyant forces on the overlying soils and bedrock, lateral restraining hydrostatic pressures were removed from the coal pillars. Combined with the weakening of the coal due to exposure to air, these changes in the state of stress of the coal pillars are believed to have lead directly to the failure of coal pillars, the mine roof and the overburden soils.

Phase One and Two boring data indicate that: the mine was flooded; overburden soils were saturated to approximately elevation 800 ±; and the bedrock was acting as an aquiclude. As the mine pool was drawn down by the auger mining operations and failures of roof rock occurred, a downward gradient between the soil and the mine interval was created. This downward flow of water within the overburden soils is believed to have carried soil into the mined interval, through the roof collapses. In addition, downward flow within subsidence features is expected due to the disturbed and potentially loose nature of the soils within subsidence features. Thus, subsidence features became larger and provide a mechanism for continued settlement. Figure 8 Illustrates

the suspected mechanisms of subsidence.
