MINE SUBSIDENCE INVESTIGATIONS IN HILLSLOPE/LANDFILL AREAS¹

James W. Mahar PhD/LPG and David A. Berner BSCE/EIT²

Abstract. The procedures for carrying out three mine subsidence investigations in damaged homes on and adjacent to slopes and landfills are discussed in this paper. The procedures basically involve a review of the geotechnical/coal mine literature, field studies of the damage to structures and site specific topographic/geologic conditions and instrumentation to monitor ground movement. In cases where the valley is shallow (less than 15 M [50 ft] of re-lief) and bedrock is exposed, precise level line surveys can be carried out on settlement points placed in a profile line from the crest to the floor of the valley. In landfills and deeper valleys where rock is not exposed, bore holes should be rig drilled and settlement points, extensometers and/or inclinometers used to identify the nature of any ground movement. Observations of rock disturbance in the outcrop exposures or in the cores provide an index of potential mine subsidence movement. The absence of such disturbance indicates that the hillslope or landfill is not being affect-ed by failure at mine level. The techni

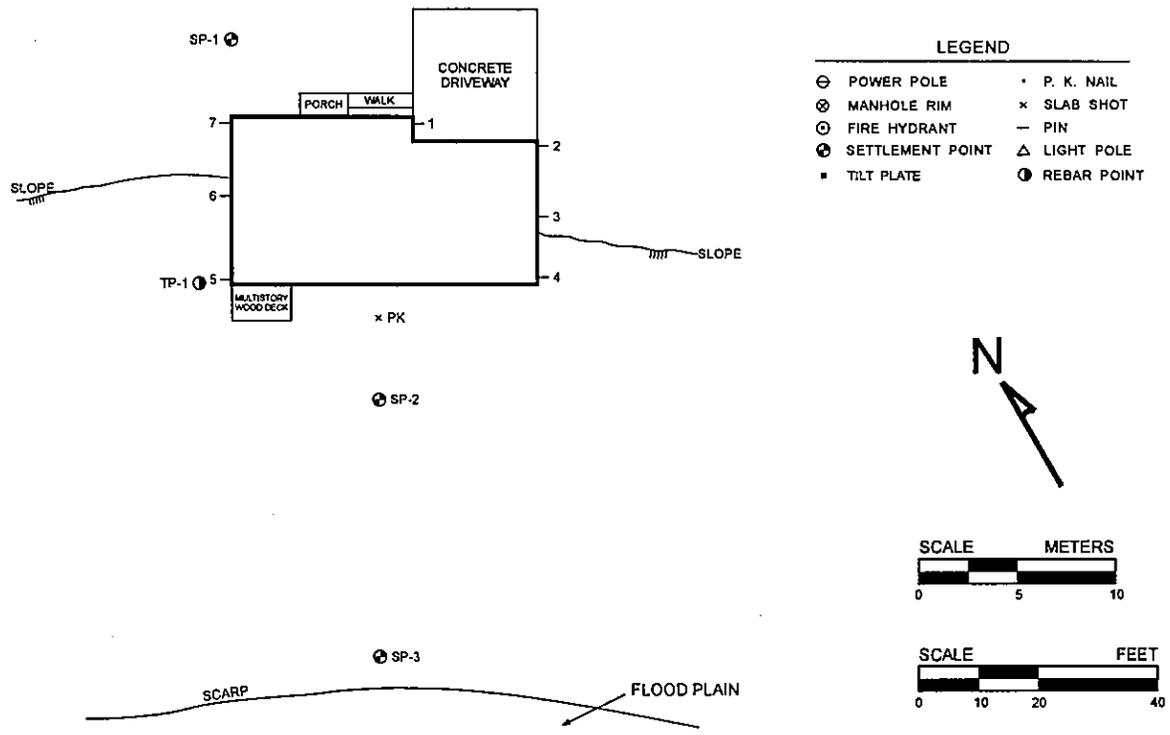
FIG. 1 PLAN MAP SHOWING THE LOCATIONS OF MONITORING POINTS ON AND AROUND THE FIRST CASE - CATLIN, ILLINOIS

To determine the cause of the damage, a series of settlement points were installed in hand augered bore holes at various points along the ground surface profile (Figs 1 and 2). Because the valley is shallow (10 m [34 ft] from crest to channel) and rock was exposed in the stream banks, settlement point instrumentation was adequate to evaluate the ground movement. One settlement point was driven to refusal and concrete-anchored in the shale exposed in the creek bank (SP-5). There is no indication of bedrock disturbance along the exposed length of the stream valley. Two other settlement points were driven to refusal in bedrock in the depression and on the outside edge of the scarp (SP-4 and SP-3), respectively. The fourth and fifth rods were driven to refusal in the fill slope behind the home and in soil in front of the residence.

If subsidence is responsible for the ground movement and damage to the structure, the center of the movement zone must be located south of the home. In the instrumentation arrangement, the downslope

extensometers (SP-3 to SP-5) are used to look for down-ward movement in rock. Since the mode of failure in mine subsidence begins at mine level below the soil/rock contact and progresses upward, the settlement points founded in rock should have significant downward movement if mine collapse is responsible for the damage. In the absence of downward movement in the rock, the settlement points installed in the fill and overburden soils should show upward and downward displacement consistent with moisture content changes and creep in the hillslope soils.

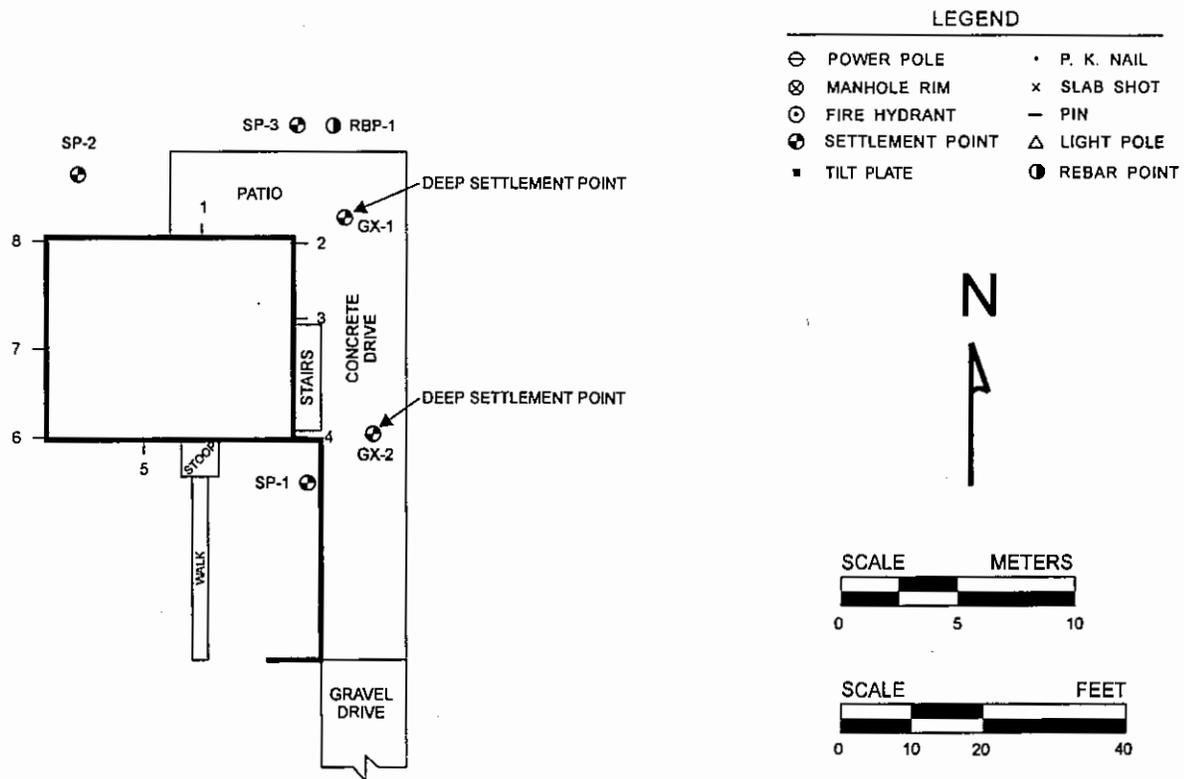
FIG. 3 PLAN MAP SHOWING THE LOCATIONS OF MONITORING POINTS ON AND AROUND THE SECOND CASE - STREATOR, ILLINOIS

The next case involves a dwelling on a landfill in which deep settlement points were installed to check the ground movement in rock above mine level (see Fig. 3 and 4). The landfill was placed to partially cover a valley which apparently was a former sand and gravel operation. The home is a single story dwelling with a walkout basement. The property is located 20 to 30 m (70 to 100 ft) south of the valley bank. Soil and rubble consisting of tires, concrete blocks and organic debris litter the side slopes of the former pit. Apparently, fill material was used to level out the area for the construction of the home.

The residence is a one-story, wood-frame structure with a full concrete block basement. The damage was concentrated on the east side of the basement where diagonal cracks 3 to 6 mm (1/8 to 1/4 in.) wide were present in the southeast and northeast corners, respectively. The wall tilted out at the top 20 mm/0.6 m (13/16 in./2 ft) and the floor slab had a large crack normal to the east wall. The greatest damage was in the northeast corner of the basement closest to the center of the landfill. Several small depressions were observed in the back yard between the home and the former sand/gravel pit. Abandoned room and pillar mines are located 18 to 21 m (60 to 70 ft) below the ground surface.

Several attempts were made to install settlement points in augered bore holes near the northeast corner in the area of greatest damage (Figs. 3 and 4). Voids were encountered between the ground surface and the obstructions. Each attempt to drive the settlement points was met with premature refusal in which the rods could not be driven below shallow obstructions in the fill. In order to determine whether the damage was caused by mine subsidence or near

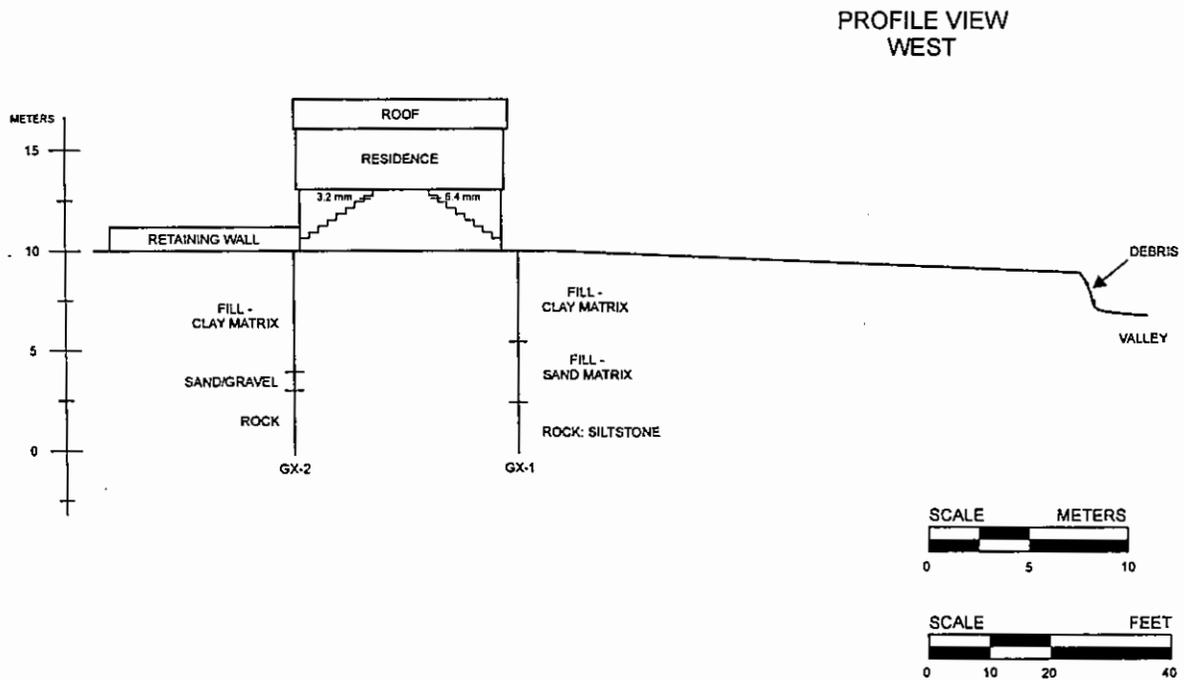
FIG. 4 PROFILE MAP SHOWING THE SECOND CASE - STREATOR, ILLINOIS

surface fill settlement, two deep settlement points were anchored 2.4 m (8 ft) into rock. The settlement points were located near the northeast and southeast corners and were placed in bore holes advanced with a drilling rig. To confirm that the anchor points were founded in rock, cores were taken 2.4 m (8 ft) below the soil/rock contact. Continuous split spoon samples were obtained in the soil profile to establish the thickness of the fill and to determine the nature of the overburden materials. Precise level line surveys were carried out to measure any downward movement in the settlement points as well as in monitoring points placed on the residence. After drilling into the bedrock, a single settlement point rod was grouted in each bore hole at a depth of approximately 10 m (33 ft) below the ground surface. The bore hole results show the presence of 7 to 7.7 m (23 to 25.4 ft) of fill. The fill consists of decomposed brick fragments, coal, glass, asphalt and organic particles/layers in a lean clay or sand matrix. A 0.6 m (2 ft) thick horizon of very soft and wet fill was encountered between depths of 2.7 to 4 m (9 to 13 ft). The fill matrix coarsened from south to north toward the former sand and gravel pit. Rock was encountered roughly 7.6 m (25 ft) below the ground surface. The rock is a light to medium gray siltstone. The upper 0.6 to 0.8 m (2 to 2.5 ft) of rock below the contact is weathered. Core recovery and RQD values in rock are 83 to 90% and 63 to 69%, respectively. Bedding is horizontal and the core showed no evidence of disturbance. However, it was necessary to monitor the ground movement because the core results alone are not completely conclusive. Moreover, mine subsidence could take place by downward movement of the roof primarily as a unit with little or no bedding disturbance or rotation.

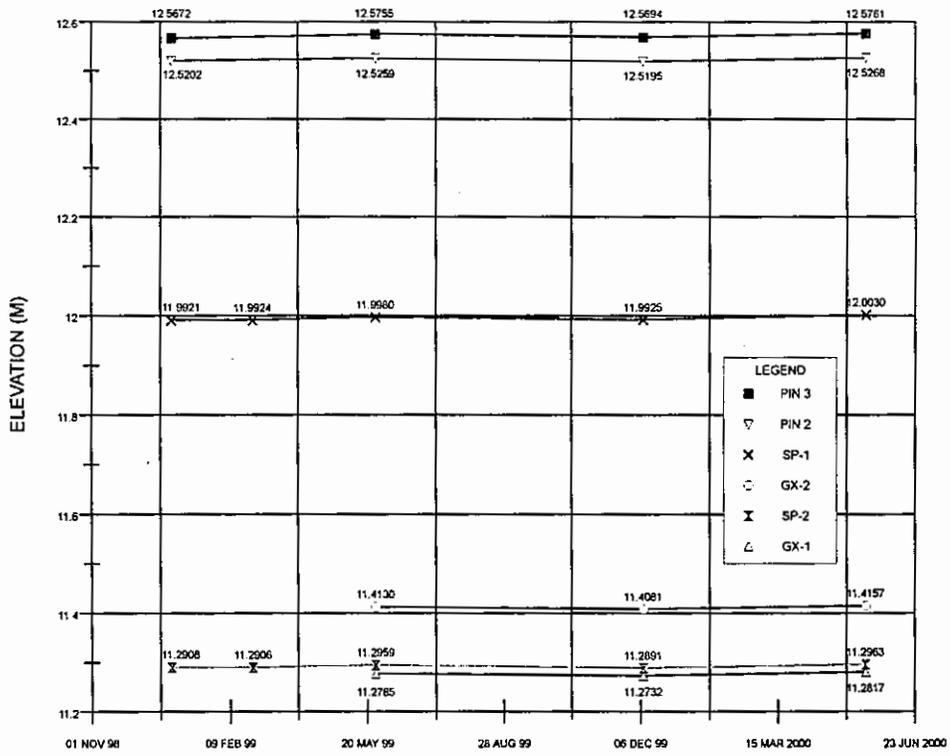
FIG. 5 PLOT OF ELEVATIONS ALONG THE PROFILE VIEW OVER TIME

The settlement data along with the bore hole and damage studies clearly showed that the damage to the structure was not caused by mine subsidence. Moreover there was no consistent downward movement of the settlement/monitoring points that would be indicative of mine subsidence (Fig. 5). Clearly the damage was caused by settlement of the soft and organic rich layers in the fill and possibly downward migration of the finer soil particles (piping) into the fill voids.

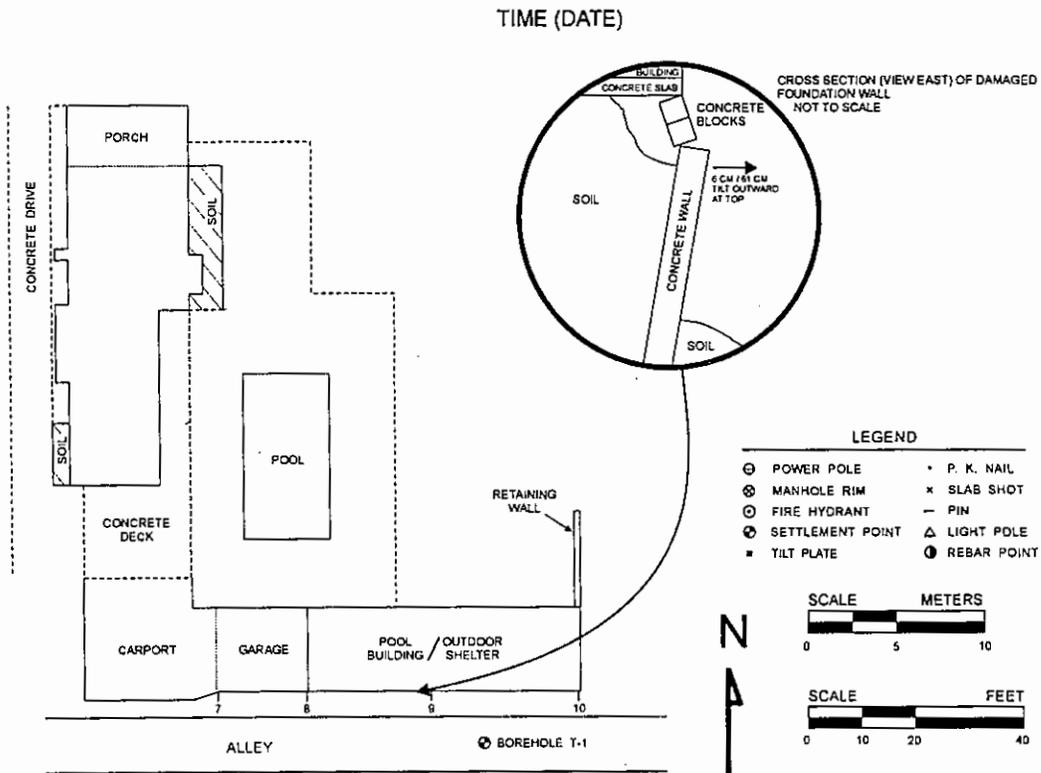
FIG. 6 PLAN MAP SHOWING THE LOCATIONS OF MONITORING POINTS ON AND AROUND THE THIRD CASE - SPRING VALLEY, ILLINOIS

a ridge in Spring Valley, Illinois (see Figs. 6 and 7). The ridge is approximately 30 m (100 ft) vertically above the Illinois River channel. The home has an inground pool and several outbuildings at the top of the slope. The initial inspection revealed a severely buckled 2.4 m (8 ft) high foundation wall of the outbuilding adjacent to the slope with small scarps and depressions in the alley behind the buildings. The alley adjoining the buildings is supported by a 0.9 m (3 ft) high timber retaining wall which runs parallel with the ridge. The timber wall is bowed out 0.6 m (2 ft) at the top. Dwellings are present on the slope below the alley.

The slope down to the river does not have any rock outcrops or obvious scarps indicative of hillside movement. To determine whether the damage was induced by mine subsidence or is being caused by slope creep/bearing failure, a 30.3 m (99.4 ft) bore hole was drilled with a rig in the alley adjacent to the damaged structure (see Figs. 6 and 7). Split spoon sampling and coring were carried out to a depth of 23.5 m (77.2 ft) in the soil. Rock cores were obtained below 23.5 m down to a depth of 30.3 m (99.4 ft). A deep extensometer rod was installed in bedrock at the bottom of the hole. A second extensometer rod was installed 2 m (6 ft) below the rock/soil contact. The inclinometer casing was placed at a depth of 10 m (33 ft) in the upper part of the soil. The bore hole results show 2.3 m (7.5 ft) of loess above glacial till. The majority of the wind-blown deposit is a soft, moist to wet lean clay with fine sand. The underlying till is stiff to hard lean clay to clayey sand. A perched ground water table was found 3.2 m (10.5 ft) below the alley surface. The rock is a gray to olive green shale interbedded with limestone. The bedding in the core samples is horizontal.

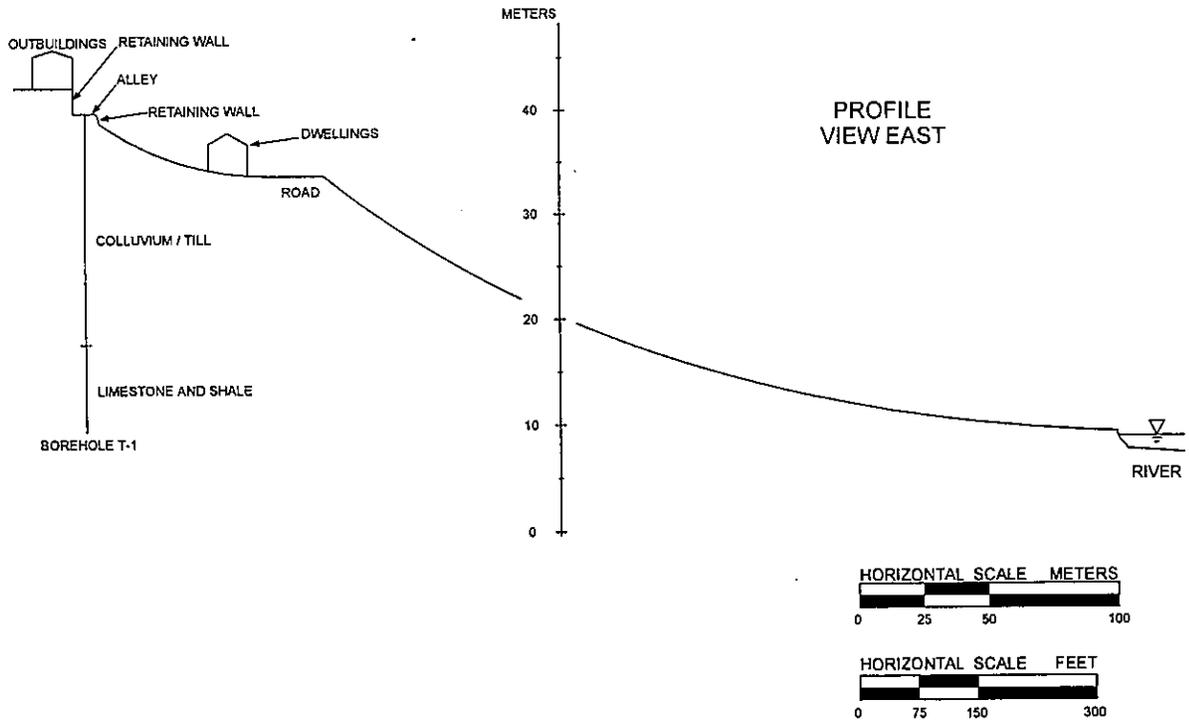
FIG. 7 SLOPE PROFILE SOUTH OF THE THIRD CASE - SPRING VALLEY, ILLINOIS

Installation of the inclinometer will allow measurement of the near surface horizontal slope movement which may be responsible for the damage. The extensometers will be used to measure any vertical elevation change in the rock. If mine subsidence is causing the damage, both extensometer rods will undergo downward displacement with the deepest anchor showing the greatest movement.
