USES OF THE BOREHOLE CAMERA IN HYDROLOGIC INVESTIGATIONS RELATED TO COAL MINING¹

Jay W. Hawkins² and Robert S. Evans

Proceedings America Society of Mining and Reclamation, 2004 pp 847-859

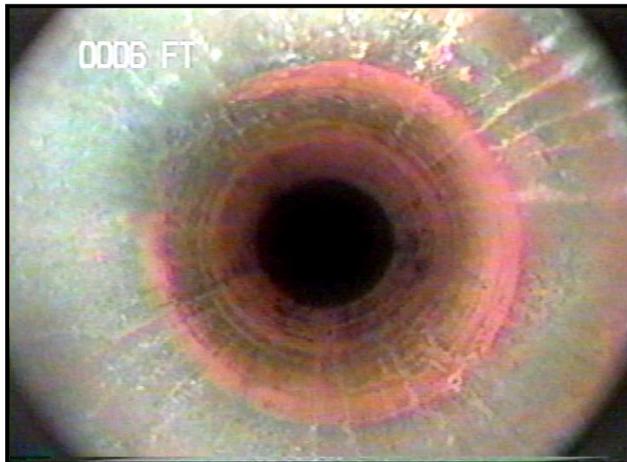
The borehole camera was used to view the condition of a significant number of the wells. In the course of inspecting the condition of the wells, historic water levels (Fig. 1) were ascertained

Figure 1. Iron oxide ring indicating the historic water level.

from the upper limit of extensive iron staining and casing corrosion in several wells. Most of the wells had iron concentrations exceeding 1.0 mg/L, which is well above the threshold for iron precipitation and staining. The observed water level for wells where a historic water level was determined was between 14 and 24 feet lower.

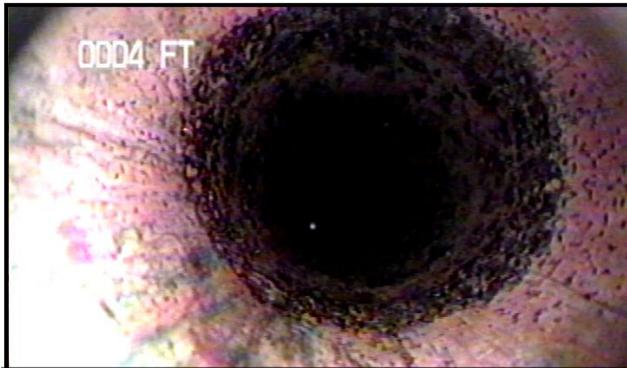
Figure 2. Upper limit of a corrosion zone on steel casing.

The location of the staining or corrosion (Fig. 2) is an indication of the average water level over time. While the notation of staining or corrosion may not be conclusive as to what the exact water level was prior to mining in any single well, observing this phenomenon in several wells in close proximity to one another is strong evidence that there has been a widespread change in

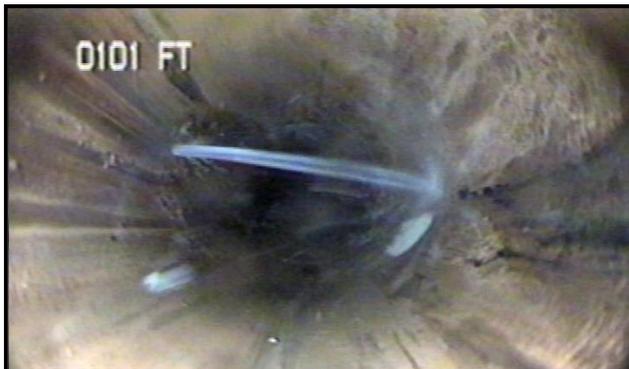
Figure 3. Rupture in PVC casing allowing mine water to enter water well.

The borehole camera was employed to help determine the cause of the change in water quality. At the 102-foot level a rupture (Fig. 3) in the casing was observed. Mine water under high pressure was streaming through a break in the PVC casing and then flowing unimpeded downward. The reason for this casing breach is not known.

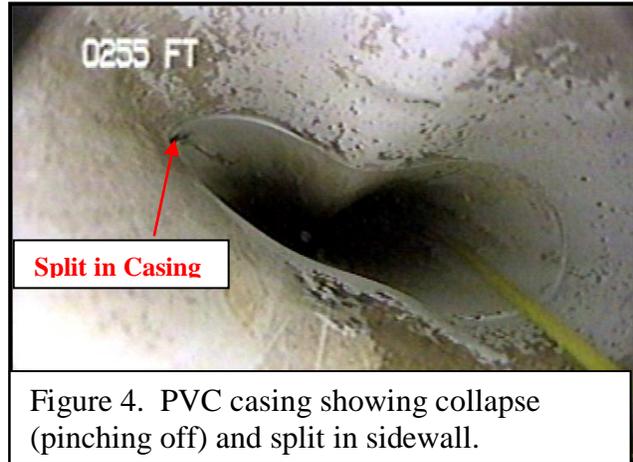
Figure 4. PVC casing showing collapse (pinching off) and split in sidewall.

and to determine the possibility of extracting the transducer. At the 256-foot level the casing (schedule 40 PVC) had collapsed or pinched (Fig. 4). The process of pinching off the casing, a split formed at a joint and a significant ground water inflow from overlying aquifers recharged the monitoring well bore. This was the source of the rapid rise in water level observed. The collapse of the casing is what prevented the removal of the pressure transducer.

It is likely that additional subsidence movement above the mine (several years) after abandonment was the cause of the casing failure. This well has been replaced with a new well using steel casing.

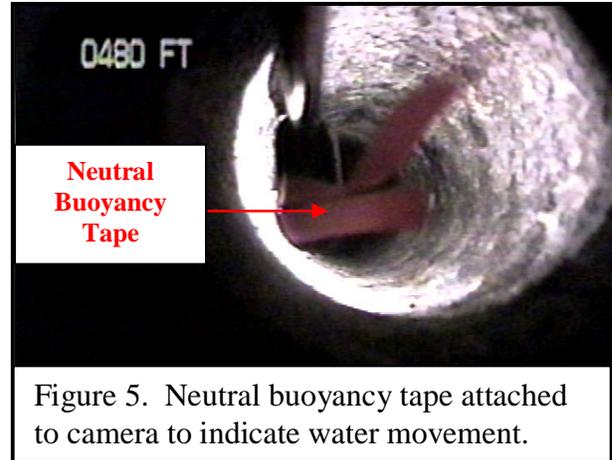
The borehole camera by itself may not be able to note inflow points below the water level, unless there is some variation in the color or clarity of the inflowing water. Therefore, a neutral-buoyancy tape (Fig. 5) was attached to the camera to identify water movement within the well bore, which indicates inflow points and a relative indication of the rate of flow. As

Figure 5. Neutral buoyancy tape attached to camera to indicate water movement.

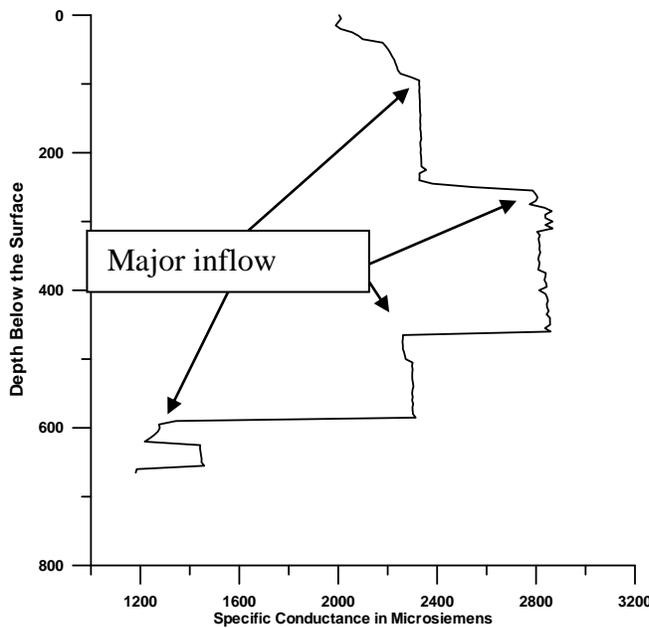
Figure 6. Specific conductance log showing the major inflow points.

Using the camera with a neutral-buoyancy piece of tape, we were able to determine that the artesian well had no less than four discrete major inflow points and several more minor inflow points. These inflow points were confirmed with a specific conductance meter, which was used to log the hole at five-foot intervals. Figure 6 is the specific conductivity log of the artesian well with the location of the major water-bearing fractures indicated by changes in specific conductance.

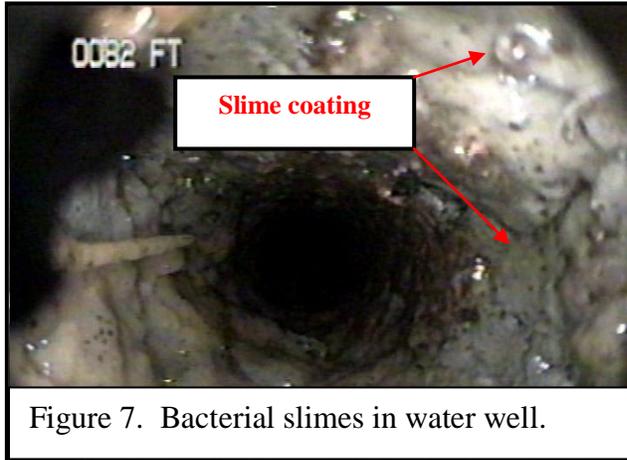
During a routine inspection of a domestic water well in the course of an investigation of alleged yield loss, the presence of massive bacterial colonies (slimes) were noted (Fig. 7). The well is located on ridge adjacent to an underground (longwall) mine panel in Washington County, Pennsylvania.

The bacterial slimes exhibited a variety of colors including translucent white, gray, pink, yellowish, and orange. The well was located in the middle of a horse pasture, so the nutrient source for the large bacterial colonies is likely the nitrates from the horse manure.

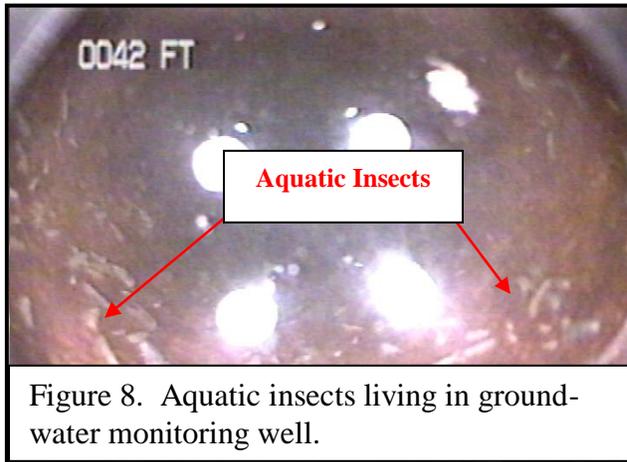
determine its potential for monitoring of a flooding underground mine. The well which had been used for many years no longer had records for the construction details and total depth. While not really a problem in terms potability, this well had a colony of aquatic insects living near the surface of the water (Fig. 8). Although the species of these insects is not known, they

appeared to be some type of amphipod. It is doubtful that pumping from this well would yield any of these insects. This is because they were only found at near the surface and pumping at a lower level should not encounter them.

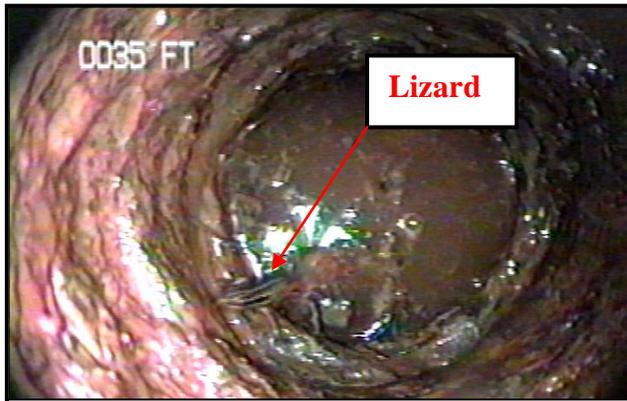
One of the abandoned wells was being capped with a rock. When the rock was lifted a large lizard came out from beneath the rock and unfortunately scurried into the open hole (Fig. 9).

Figure 9. Lizard in domestic water well.

Given the vertical and wet sides of the well, the lizard became permanently trapped.

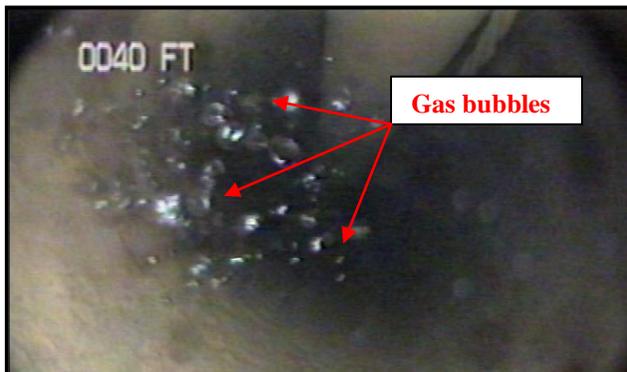
Figure 10. Gas bubbles in municipal water well.

The investigation of potential dewatering of a well field for a small municipal water supplier in Guernsey County, Ohio revealed significant influxes of hydrogen sulfide from fractures intersected by the borehole (Fig. 10). In this well, gas inflow occurred near the 46-foot level and was in the form of periodic

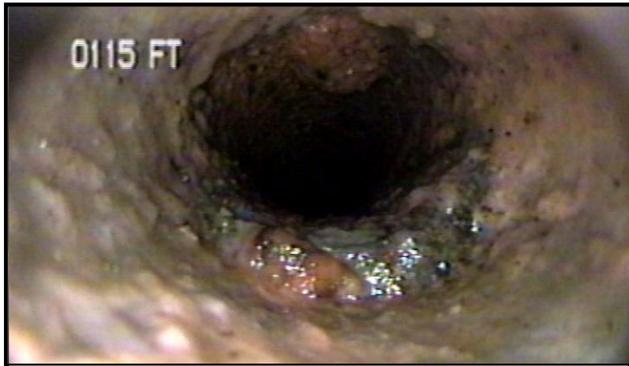
One of the more subtle changes includes slight offsets (Fig. 11) of the borehole caused by adjacent mining. In one case from Washington County, Pennsylvania, an undeveloped domestic

Figure 11. Offset in rock layers caused by subsidence.

water well was situated adjacent to a completed longwall panel. The tensile stresses created by the subsidence caused a 2 to 3 inch offset in the well bore. The offset is partially concealed by bacterial slime.

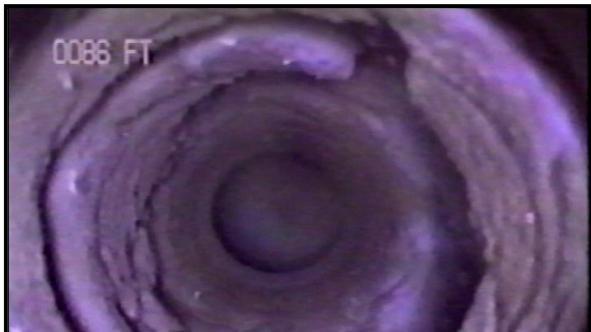
Fractured overburden for an abandoned partially subsided underground mine was viewed using the borehole camera. The fractures (Fig. 12, Fig. 13) are characteristically irregular, sharp edged, and indicative of fairly recent movement. They tend to exhibit an openness that signifies a downward movement caused by tensile stresses from gravitational forces. The fractures tend to be an accentuation of pre-existing horizontal fractures (bedding plane separations) or are an oblique angle.

Figure12. Accentuation of horizontal fractures in borehole.

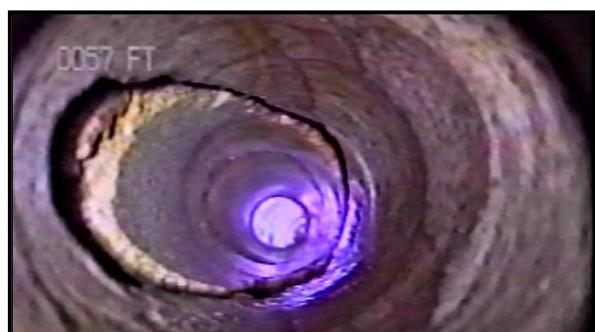
Figure13. Accentuation of oblique fractures in borehole.
