PROBLEMS OF RECLAIMING AREAS AFFECTED

BY MINE FIRES - A CASE STUDY<sup>1</sup>

K. K. Malhotra and P. R. Sinha<sup>2</sup>

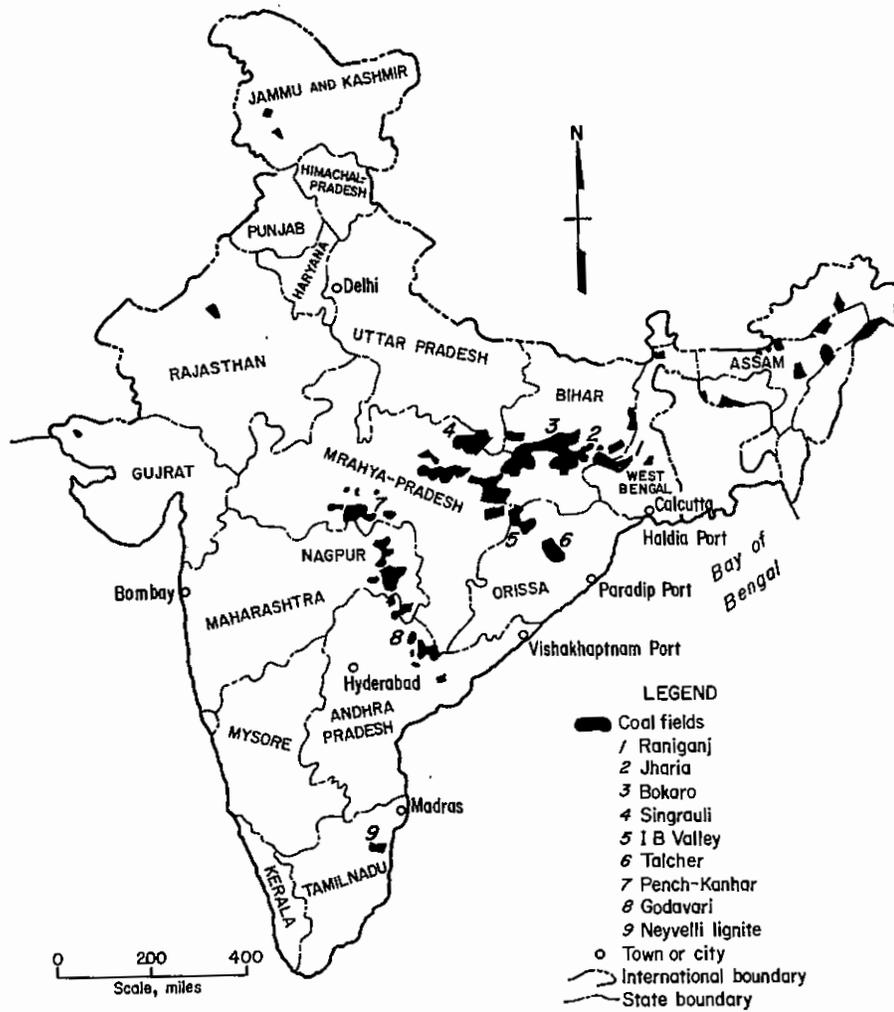
Figure 1.--Major coalfields of India.

The coal industry of India is about 200 years old; the major coalfields, shown in figure 1, occur in sedimentary formations in the eastern half of the country. Most of the coal is bituminous, with some lignite, and is classified as coking or non-coking for reserve estimation. Table 1 summarizes the estimated reserves of each coal type and shows

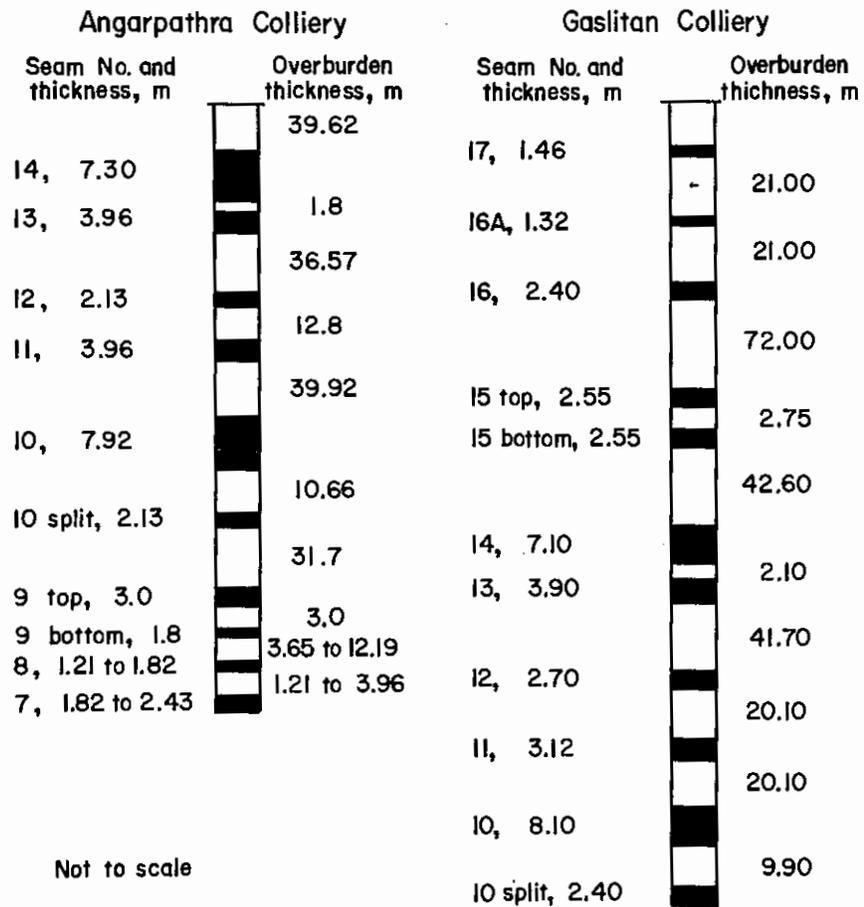
Figure 2.--Vertical location, thickness, and spacing of coal seams at the Angarpathra and Gaslitan Collieries in the Katras area.

The Jharia Coalfield has about 19 mineable seams, labeled 0 through 19 from the bottom to the top of the stratigraphic sequence. Figure 2 shows the vertical locations, thicknesses, and spacing of the seams at the Angarpathra and Gaslitan collieries, which are typical of the mines operating in the area. The upper 11 seams (9 to 19) have less ash than the lower seams and therefore have better coking characteristics; these are the seams that have been mined most extensively to date.
