HOLLOW FILL CONSTRUCTION AT THE AMOS RIDGE EXPERIMENTAL PRACTICE¹

Carl E. Zipper and W. Lee Daniels²

¹Paper presented at the 1989 National Meeting of the American Society for Surface Mining and Reclamation, Calgary, Alberta, Canada. Publication in this Proceedings does not preclude the authors from publishing their manuscripts, either in whole or in part, in other publication outlets.

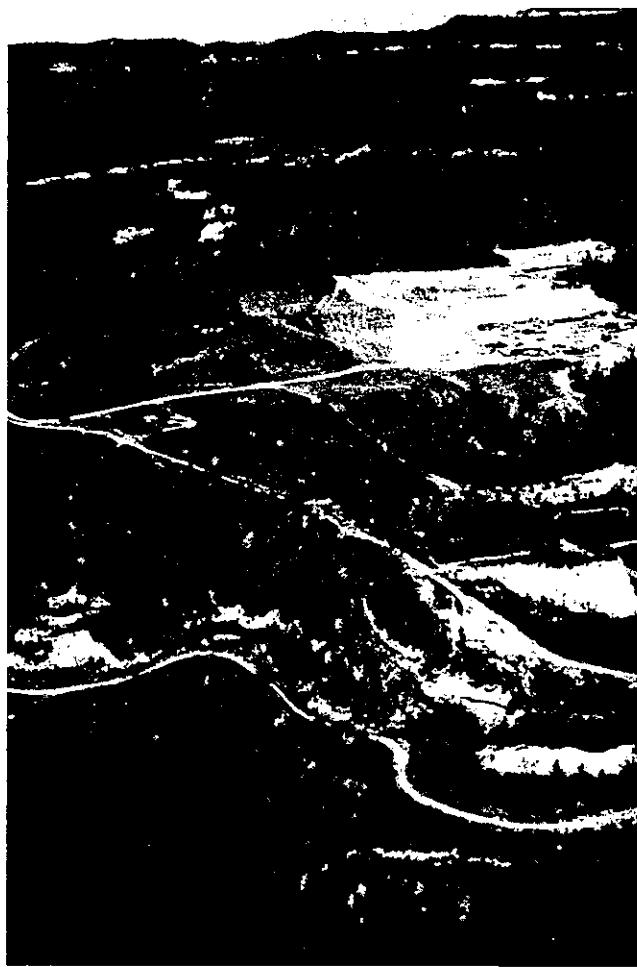
Figure 1. An aerial photograph of the Amos Ridge site in October, 1987. Active mining is shown on the right side of the photo; reclaimed areas are located left of the active mining area. The outslopes of HF1 and HF2 are visible in the reclaimed area; HF3 was under construction at this time. Exposed highwalls above and below the mining site are the result of pre-1977 mining. Experimental plots are visible on the level bench area to the immediate left of HF1.

There were two distinct components to the experimental spoil handling procedures employed in reclaiming the mining site; both were essential to the ultimate result: a stable, environmentally-sound landform with an improved land use potential, relative to the steeply-sloping pre-mining landform (Fig. 1).

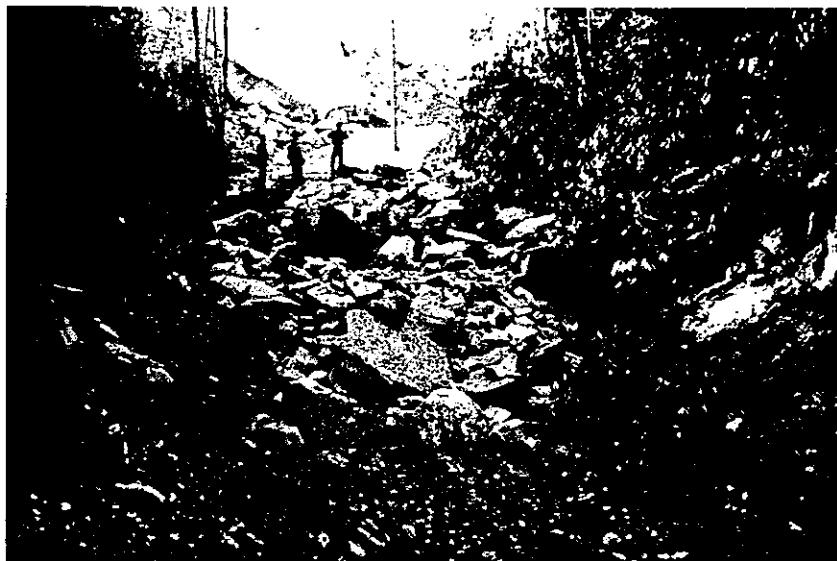
Figure 5. Underdrain of HF3 during construction in December, 1986.

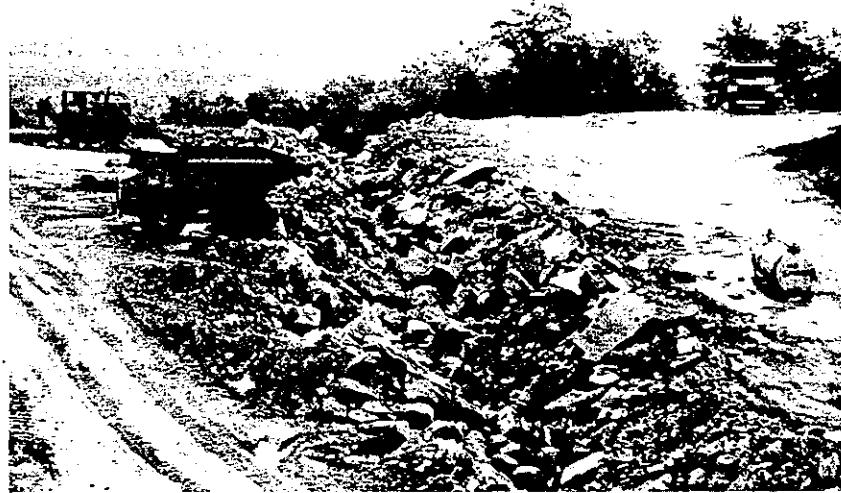
Figure 6. Upper surface of HF2 during the final stage of fill construction, prior to reclamation.

HF3 was the most costly of the three fills, due primarily to the direct cost of establishing the underdrain. There is also a major disadvantage to HF3 from an operational standpoint: the entire drain must be constructed before filling of the hollow can be initiated. The drain runs down the center of the hollow, the precise location where operations are most likely to be disrupted in the event of wet weather. This requirement to install the drain before initiating spoil disposal can act as a major constraint on mining operations. In both HF1 and HF2, drains were constructed as integral components of spoil disposal processes (Fig. 6).
