# REHABILITATION OF A STORM WATER RETENTION BASIN AND PUMP STATION<sup>1</sup>

**Abstract:** An area of tidal lands along San Francisco Bay was mined previously for sand and gravel to provide aggregate materials for the construction of military bases and highways. As the area became urbanized the quarries encountered difficulty operating within increasing environmental regulations. The land values increased and many operations were re-developed for residential and commercial construction. Drainage of storm water to prevent flooding and inundation was provided through the creation of drainage assessment districts. The districts are funded by assessing special taxes on properties within the district. This paper focuses on a situation at a specific site that has been negatively impacted by the operation and management of the drainage facility.

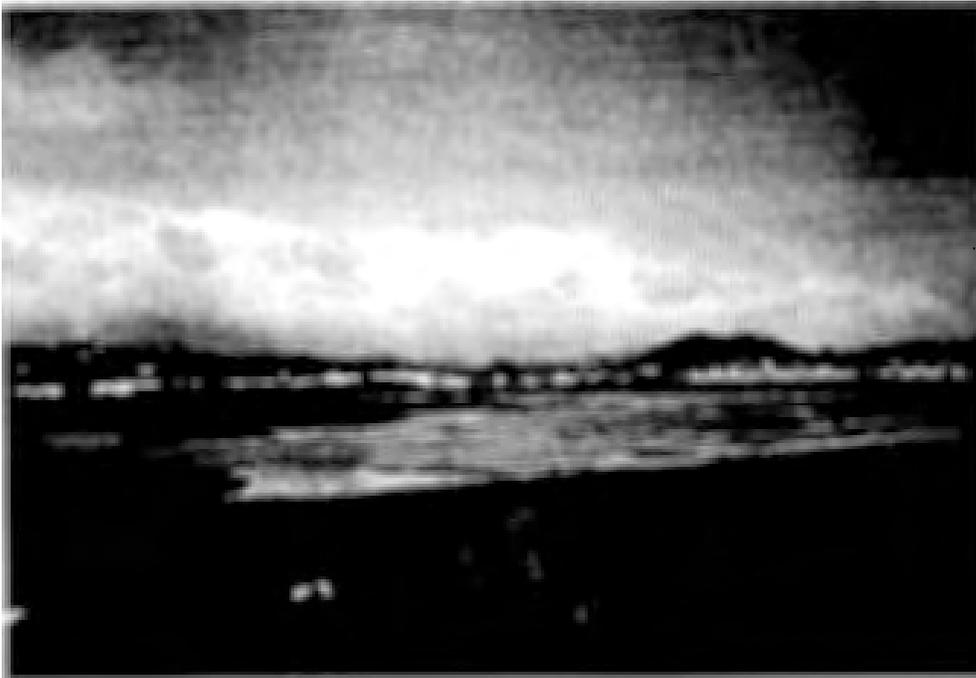
As a result of these two problems adjacent lands have become flooded again and subject to long periods of inundation (Figure 3). Portions of the property that were previously classified as uplands have now become wetlands, and thus come under the

Figure 3. Inundated land north of pump station

- 1) The pond and entrance canal would be excavated to remove accumulated sediment.
- 2) The intakes of both primary pumps would be lowered and the controls reset to start the pump motors at a lower water elevation.
- 3) An auxiliary submersible pump would be installed to operate at lower pond water elevations.

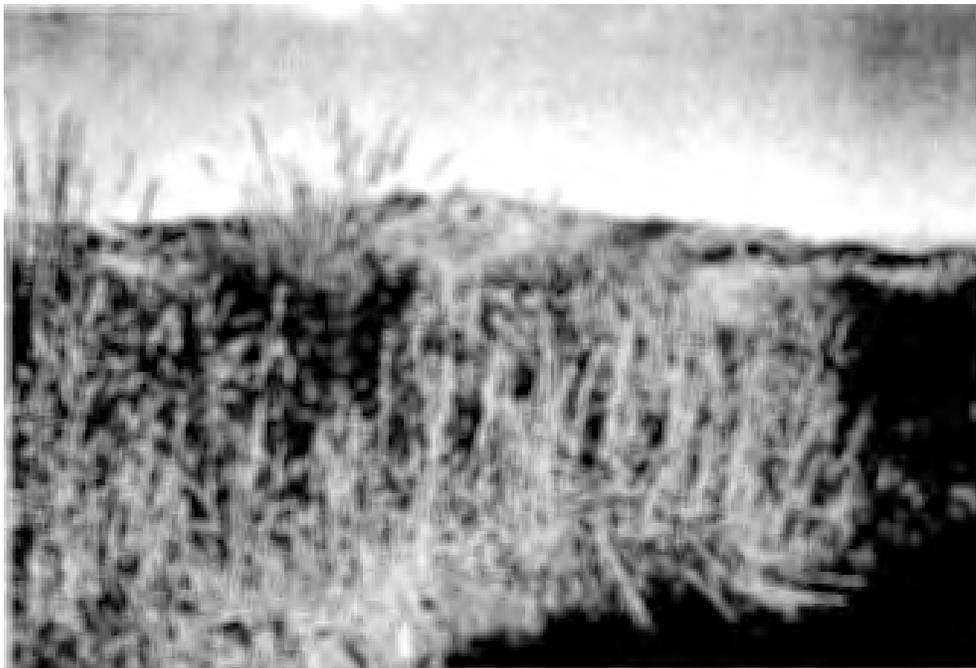
Figure 4. Wetland vegetation

jurisdiction of the U.S. Army Corps of Engineers and attendant regulatory conditions and controls. Development of the property is also hindered by public sentiment over these "new" wetlands (Figure 4). The owners of Canalways filed suit against the District claiming unlawful taking of the land.

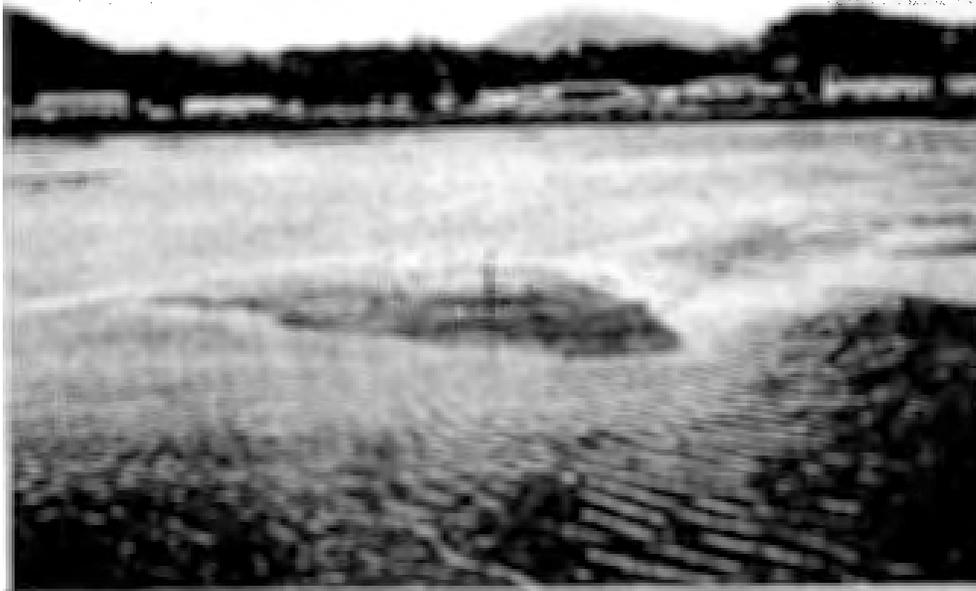
District civil engineers to prepare topographic contour maps. Examination of topographic data revealed that the entrance canal and basin had become filled with sediment to a depth of several feet, greatly reducing the storage capacity for storm water runoff (Figure 5). A study of the original pond design floor elevations compared to the current conditions showed accumulated sediment accumulation of about 5,000 cubic yards. An excavation plan was proposed to remove the accumulated sediment using a dragline and haul the sediment offsite for use as fill to repair damaged levees.

Figure 5. Sedimentation of detention basin

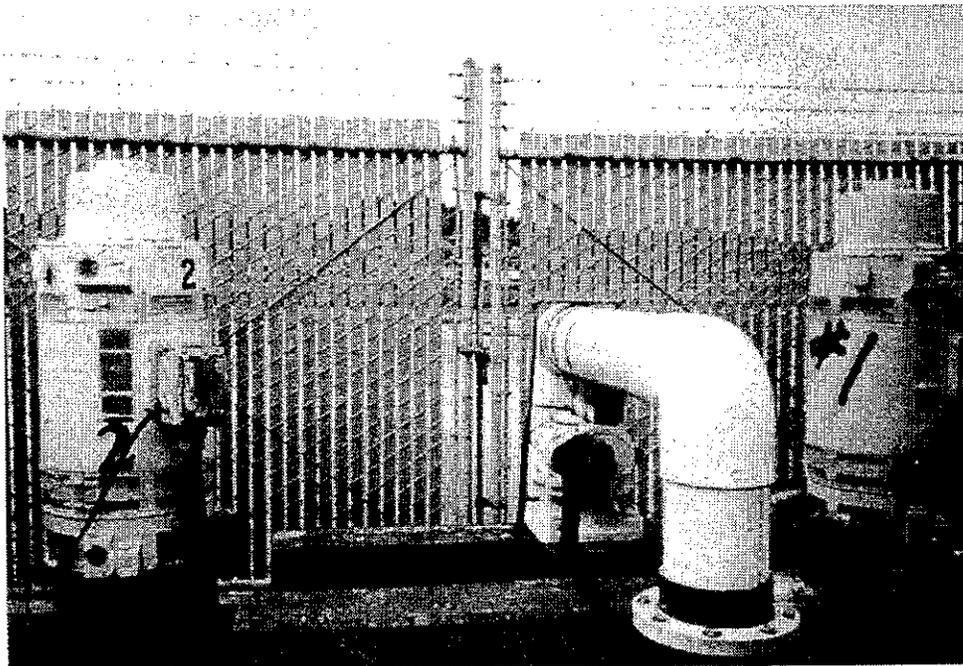
Examination of the pump station engineering drawings, specifications, and pump actuation control system revealed that the pumps had sufficient pumping capacity to perform as designed. The two pumps each have a rated installed capacity of 50 cubic feet per second (22,442 gpm) for a system total capacity of 100 cubic feet per second (44,884 gpm) (Figure 6).

Figure 6. Pump motors

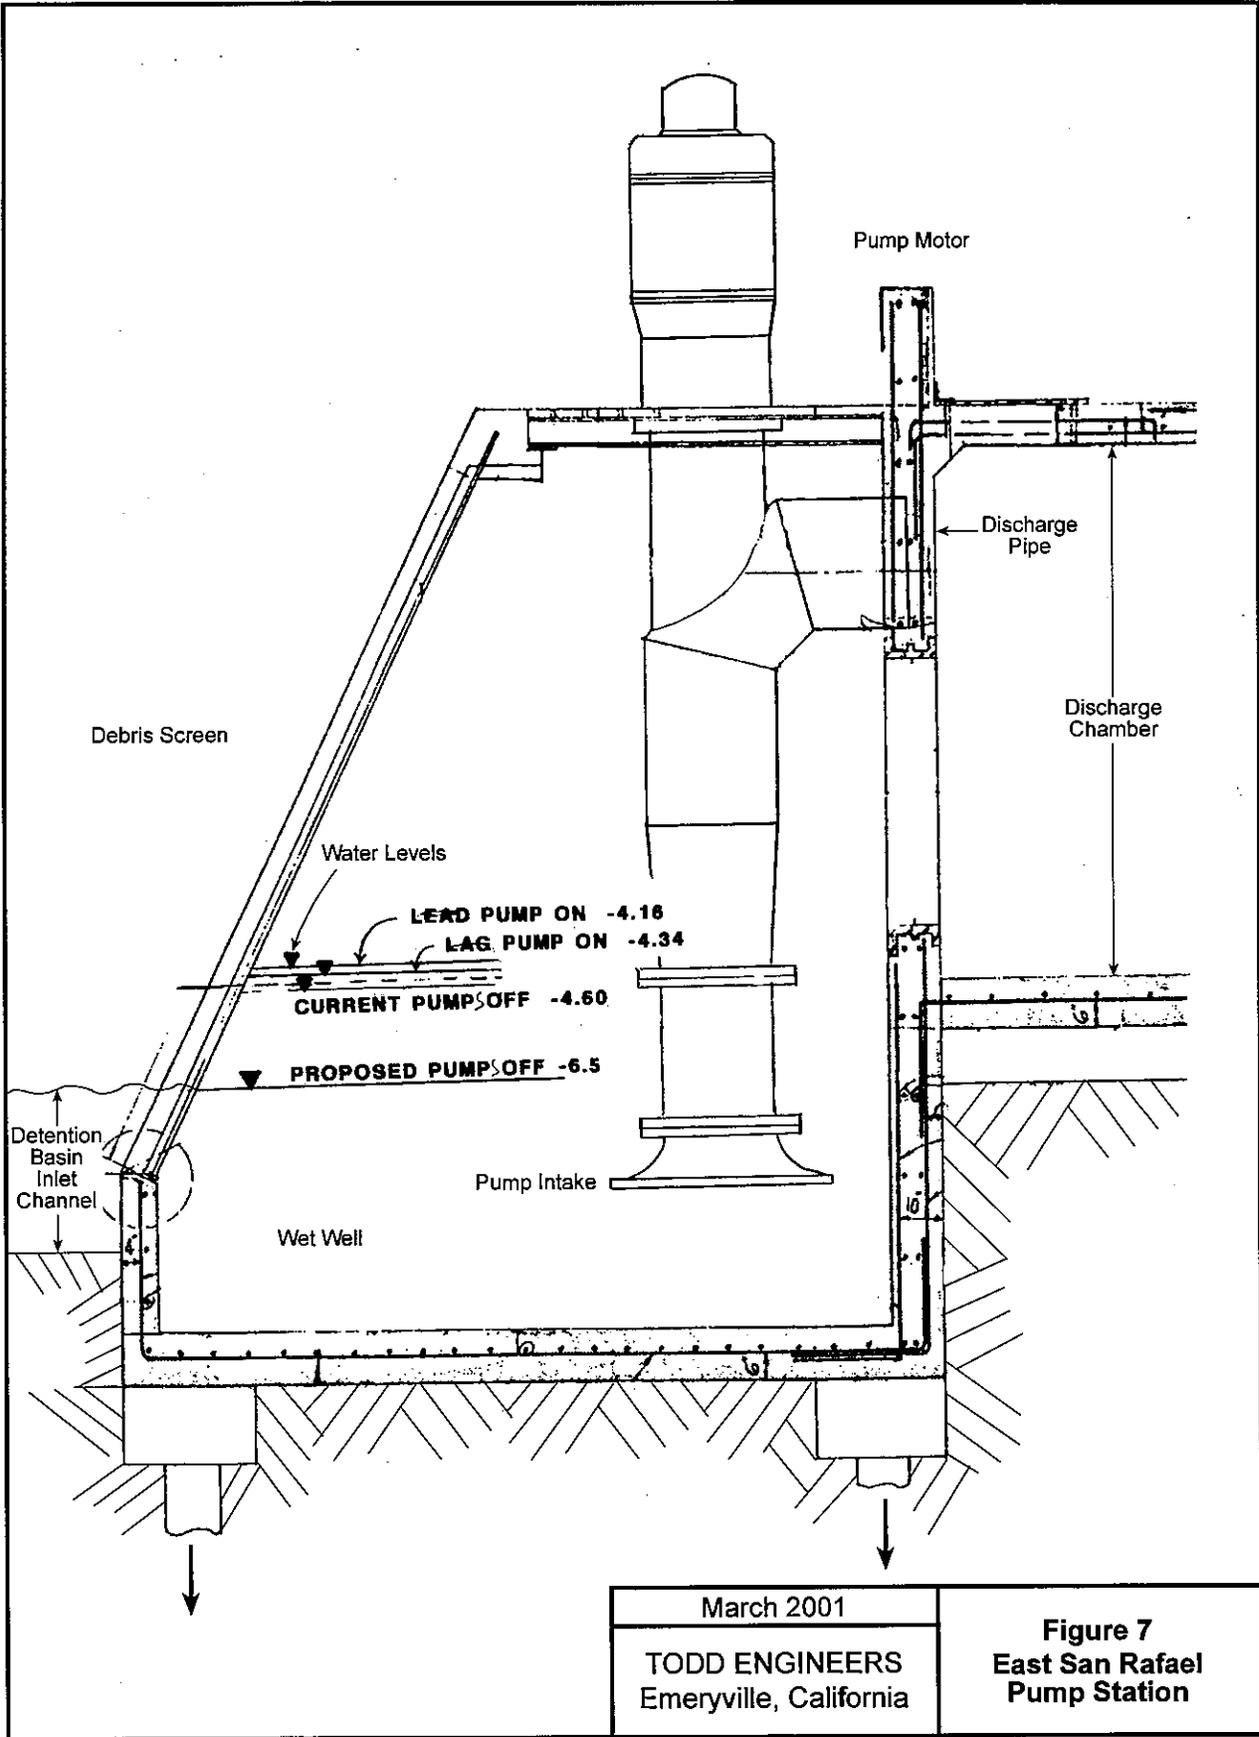
<b>Figure 7</b> <b>East San Rafael</b> <b>Pump Station</b>
--

Pump motor actuation was controlled by pressure transducers set to start the lead pump at water elevation of 4.16 feet below mean sea level and to turn off when the water elevation dropped to 4.60 feet below sea level. The lag pump was set to start when the water surface had been lowered one half foot (Figure 7). It was determined that the actuator settings were allowing high water elevations in the pond because the settings were too high. Discussions with the pump manufacturer also indicated that the pump intakes could be lowered as much as two to three feet without cavitation. Lowering the actuation levels allowed lower pond water elevation.

Pond capacity calculations were made for one-foot water level increments. The capacity of the pumps compared to the pond capacity revealed that at shallow pond depths the pumps were subject to cycling on and off at an unacceptable frequency. High cycling frequencies damage controls and pump motors. Therefore a lower capacity (600 gpm) auxiliary pump could be installed in the wet well to operate at lower pond water levels. This modification would allow the pond water elevation to be lowered even further.

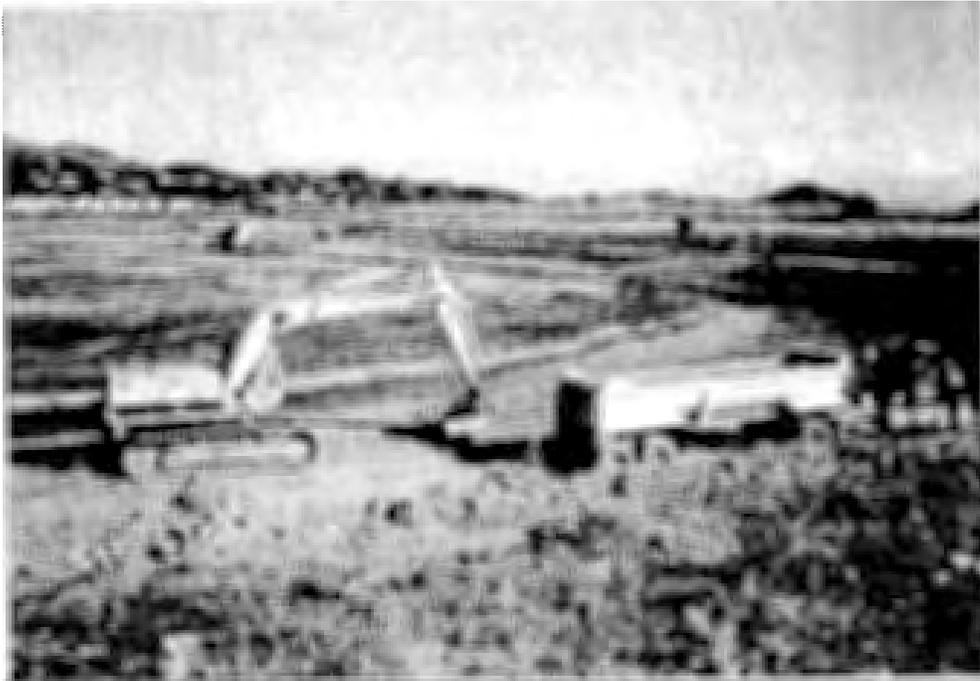
Figure 8. Excavation of detention basin inlet canal showing pump station in background

As a result of the cooperation between the District engineers and those representing Canalways a solution was found to the flooding and inundation of Canalways land and that of other adjacent property owners. A settlement agreement was negotiated to avoid litigating at trial. The excavation of the detention basin pond has been completed (Figure 8) and the modifications to the pump station are scheduled to be performed in the near future (Figure 9), thus completing a successful rehabilitation project.

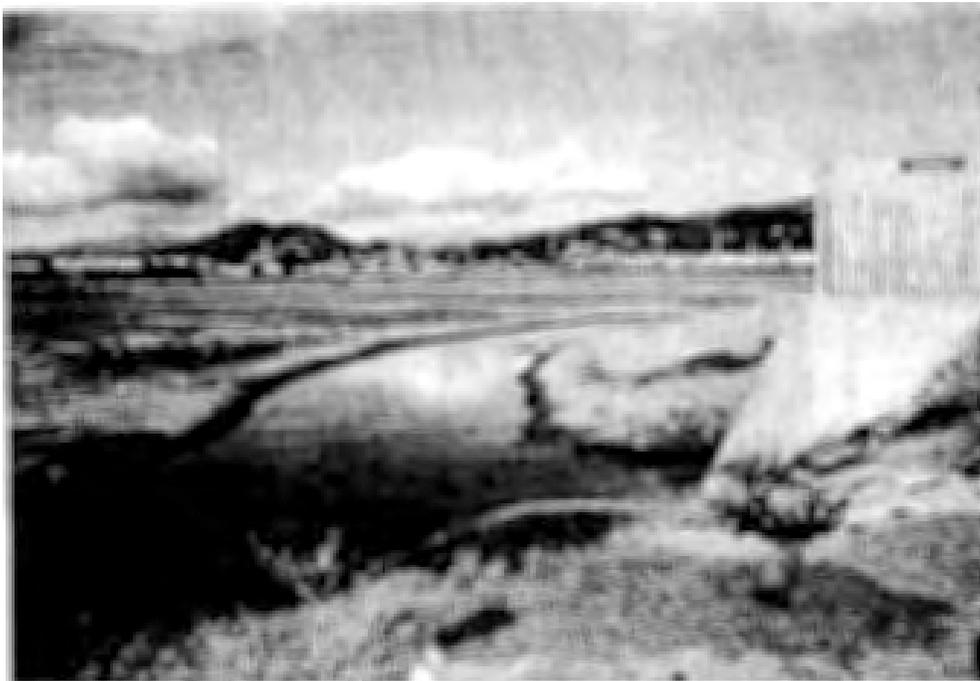
Figure 9. Pumpstation showing inlet canal
