BIO-ENGINEERED STREAMBANK STABILIZATION USING WETLAND SOD ON THE TETON RIVER: A CASE STUDY¹

Abstract. Wetland sod in combination with erosion control fabric was used to reconstruct and stabilize an eroding streambank on the Teton River in southeast Idaho. The river has an average base flow of 5.67 m³/s and an average peak flow of 34 m³/s. Above and throughout the study area the Teton River is a predominantly ground water fed, free flowing system with a moderate spring run-off. Conditions at the study site pre-construction included an average bank height of 1.07 m, an average bank slope of 2:1 and dominant bank vegetation consisting of introduced pasture grasses. The dominant soil type was a silty clay loam. The existing bank was reconstructed by first excavating the bank down to the base-flow water line to a width of 3.66 m. Two layers of long-term erosion control fabric were staked onto the base of the excavated bank using 20 cm wire staples. Soil was compacted onto the erosion control fabric layers to a depth of 0.30 m. Approximately 1 m of the erosion control fabric was wrapped up onto the compacted soil to build the initial toe of reconstructed bank. The remaining soil was slo

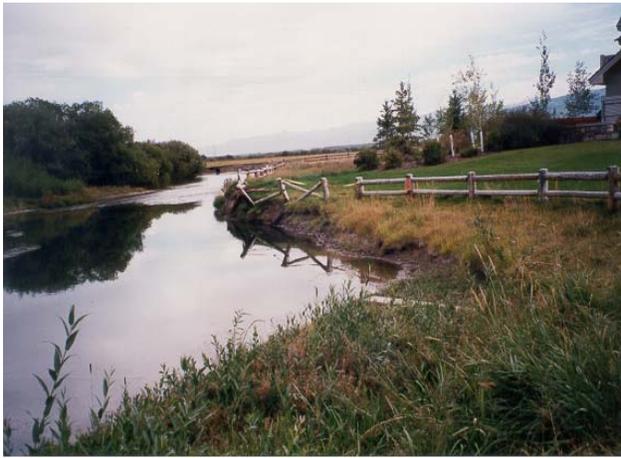
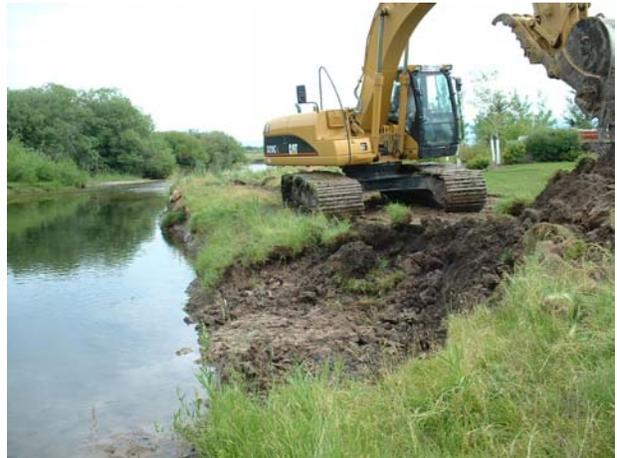
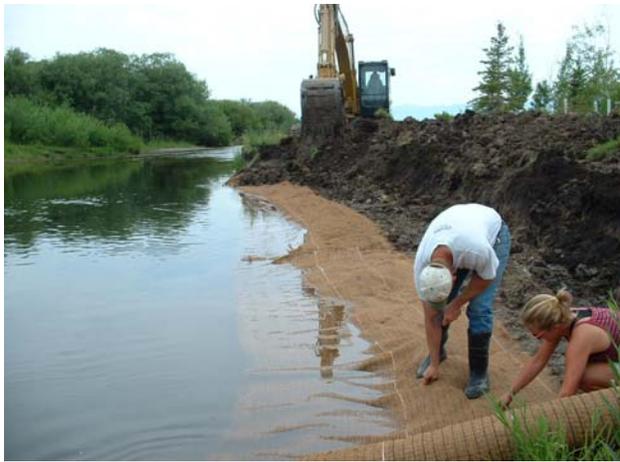
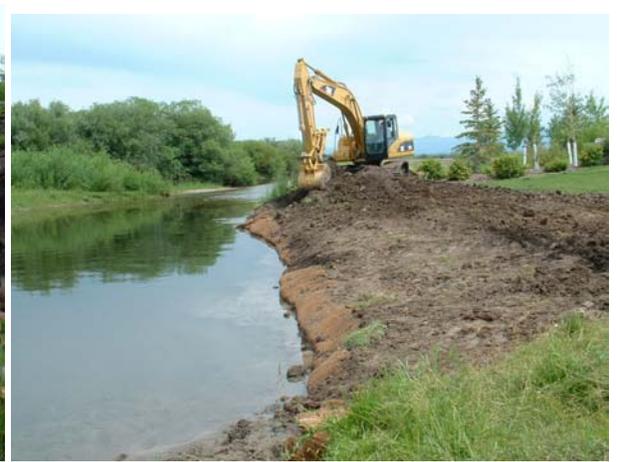
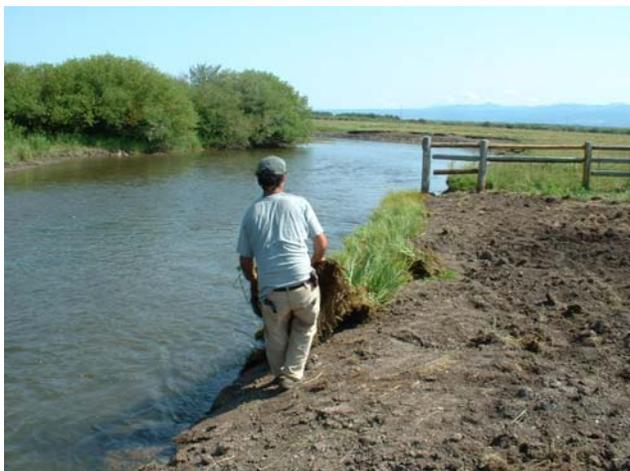
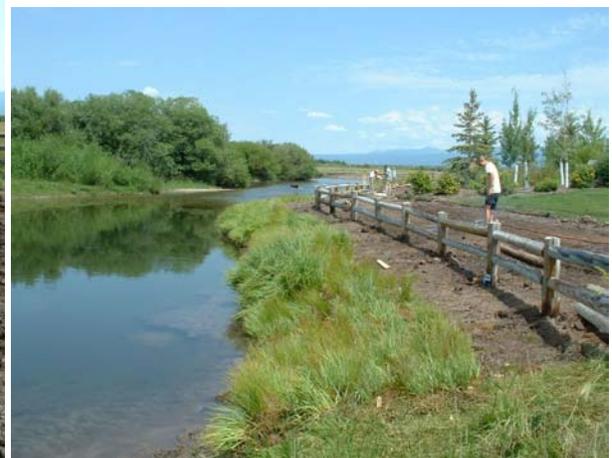
Figure 1. Picture sequence from pre-construction through wetland sod installation.

The existing bank was reconstructed by first excavating the bank down to the base-flow water line to a width of 3.66 m. Two layers of long-term erosion control fabric were staked onto the base of the excavated bank using 20 cm wire staples. Soil was compacted onto the erosion control fabric layers to a depth of 30 cm. Approximately 1 m of the erosion control fabric was wrapped up onto the compacted soil to build the initial toe of reconstructed bank. The remaining

soil was sloped back to create a bank with an average slope of 3:1. Wetland sod comprising of *Carex nebrascensis*, *Carex utriculata* and *Juncus balticus* was installed in two rows using 30 cm lath staking every 0.8 m². Wetland sod is a new restoration product developed to rapidly establish wetland vegetation. It is an integrated unit of erosion control matting (5m(*l*)x1m(*w*)x0.08m(*d*)) and containerized nursery plugs (100 per unit) grown in a nursery setting for approximately 8 weeks to promote maximum root growth. A total of 32 wetland Sod units were installed over 141 m² (Figure 1). The entire project was constructed in 2 days at a cost of \$195 per linear meter including design, permitting, excavation and revegetation. A temporary irrigation system was installed to irrigate the project daily through the first growing season.

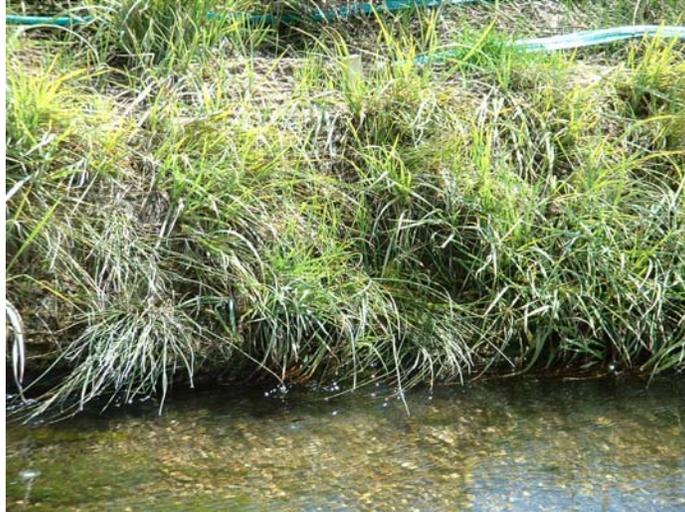
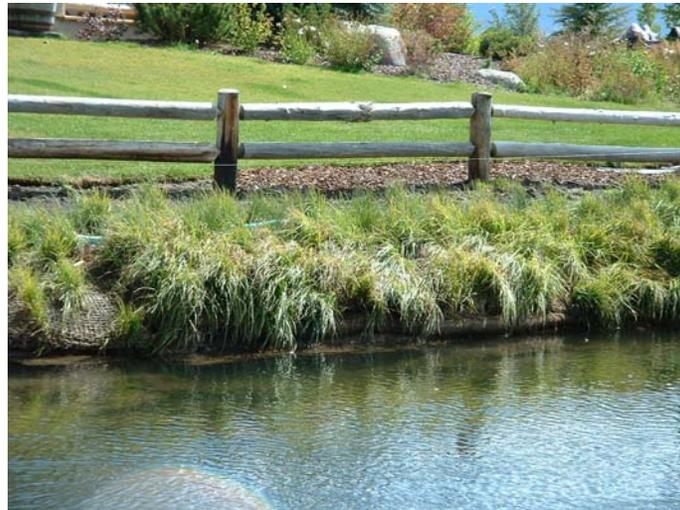
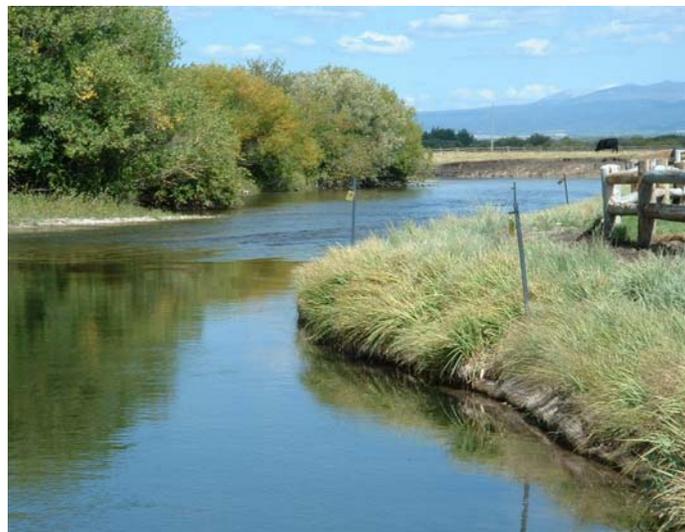
The project was constructed in July of 2002. Four days post construction a herd of 15 calves and one bull swam across the river and climbed onto the newly constructed bank to graze for a few hours until caught. The cattle were herded off of the project and an electric fence was quickly installed to prevent future incidents. The wetland sod material was significantly browsed but remained in place with the roots of the material protected by the erosion control matting. One week post-construction a storm event resulted in an increased stage of the river by 30 cm. The entire project remained intact and thrived under the increased hydrology. Within 1 month, the wetland sod pieces could not be displaced and were fully rooted into the underlying soil and erosion control fabric (Figure 2).

Figure 2. Project pictures 1.5 months post-construction.

Wetland sod was an effective way to establish wetland plants on an outside meander on the Teton River in one growing season (Figure 2). Its unique attributes including mature roots and rhizomes, protective erosion matting and established top-growth combined to establish wetland vegetation quickly in a high velocity zone. This bank stabilization project will continue to be monitored for five years to evaluate the success of our techniques under natural stresses including: anchor ice, ice dams, spring-run off and livestock and wildlife depredation. The initial tolerance to high flows and livestock depredation, and the quick rooting capabilities of wetland sod indicate that this wetland revegetation technique may have a wide range of applications in the high shear stress environment along eroding stream banks. Future studies calculating the actual shear stress tolerances of wetland sod compared to rock and traditional erosion control fabric would help determine the maximum velocity zones where wetland sod is a suitable technique to establish wetland vegetation.
