SUSTAINABLE PASSIVE TREATMENT OF MINE DRAINAGE: DEMONSTRATION OF MANGANESE RESOURCE RECOVERY(A Preliminary Case Study)¹

Clifford Denholm², Timothy Danehy, Shaun Busler, Robert Dolence, and Margaret Dunn

Proceedings America Society of Mining and Reclamation, 2008 pp 285-297

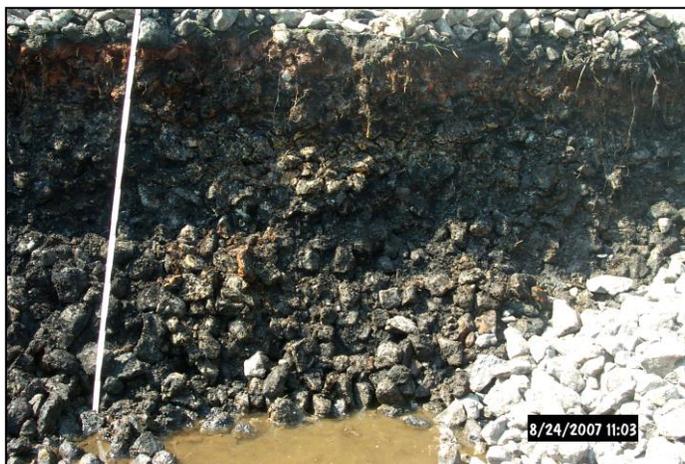
Figure 3. Manganese material filled void spaces and coated limestone aggregate prior to recovery

By 2003, the accumulation of Mn as well as other metals, sediment, vegetation, etc. resulted in the HFLB component having small pockets of standing water. During high flow periods, a portion of the influent water would flow across the top of the HFLB and over an emergency spillway instead of flowing through the stone, which reduced treatment effectiveness.

stone. In addition to vegetative growth, including what appeared to be algal (?) mats, Mn material was observed on the limestone aggregate and in the void spaces (See Fig. 3). The impact of the backflushing and stirring events was short lived. In October 2004, a trench was excavated at the beginning and the end of the HFLB, exposing the manifold collection pipe. In addition, the outlet piping was reconfigured to provide the ability to raise and lower the head as well as drain the HFLB. During this work, the pond was drained and the vegetative material and manganese-bearing precipitates on the surface of the bed were allowed to dry, “breaking up” some of the accumulated material. This effort resulted in improved flow through the bed with the water level remaining below the surface of the stone for one year. After that period, the water level again began to rise and typically a small portion was observed discharging through the emergency spillway. A new approach was required.

Through a literature and Internet search and bench-scale studies, a proposed method to simultaneously restore the efficacy and functionality of the HFLB and to recover the material was developed. This was accomplished through the use and combination of several existing products or conceptual ideas into a unique process that, to our knowledge, had not been previously attempted. One aspect that makes this system unique is the portability and quick set-up time of the recovery system (even in remote locations).

The first implementation of this process was conducted in August and September of 2007 at the De Sale Phase 2 passive treatment system. The influent flow was bypassed and the HFLB was drained. (During this seasonal low-flow period, the drainage was adequately treated by manipulating the flow through the other passive components.) Two wash pits were excavated within the HFLB, lined with impermeable material, and filled with water from the treatment wetland using a small pump. Using an excavator with a rotating screen attachment called a Flip Screen (Flip Screen Australia Pty Ltd., New South Wales), the bucket was filled with the limestone aggregate and the Mn-bearing material was removed by rotating the Flip Screen within the wash pit (See Fig. 4 and 5). Material passing the 3/8-inch (0.95 cm) screen settled within the wash pit while the limestone aggregate remained in the bucket. (Note that screens with different size openings are readily interchangeable.) The now clean and refurbished treatment media was then returned to the HFLB. The slurry was generally pumped into flexible intermediate bulk containers (FIBC) held in place with a frame structure for settling and dewatering. In some cases, the water in the wash pit was allowed to evaporate and was then excavated (See Fig. 6) and stockpiled on a pad for additional drying prior to placement in an FIBC. Thirty-two bulk containers, each containing approximately one ton of recovered material, were removed from the site. In addition, an estimated 25-50 tons (23-45 metric tons) of recovered material was left within the wash pits for future removal.

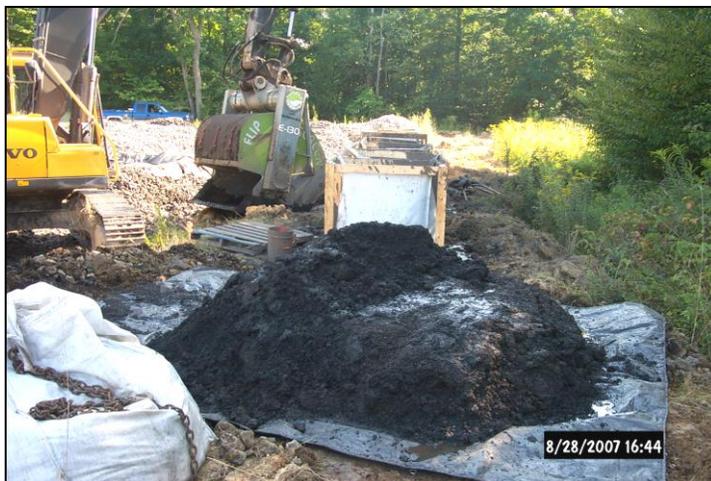
Figure 6. View of recovered manganese material excavated from wash pit

Samples from 4 of the 32 totes were collected for laboratory testing, including particle-size distribution, bulk chemical analysis, and x-ray diffraction. Not all of the results from these analyses were available at the time of writing this paper. Grab samples of the material directly from the HFLB were collected by hand in 2005. Laboratory analyses indicated that the material was about 50% Mn on an as-received basis with a loss-on-ignition of about 20%. X-ray diffraction conducted on the samples revealed that the Mn material was a mixture of todorokite and birnessite. Preliminary X-Ray Fluorescence (XRF) results of the material recovered in 2007 report major oxides about 25% MnO, 25% SiO₂, 10% Al₂O₃, 10% CaO, and 25% Loss-on-Ignition. Limestone and quartz were identified by visual examination using a hand-lens. The material fizzed aggressively with 10% HCl indicating the presence of limestone as well as with H₂O₂ indicating the presence of Mn oxides. The preliminary analyses suggest that the recovered

Mn has become diluted primarily with limestone and quartz by the recovery process. Future efforts will include attempts to improve the recovery process to minimize dilution of the Mn material and to examine beneficiation processes to remove impurities.

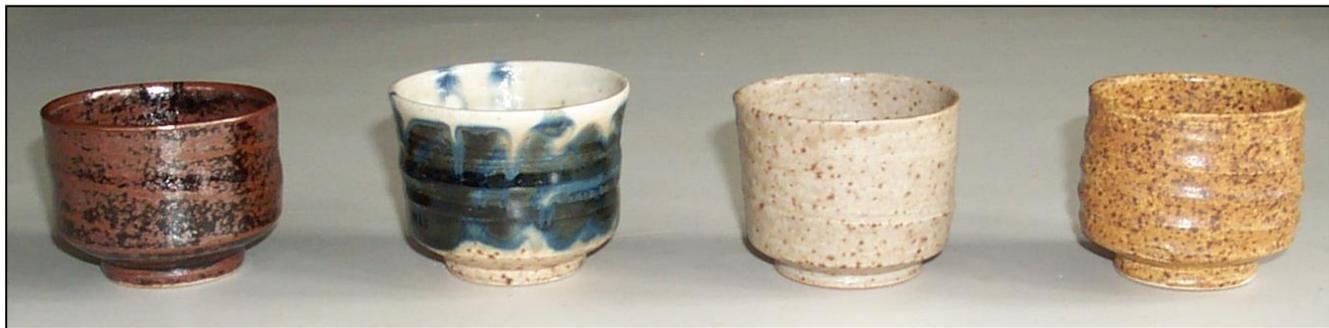
Figure 8: Examples of pottery with glazes using recovered Mn and Fe oxides formed at low pH

While Mn is used in a variety of products and processes including steel, batteries, chemicals, fertilizers, animal feeds, etc., current markets targeted include the use as colorants in bricks and cement and in ceramic glazes (BioMost, 2005). The recovered material is currently being utilized in ceramic glazes (See Fig. 8) and demand is growing. Over 300 hand-thrown pieces by local artisans have been sold or are on order. The colorant is also being sold by non-profits as a “green product” to the ceramics industry.
