CREATING SUSTAINABLE VEGETATED COVERS OVER DIFFICULT SLOPES¹

Daniel F Senf²

Abstract Vegetated covers on steep slopes (greater than 1H:1V) and over geomembrane covers are highly desirable. However, challenges with both the structural stability and sustainability of those covers have prevented their extensive use. Using creative combinations of proven materials, soil-bioengineering techniques, and innovative installation methods, the highly desirable outcomes can be economically obtained. This paper reviews the materials and construction methods used in four successful applications. A vegetated cover on a 70-degree cut slope in the Amazon basin was established in the first application. In the second application, a vegetated cover over a low-pH, 60-degree rock face at over 4,300 m above sea was established. In the third application, a vegetated cover was established over a geomembrane cap in a high-rainfall area of Brazil and in the last application, an aggregate protective cover was established over a geomembrane on a 1H:1V slope in Pennsylvania.

Proceedings America Society of Mining and Reclamation, 2010 pp 1040-1058

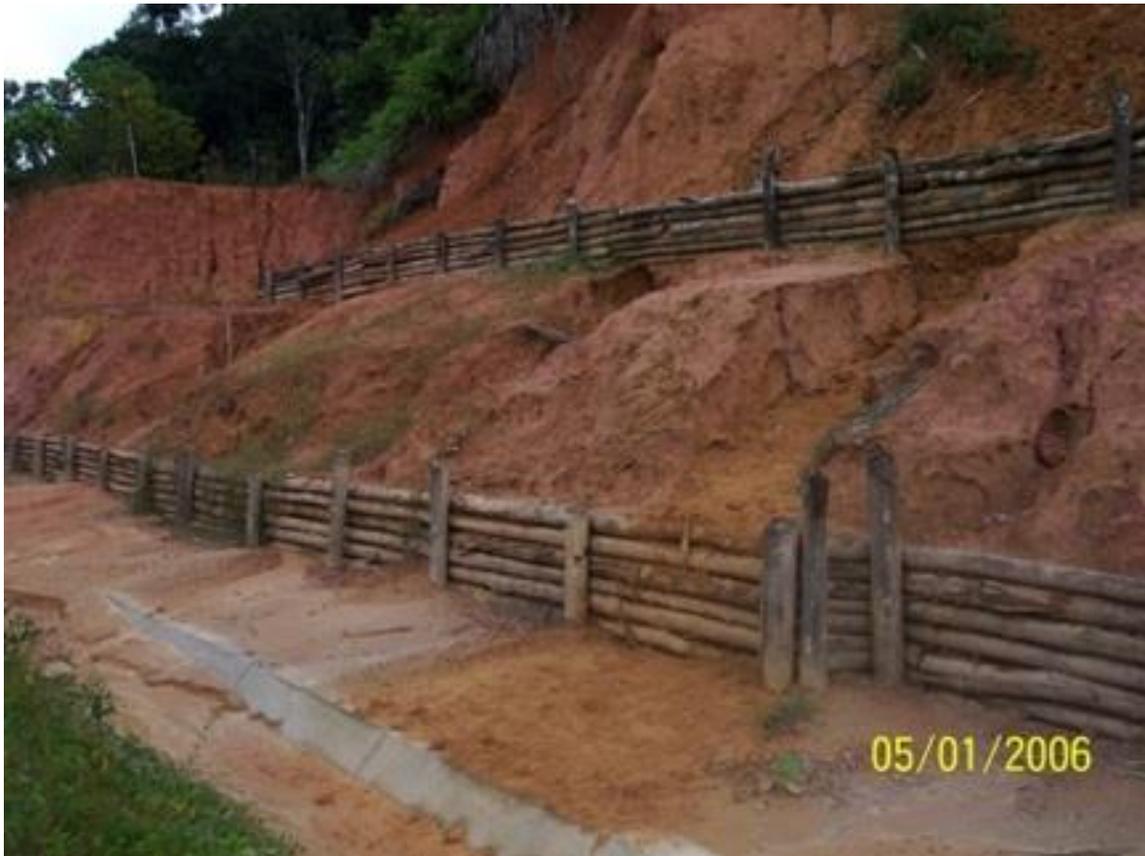
Figure 1. One of many slope surface stabilization schemes which seldom works well.

A road is cut into an area to be mined. The nearly sterile, *in situ* soil is highly cohesive, therefore, to minimize earthwork, 1H:2V slopes are cut. There is a definite benefit in steep slopes as long as they have long-term surface stability. However, surface stability should not be dependent on soil characteristics only. Figure 1 shows a common lateritic clay soil found in many areas of the world.

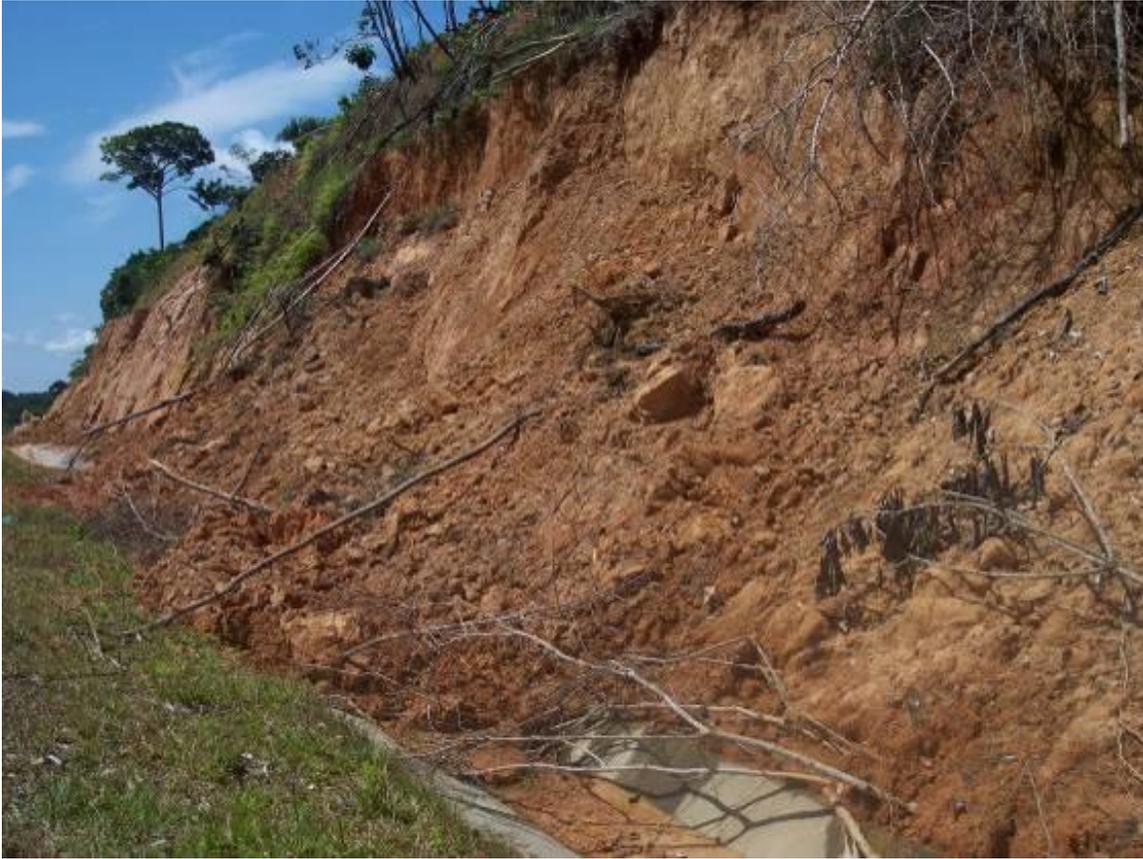
Figure 4. Damages from an unprotected slope along a highway road cut between Iquitos and Nauta, Peru.

During the construction of the highway between Iquitos and Nauta, Peru, many cut/fill areas were required through the native, lateritic clay soil. Standard practice is to cut steep slopes with angles from 65-75 degrees so the highway footprint is kept to a minimum. Cut depths were up to 18 m. The resulting soil erosion produced a considerable number of slides, which obstructed the ditches, overflowing them, and impounding water. This forced the water to flow outside of the

ditch and to saturate the slope toe. This in turn resulted in soil loss and new slides finally causing flooding which damaged the highway structure. Figure 4 illustrates the problem.

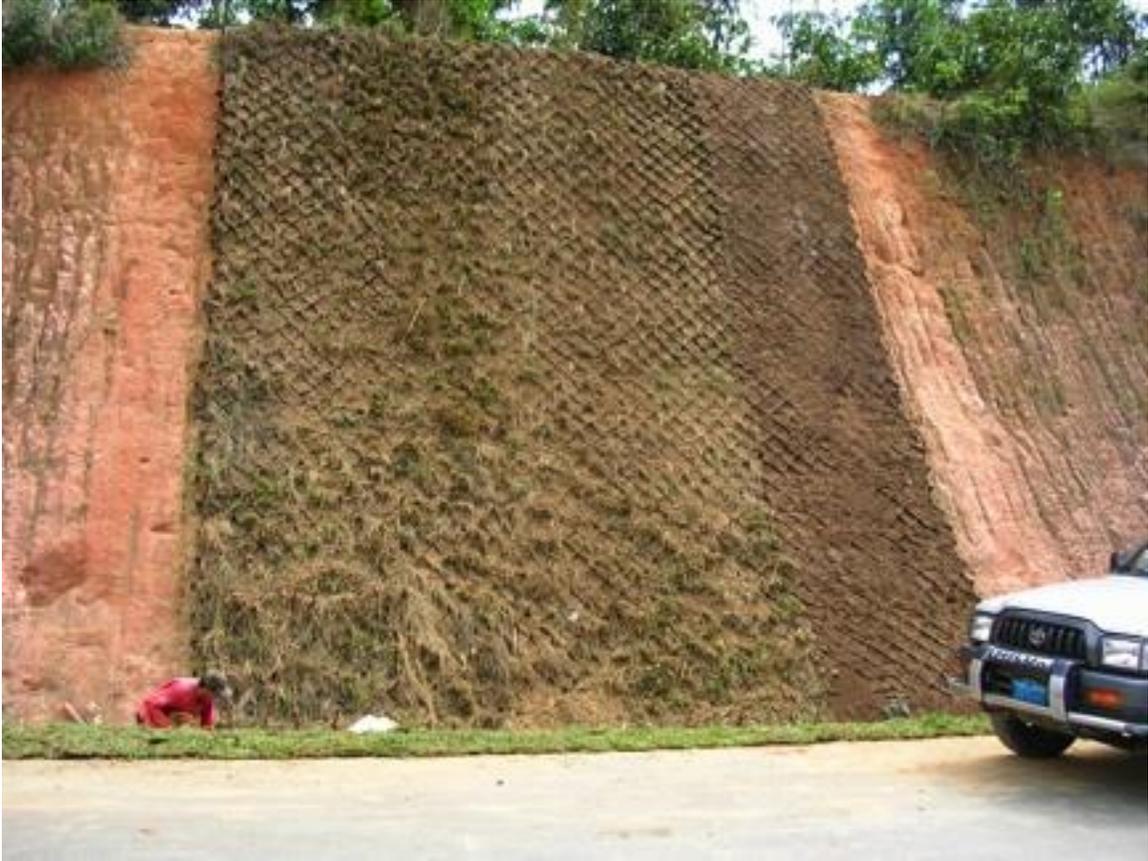
Figure 5. The completed installation of the west slope system on a highway road cut in Peru.

To demonstrate the performance of a vegetated geocell stabilization system for steep slopes, two test sites were chosen; one on the west side and one on the east side of the highway. Both slopes were 16 m +/- in height with a 70-degree +/- slope angle. Over the slopes, a 100 mm depth textured perforated geocell was placed. It was then anchored at the top of the slope using tendons and a mix of wooden and steel stakes. The cells were filled with on-site organic soil containing seed propagules and seedlings. Use of on-site soils and vegetation ensure greater survivability of the system since nature already selected these species for the site-specific varying climatic conditions. Figure 5 depicts the west slope after installation of the system.

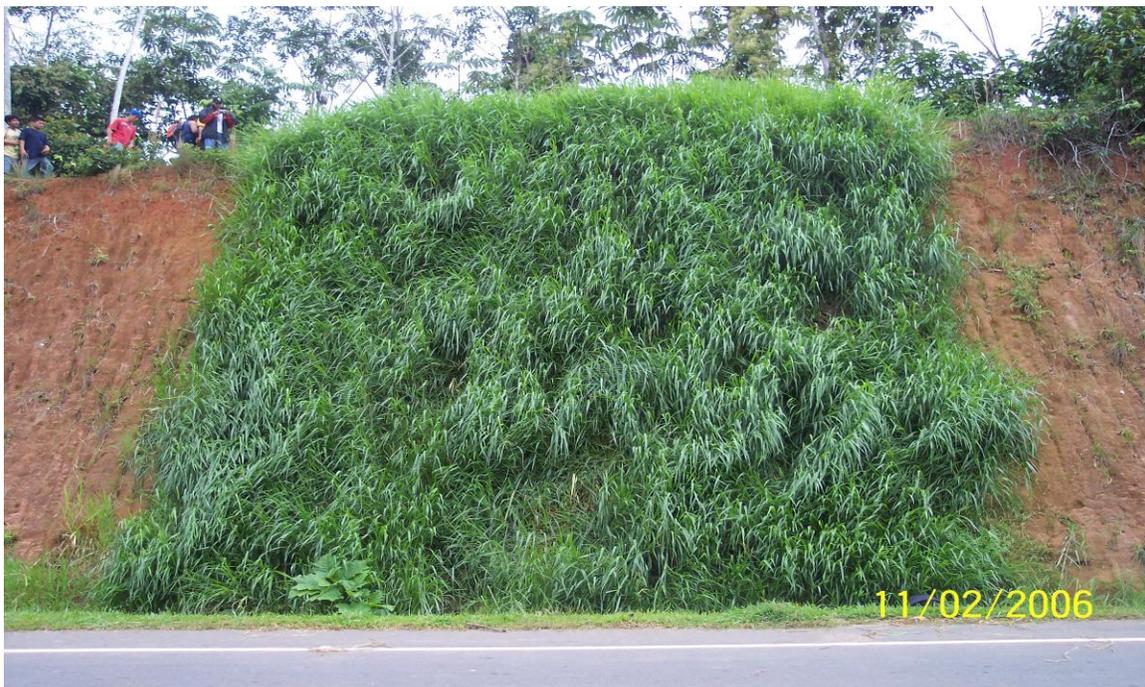
Figure 6. The system as it becomes mature.

time, the strength of the system increases and the slope stabilization further improves. Figure 6 shows the slope eight months after the original installation.

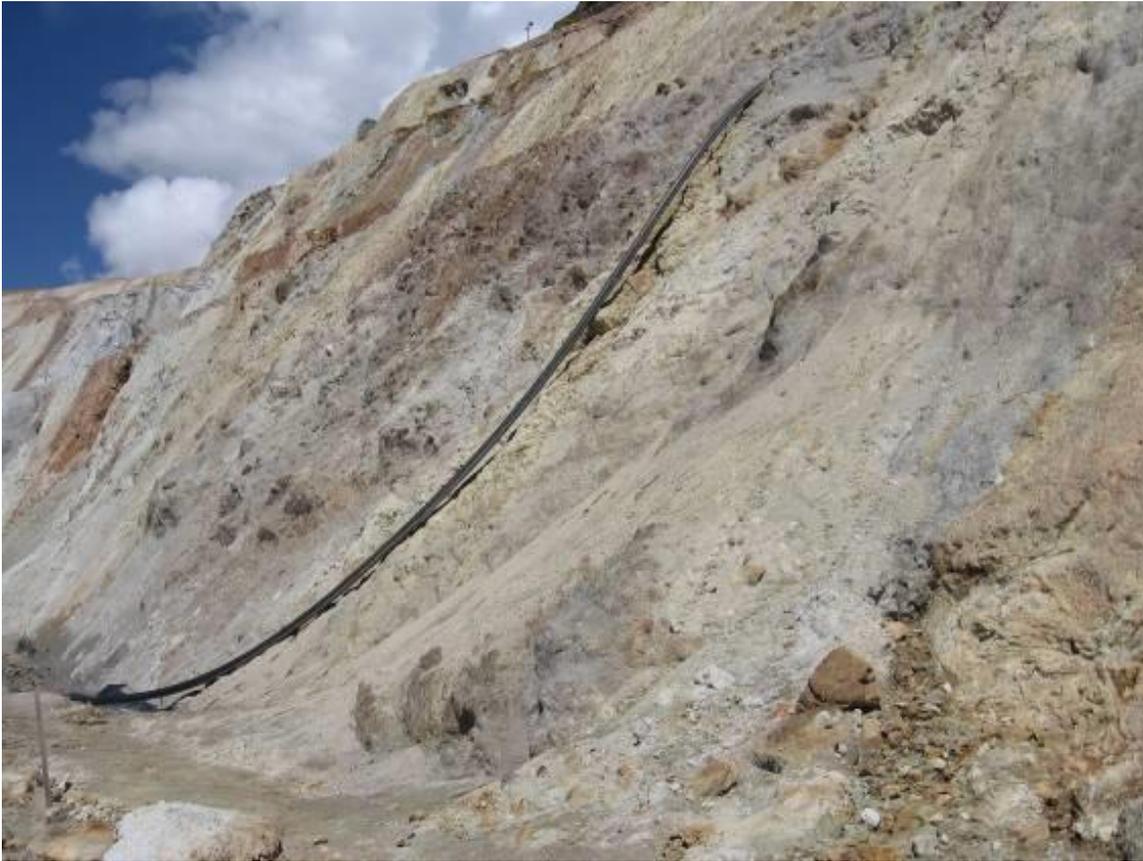
Figure 7. One of the typical rock faces requiring sustainable vegetation.

Developing a structurally-scaleable support system to permit sustainable vegetation cover over steep irregular rock faces for open-pit mines while protecting the rock surface from rainwater induced degradation is challenging. Figure 7 shows the rock face where a geocell / geogrid structure holds topsoil in place so a sustainable vegetation cover can be developed.

This particular open-pit mine is located in the Peruvian Andes at over 4,300 m above sea level. The open-pit walls have slopes greater than 1H:1.75V and an average height of 8 to 10 m. Site temperatures fluctuate between -7 and 21 ° C.

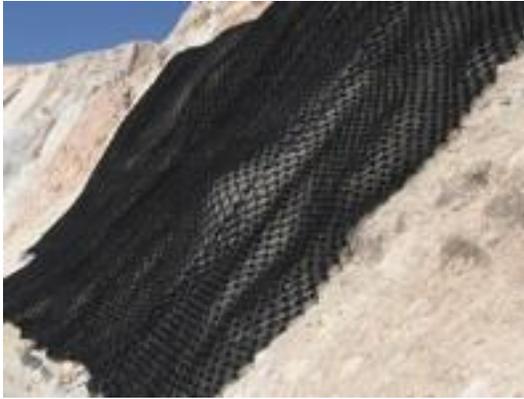
Figure 8. The geocell / geogrid system ready for soil infilling.

Sections were pre-assembled on a flat work area, rolled up, and carried to the top of the slope. Once there, the upper geogrid portion of the section was anchored in a trench and then rolled down the slope. Figure 8 shows the section expanded down the rock face. Once anchored and expanded down the slope, the sections were filled with local topsoil as show in Fig. 9.

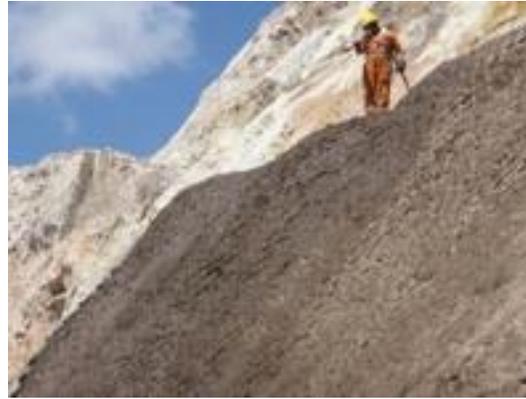
Figure 9. Irrigation of the soil-filled system with a bacteria-rich water.

The open pit mine exposed soils have low pH and provide little support for vegetation development. In addition, negative factors such as acid rains, dry winds, low relative humidity, and low temperatures contribute to the harsh environment. Therefore, a solution of on-site soil bacteria was developed and applied to the soil infill. The vegetation develops quickly and becomes sustainable. The results are shown in Fig. 10.

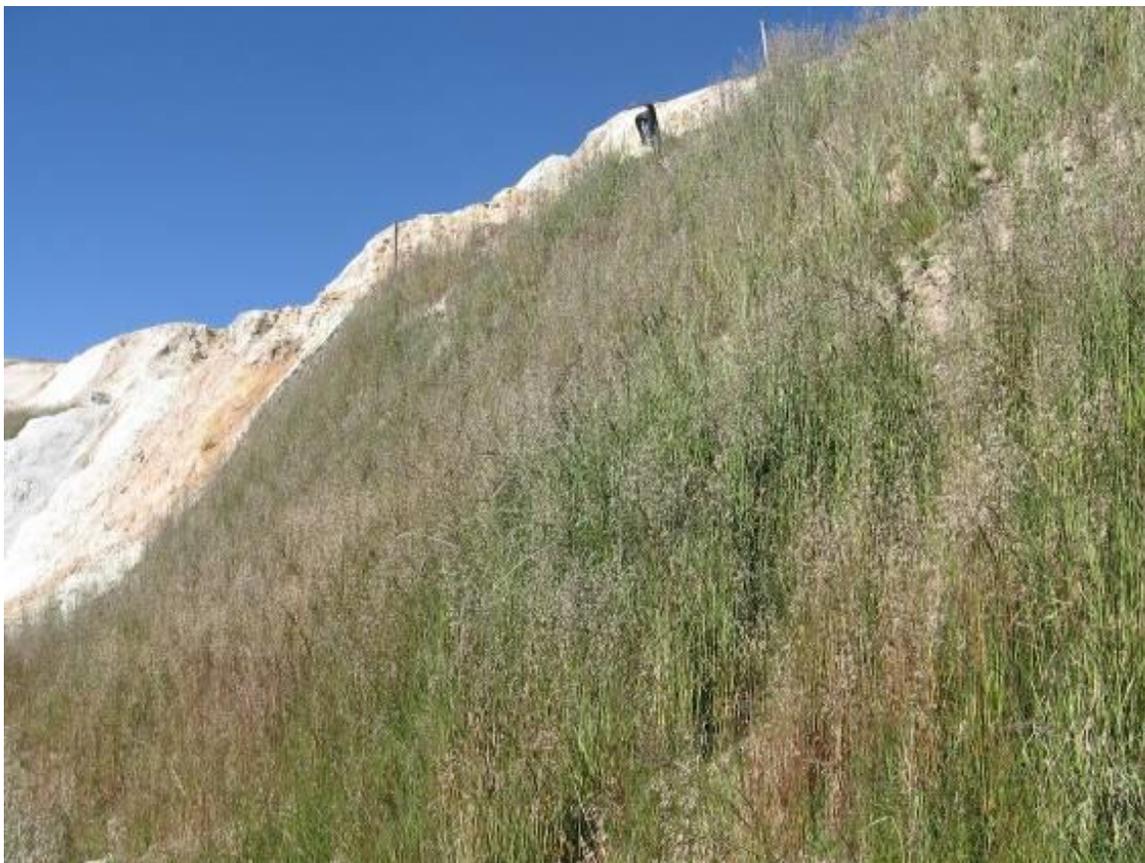
Figure 10. Sustainable local vegetation established over the rock surface in Peru.

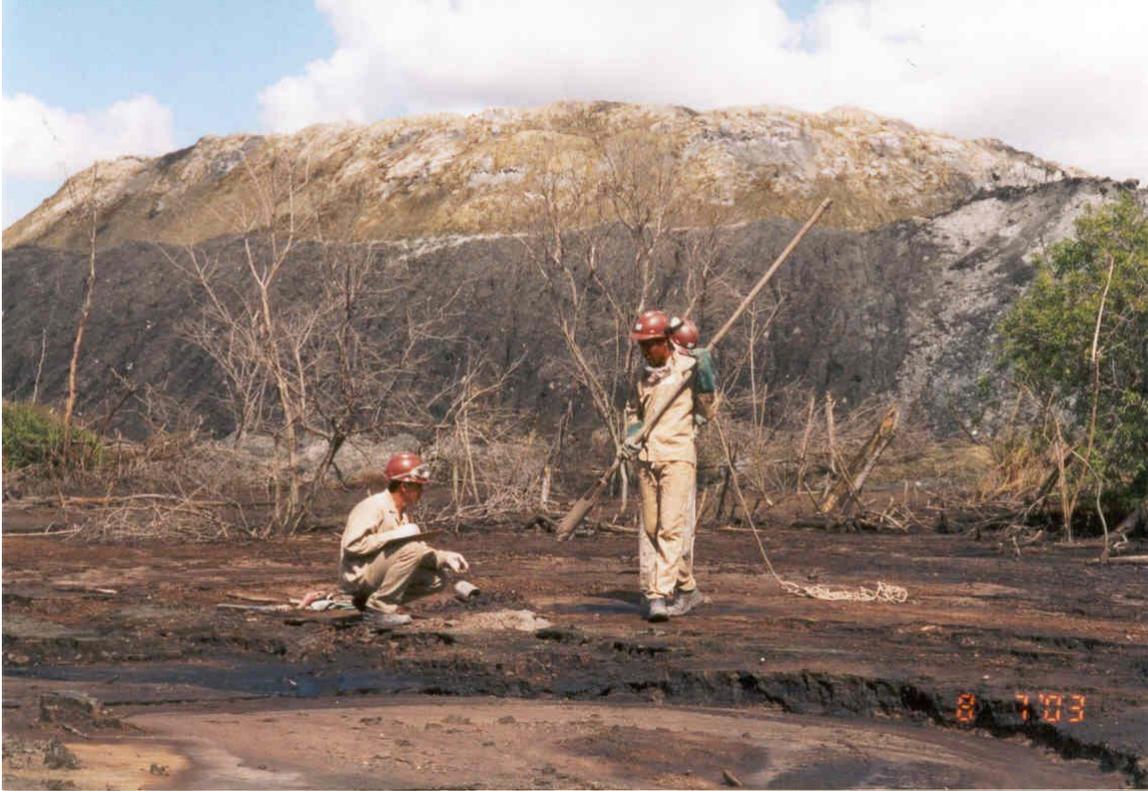
Figure 11. The residue dumpsite in 2003.

A pulp paper mill plant in the Northeastern region of Brazil, has used a single area to dump residue for several years. Residue included organic materials, lime, contaminated soils and other non-organic materials. Figure 11 shows the dumpsite in 2003.

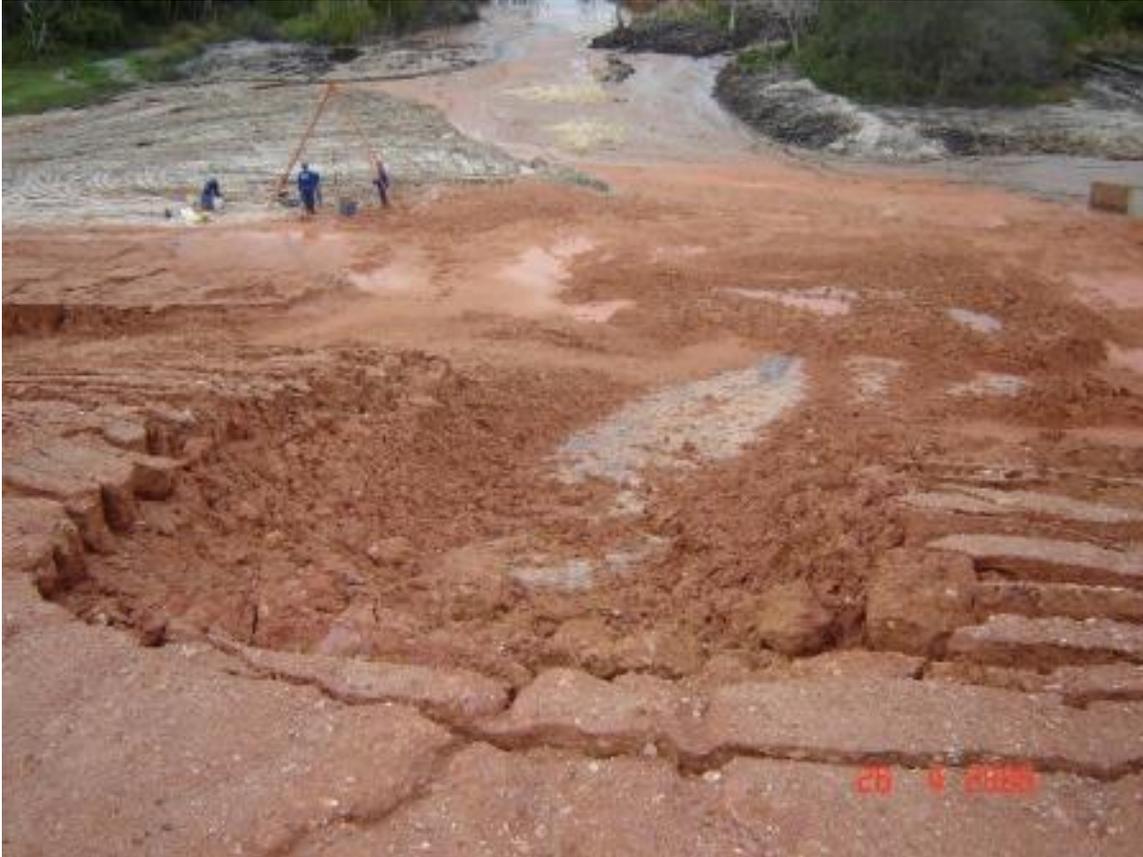
Figure 12. Typical failure of the slope-cover system.

In mid-June 2006, after a heavy rainfall, the residue cover completely failed at the geotextile-geomembrane interface. At some points along the slope crest the geotextile tore. Figure 12 shows the typical failure.

The failure was caused by the combination of a relatively low friction angle at the geotextile-geomembrane interface (even though a textured geomembrane was used), increased load from the saturated soil, and seepage forces due to water flow within the 0.60 m thick soil cover. The failure involved 1,200 m³ of cover soil and 1,800 m² of geotextile. Fortunately, the geomembrane remained in place and was not affected by the soil movement.

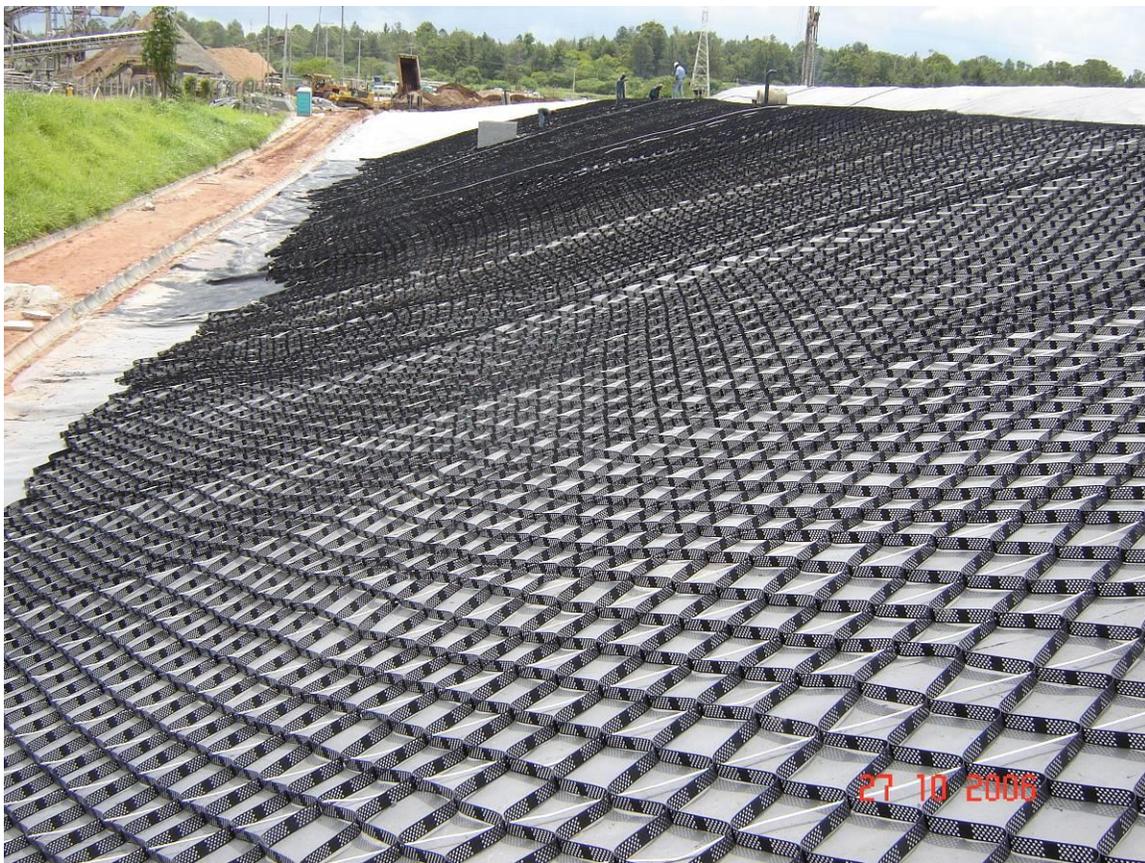
Figure 13. The tendoned geocell system ready for infilling.

The repaired system consisted of a sand-infilled, tendon reinforced, perforated geocell layer 75 mm deep, with a cell area of 1200 cm^2 installed directly over the HDPE geomembrane. In between the soil cover over the geocell layer and the geocell layer, a 200 g/m^2 non-woven geotextile was used for separation and as a filter. The main advantage of the geocell layer was to allow a sand layer to be placed directly over the geomembrane. The perforated geocell material acted as “formwork” and prevented sand flow during installation during periods of rainfall as well as to allow drainage of the sand infill. The use of a sand layer had two advantages: 1) increasing the friction angle at the critical interface with the geomembrane; and 2) providing a structural drainage layer. Figure 13 illustrates the installation process.

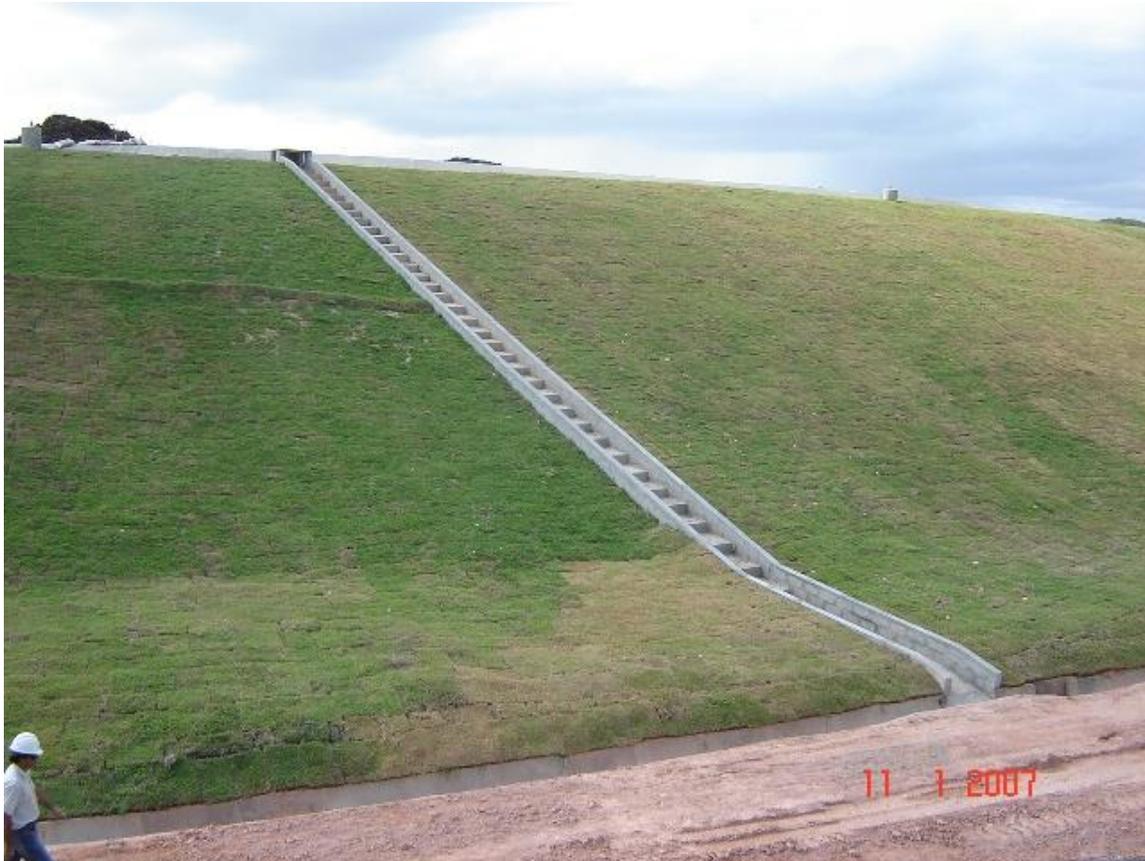
Figure 14. The vegetated system protecting the geomembrane.

The system has now been through three rainy seasons (2007, 2008, and 2009) without seeing movement to the vegetated geomembrane protection system. The system's vegetation is healthy and sustainable. Figure 14 shows the system after sod was placed over the soil surface.

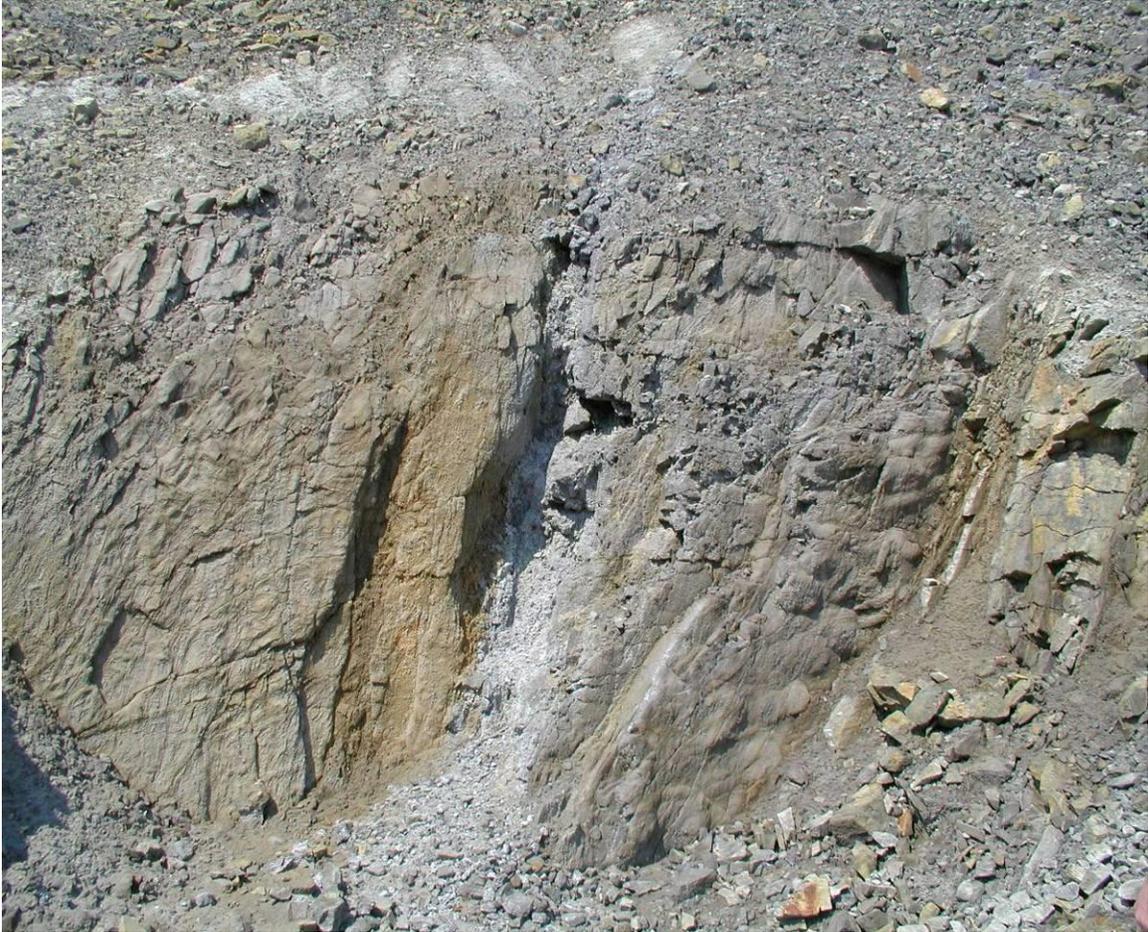
Figure 15. A pyrite vein exposed by the excavation.

The I-99 / State Route 6220 Project, extending from the Village of Bald Eagle in Blair County, Pennsylvania to the Mount Nittany Expressway (U.S.322) in Centre County, Pennsylvania, involved the construction of a four-lane limited access highway approximately 29 km long. During construction, large volumes of pyrite-bearing sandstone were exposed to air and rainfall, creating acid rock drainage containing elevated concentrations of heavy metals and sulfates. A typical pyrite vein is shown in Fig. 15. The acidity caused by the reaction of sulfuric minerals with oxygen and water threatened the quality of two adjacent, exceptional-value trout streams and local residential water wells.

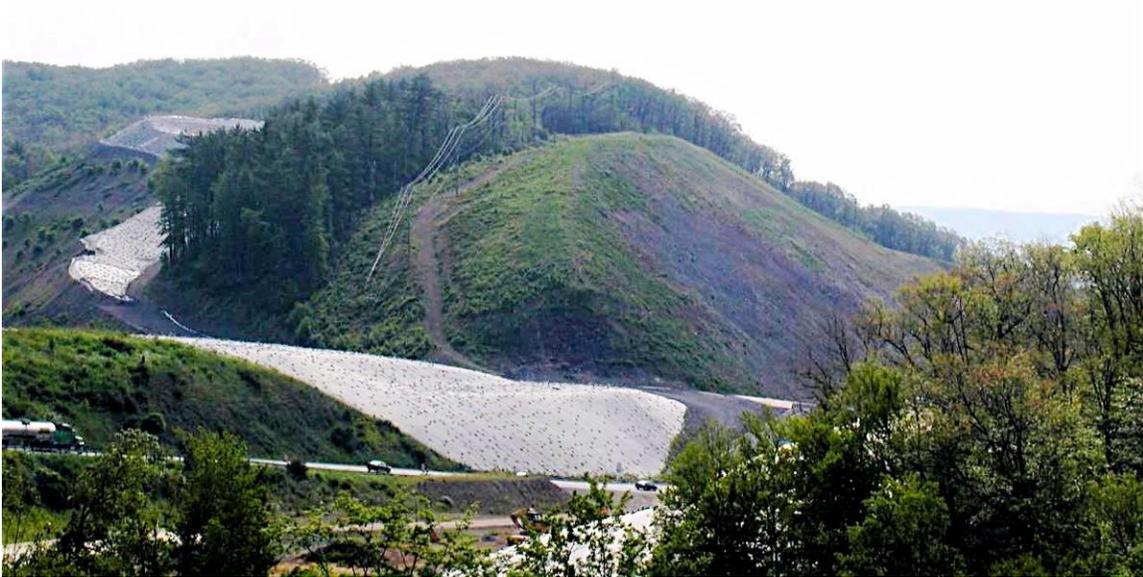
Figure 16. One of many cut faces needing encapsulation.

There were several immovable slopes ranging in length from 9.0 meters to 110 meters with inclinations from 3H:1V to 1H:1V. The most severe slope was the large cut face shown in Fig. 16. Both slope lengths and slope inclinations strongly influenced the reinforcement demand while the topography of the crest of slope influenced the practical anchor types and dimensions.
