OPPORTUNITY PONDS WETLANDS CONSTRUCTION AND REVEGETATION¹

Abstract. The Opportunity Ponds Wetlands project is a 2.2 km² (544 acre) man-made wetland located 5 km (2.4 miles) east of Anaconda, Montana. A 0.9 km² (222 acre) area of wetland was planted in 2009, and a 0.65-km² (161 acre) area was planted in 2010. Careful design, excavation, site shaping, and diligent quality assurance have resulted in exceptional plant establishment. The area west of the wetland site was used as a repository for tailings from the smelting of copper ore. Remediation of the repository includes capping the tailings with soil material obtained from nearby borrow areas. The Opportunity Ponds Wetlands are being developed on depleted borrow areas. The goal of the Opportunity Ponds Wetlands revegetation is to create functional vegetation communities that reflect natural wetland habitats. Revegetation plans correlate to the topography and hydrology that have been established. Plants utilized are species observed within native wetland areas close to the site, and plant communities are arranged in “planting zones”. Seed for plant production is collected locally and plants are grown under contract by a native plan

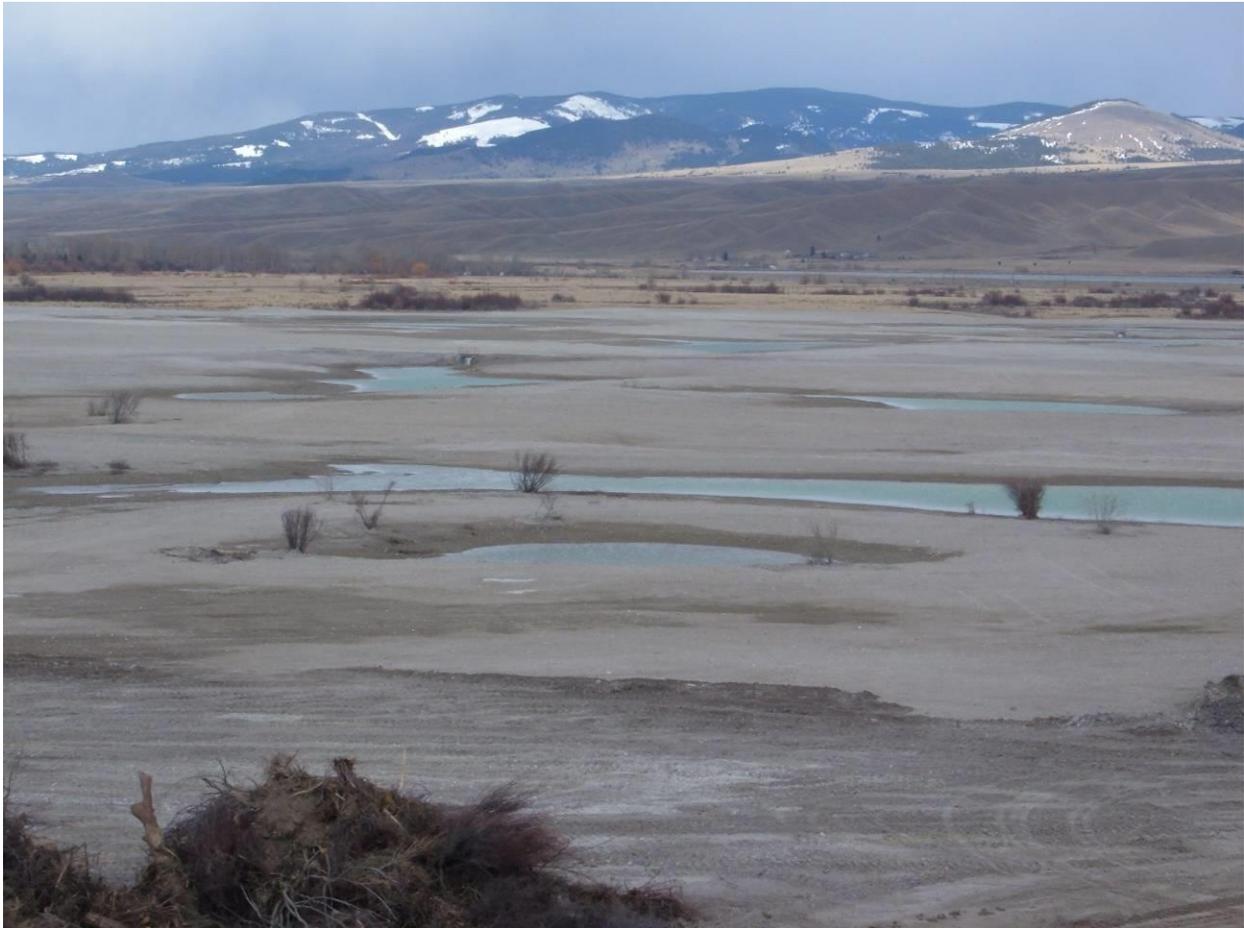
Figure 2. Site construction complete and ready for planting.

Fine-grained cover soil material was applied to a depth of 15 cm (6 inches) in the planting zones at the upper elevation tapering to 5 cm (2 inches) at the lowest level of the planting design. De-watering activities were stopped after construction and soil placement was complete and the hydrology of the site was allowed to reach equilibrium (Fig. 2).
