## **CASE STUDY: GEOMORPHIC RECLAMATION OF ABANDONED COAL MINES NEAR RATON, NEW MEXICO DESIGN AND CONSTRUCTION OVERSIGHT<sup>1</sup>**

R. Spotts<sup>2</sup>, M. Brennan, R. Wade, K.J. Malers, K.E. Carlson and Z. Isaacson

**Abstract.** In order to address hazards and environmental detriments associated with historic coal mining, the New Mexico Abandoned Mine Land Program contracted with Water & Earth Technologies, Inc. Construction for the Swastika Mine and Dutchman Canyon Reclamation Project took place over a six-month period in 2012. The geomorphic reclamation approach coupled hydrologic and hydraulic engineering analyses with geomorphic design tools to stabilize and reclaim the significantly altered landscape. Coal waste piles, a straightened and incised half-mile-long reach of the Dillon Canyon stream channel, and existing wetland features proved to be challenging design elements of this award winning project. The geomorphic landform accommodated nearly 200,000 cu. yds. of coal waste that had been abandoned in unstable piles that were degrading the adjacent stream physically and chemically. The stream reconstruction restored meanders and a functional floodplain to the impaired

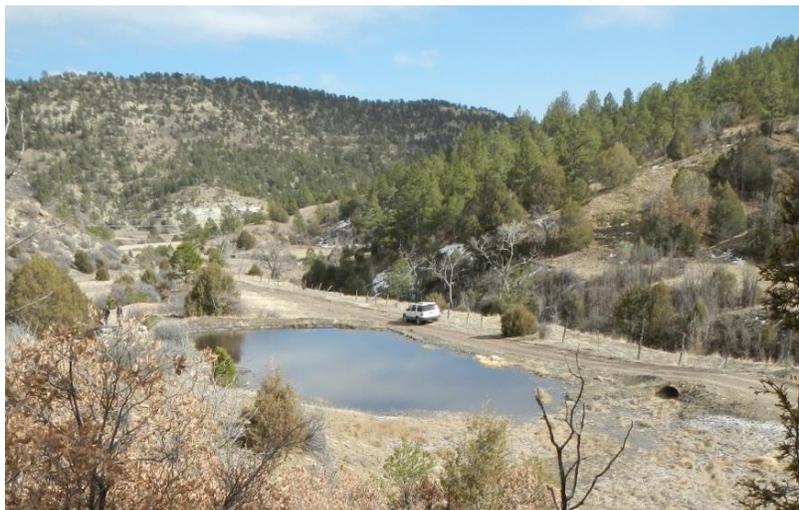
Figure 2. Wildlife pond and outlet culvert at Dutchman Canyon.

Dutchman Canyon. At the Dutchman Canyon site (Figure 2), sodic mine seepage was collected in a pair of existing wildlife ponds draining directly to the Dutchman Canyon stream channel through a culvert. The embankments forming the ponds were inadequate to prevent flows from damaging the adjacent dirt access road, and the ponds provided minimal treatment of the seepage prior to its release. The Project included road and embankment improvements as well as a new spillway that directs outflow from the ponds to a constructed passive treatment wetland area in an adjacent meadow before conveying flow across the road and into the channel. Improving the quality of the water that reaches the Dutchman Canyon channel and creating a salt-tolerant wetland area were the primary goals of the work at Dutchman Canyon.

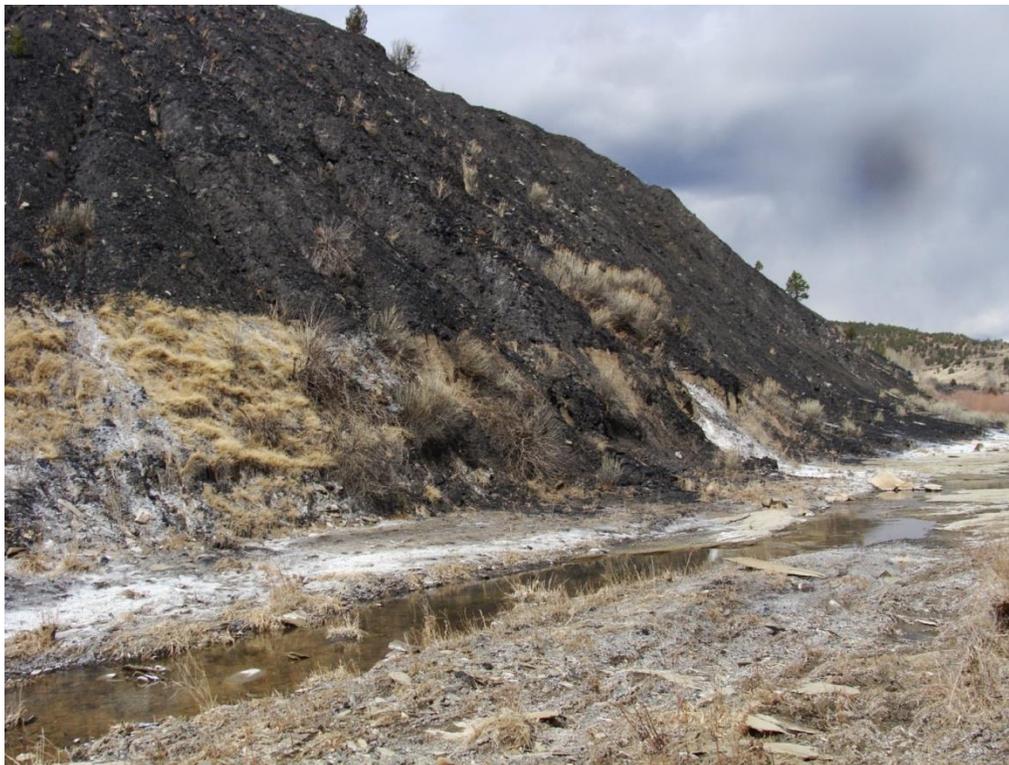
Figure 3. Degraded Dillon Canyon stream channel at Swastika.

Swastika Mine. The Swastika abandoned mine site was the focus of the geomorphic reclamation efforts. At Swastika, and at many other pre-law sites in the Canyon, coal that was mined but could not be sold (coal waste, or “gob”) was dumped in angle-of repose piles stretching along the base of the hillsides adjacent to the mines. At the Swastika mine site nearly 200,000 cu. yds. of coal waste had been abandoned in several steep, unstable piles. The largest of these piles was placed immediately adjacent to the Dillon Canyon stream channel and was collapsing into the stream over a significant reach. In locations where the pile blocked drainages serving the subwatersheds on the hillside behind the pile, channels eroded through the coal waste as material was washed into the stream. In addition, visible precipitate in the channel indicated that chemicals leached from the pile by stormwater infiltration were degrading the stream (Figure 3). The goal of the geomorphic reclamation design for Swastika was to restore functional drainage to the landscape and create stable landforms from the coal waste material that could be successfully revegetated and would blend into the surrounding undisturbed topography.

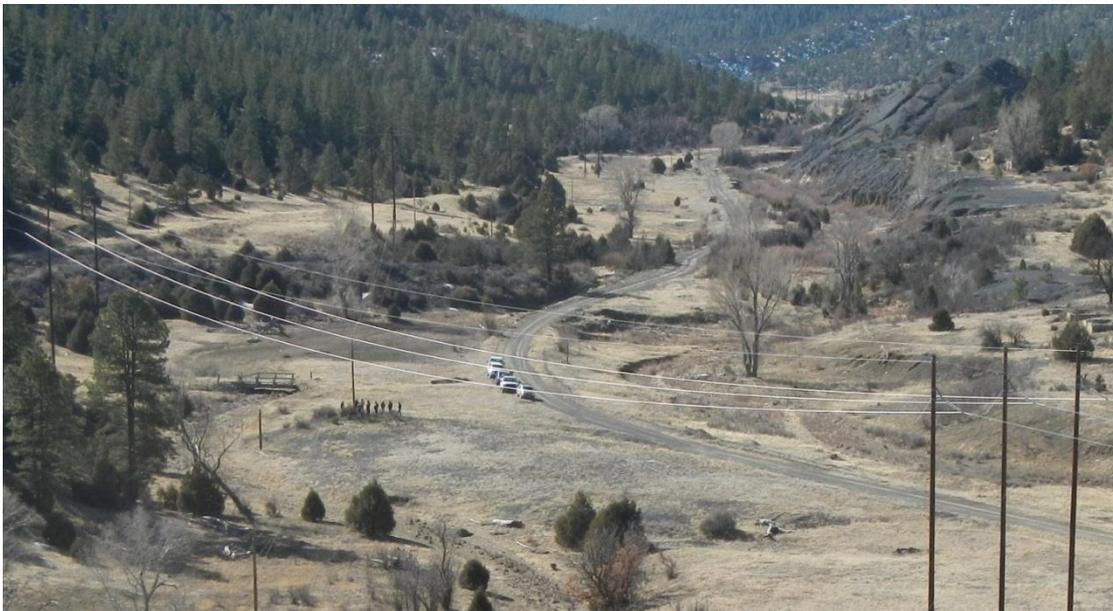
Figure 4. A significant volume of coal waste relative to the width of the valley at Swastika.

Challenges for geomorphic design at the Swastika site included the presence of many valuable cultural and natural resources lying within a valley that is narrow relative to the significant volume of gob material requiring reclamation (Figure 4). The design was required to preserve more than 183 archaeological features, including the adit, the buildings and facilities that served the mine, and the relics of the coal camp where as many as 500 miners lived at the height of coal production in the late 1920s. Archaeological features associated with the mine line the hillside behind the coal waste pile, preventing the material from being flattened back into the hillside to achieve stable land slopes. To make space for a geomorphically stable landform, realigning the stream and the road, which ran parallel at the toe of the gob pile, was required. The stream and the road were moved into the valley to the east in a design that preserved, in addition to the archaeological features, two existing power line rights-of-way and scattered areas with desirable established wetland vegetation or mature trees.

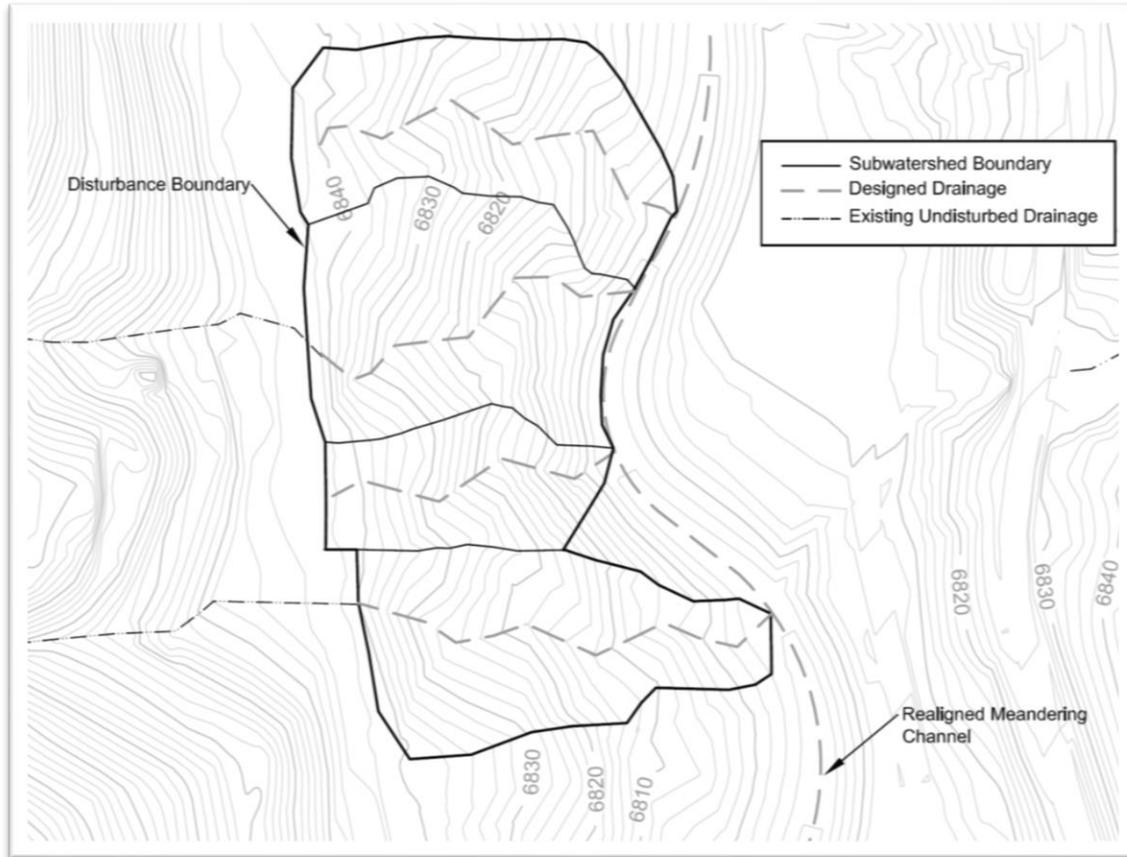
Figure 5. Design topography for a geomorphic landform at Swastika.

For the Swastika reclamation project template, undisturbed landforms were measured to determine geomorphic characteristics. The ridge-to-head-of-channel length specifies the maximum drop from a ridgeline that can be served by overland flow given rainfall and soil properties, before the appearance of visible rivulets in the landform. Drainage density measurements quantify how many channels per unit of land surface area are required to prevent erosive concentrations of flow. Steeper topography produces and requires a higher drainage density to limit both the concentration of flow and flow velocities. The drainage density dictates the number of channels input into the Natural Regrade™ with Geofluv™ model. The model designs ridges in the output landform to create subwatersheds that are each served by an integrated designed channel (Figure 5). Each subwatershed is further dissected by smaller ridges. The geomorphic landform design ties into undisturbed topography at the disturbance boundary.

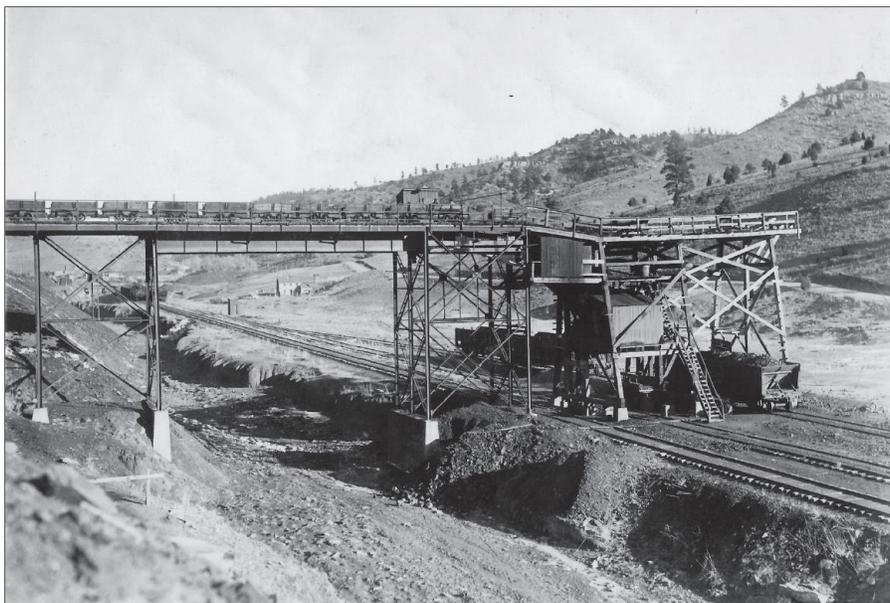
Figure 6. Historic photograph of the straightened stream channel, tipple and rail facilities at Swastika.

Realigning the stream channel served to provide space for reshaping the adjacent coal waste into landforms with more moderate slopes, both by moving the channel farther out into the valley and because the old channel was backfilled with coal waste above the elevation of the local water table. However, stream restoration for its own sake was a primary reclamation activity at Swastika, undertaken to address environmental degradation that was ongoing as a result of artificial channelization of the stream during the historic mining period. During mining, the stream was rerouted from a meandering alignment in the center of the valley to a straight alignment at the extreme west side of the valley, with rail facilities serving the mine running along the east channel bank (Figure 6). Straightening a reach of stream channel shortens the flow path and increases the slope of the channel bottom, producing faster flow capable of eroding the channel bottom during periodic high flow events. The soils in the Dillon Canyon valley are neither rocky nor clayey, and the fine silts with occasional cobbles composing the straightened channel bed and banks have little cohesion to resist shear stresses associated with high-velocity flood flows. High flow events scoured the channel bed and increased the channel depth. The additional conveyance capacity further concentrated high flows in the channel and established a tendency towards ongoing channel erosion during subsequent high flow events. The straightened reach of the Dillon Canyon channel had become deeply incised within vertical, unstable stream banks (Figure 7).

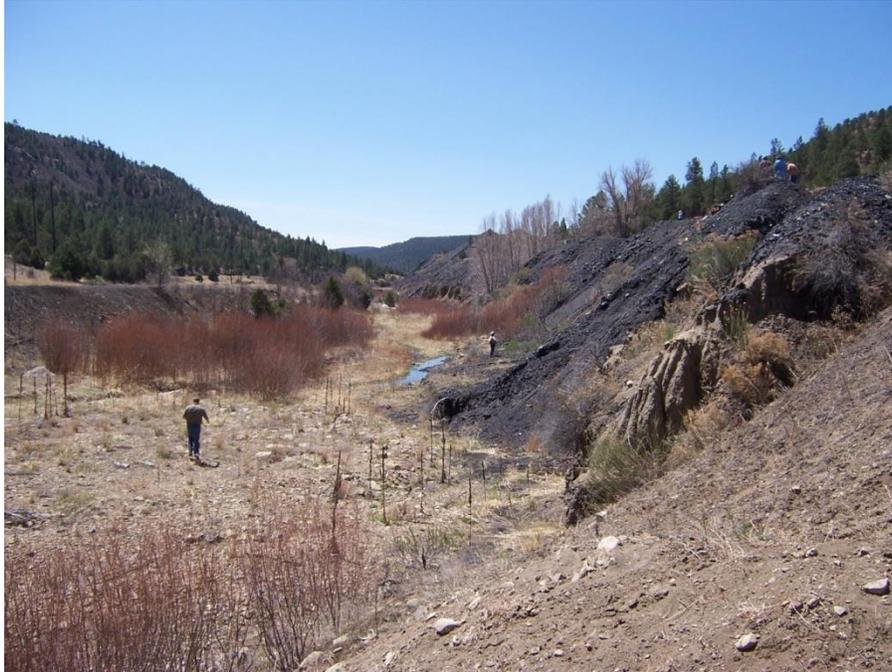
Figure 7. Degraded Dillon Canyon channel and adjacent coal waste.

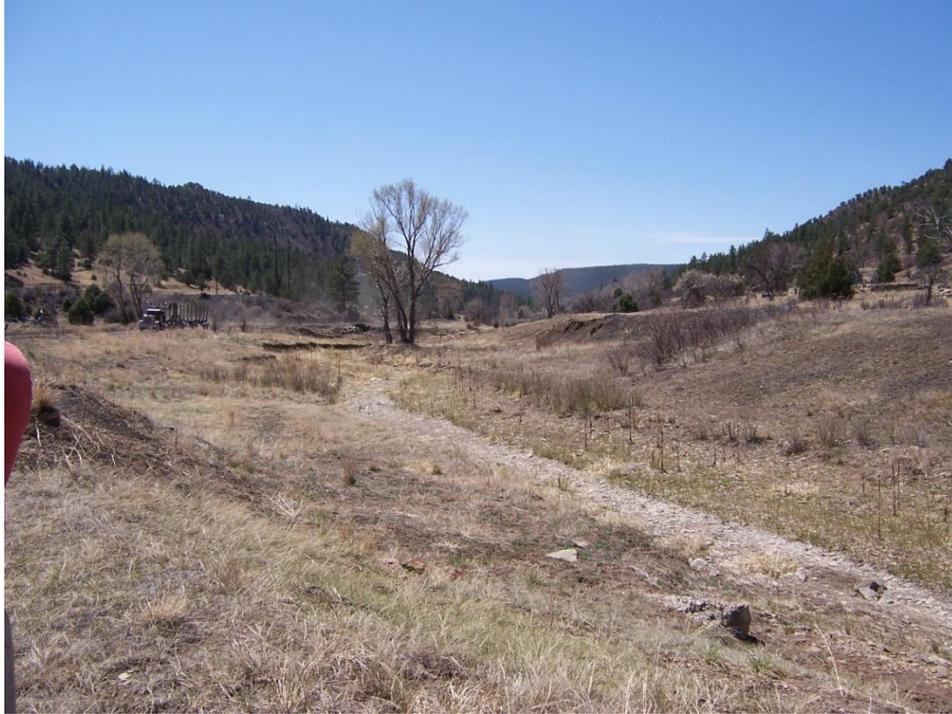
Figure 8. Typical undisturbed Dillon Canyon stream channel.

The geomorphic stream restoration design was integrated with the landform design within Natural Regrade™ with Geofluv™. The restored stream was designed to look (and function) like the stream reaches that develop naturally within Dillon Canyon given the area's climate, soils and vegetation. In Dillon Canyon, stable portions of the undisturbed stream channel are meandering and broad, with gentle vegetated stream banks surrounding a narrow low flow channel armored with small rocks (Figure 8). The relatively flat channel banks ensure that the channel is hydraulically connected to a functional floodplain that provides areas of slower, shallower flow even during high flow events. Where the low flow channel is overtopped, flow spreads out across an adjacent overbank and the erosive force of the flood flows is reduced. Vegetation able to withstand infrequent flood events can become established. The establishment of vegetation provides additional stabilization of the overbanks. For the Dillon Canyon channel, geomorphic criteria were applied to the longitudinal profile of the channel, the realignment layout or shape of the channel in a plan view, and the cross-section geometry.

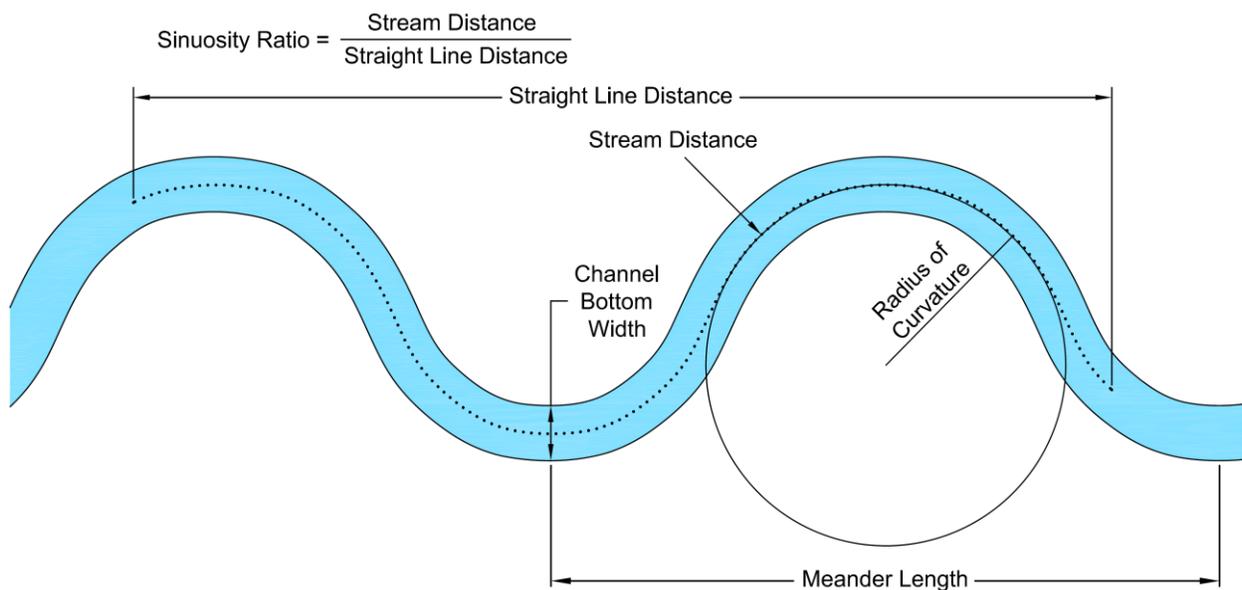
Figure 9. Geomorphic criteria included channel sinuosity, meander length, and meander radius of curvature.

Geomorphic layout parameters specified by Natural Regrade™ with Geofluv™ for the Dillon Canyon channel included a target sinuosity of 1.18, meander radius of curvature of 100 ft, and meander length of 420 ft (Figure 9). The layout was required not only to avoid disturbing archaeological features and power line poles during construction, but to ensure that these features would not be inundated by the design storm. To accommodate all of these design constraints, the layout geometry suggested by the program was altered slightly to better fit the available space in the valley, while incorporating the target values for geomorphic criteria. Approximately 3,050 ft of existing straight channel was replaced by approximately 3,350 ft of restored channel, with the increased length resulting from the restoration of a meandering stream path.

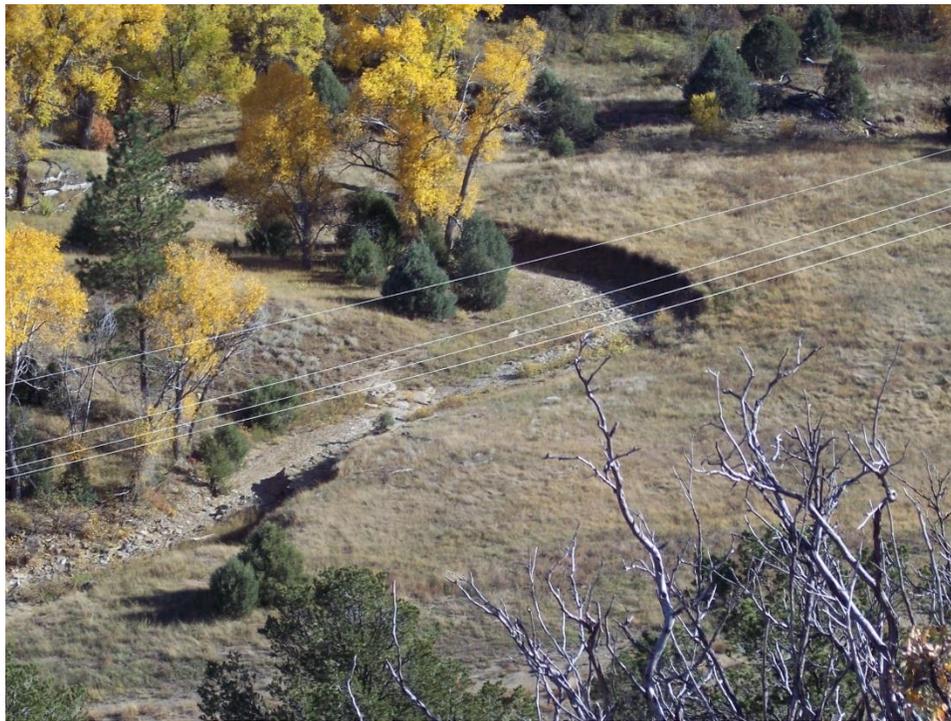
Figure 10. Undisturbed reach in Coal Canyon showing variable side slopes for channel banks.

slopes for the restored channel vary depending upon the location of the cross section within the meander pattern, as they do in undisturbed reaches of the Dillon Canyon channel (Figure 10).

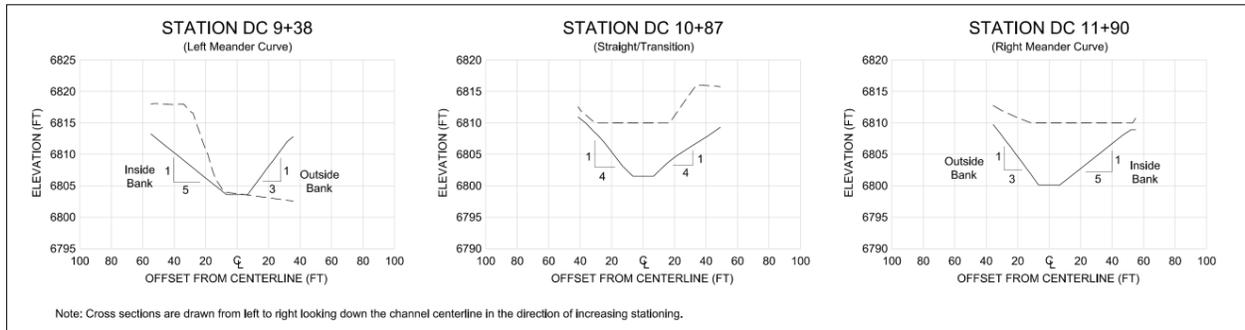
Figure 11. Excerpt from plan set illustrating typical differential side slopes for channel cross sections.

The restored channel was designed with variable side slopes, like undisturbed natural channels in Dillon Canyon (Figure 11). The bank slope on the inside of each meander is flatter

(5H:1V) than the slope at the outside bend of each meander (3H:1V). Moving downstream from a meander, both bank slopes transition to 4H:1V in the straight reach between meanders, and then transition again for the next meander. The steeper bank on the outside of the meander may experience some erosion and become steeper, but the shallower slope on the opposite, inside meander ensures that flood flows are distributed onto the overbank and slowed, allowing suspended sediments to drop out.

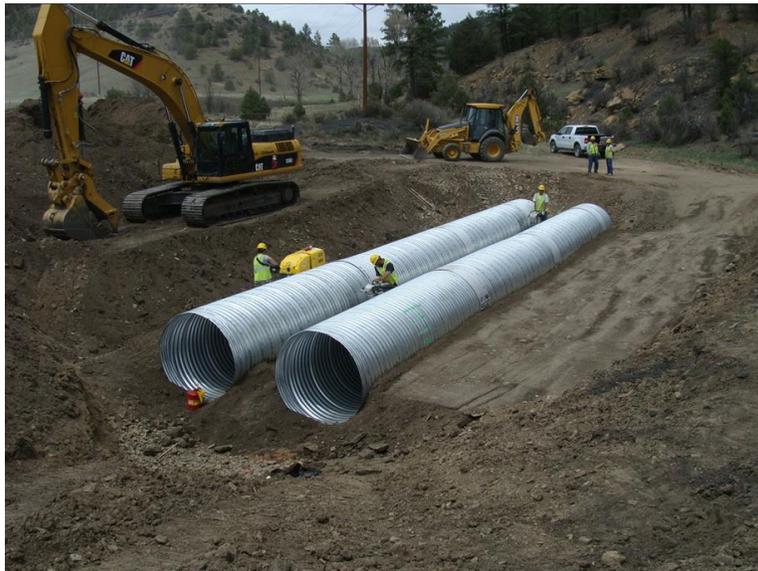
Figure 12. Culverts that convey the Coal Canyon channel under the realigned road.

Transportation Projects” (NMDOT Drainage Design Bureau, fourth revision, June 2007). The road is designed to be overtopped during large floods at locations where culverts large enough to convey the peak design flow could not be properly bedded. The road and embankments in those areas received rock surfacing. The old bridge at the mouth of Coal Canyon was seriously undersized for the flows from a watershed nearly seven square miles in area, so it was replaced by two 72-in. culverts (Figure 12) to allow the realigned road to make a perpendicular crossing of the culverts. Culvert improvements or additions were designed for six other locations to bring runoff under the realigned road and into the restored channel.

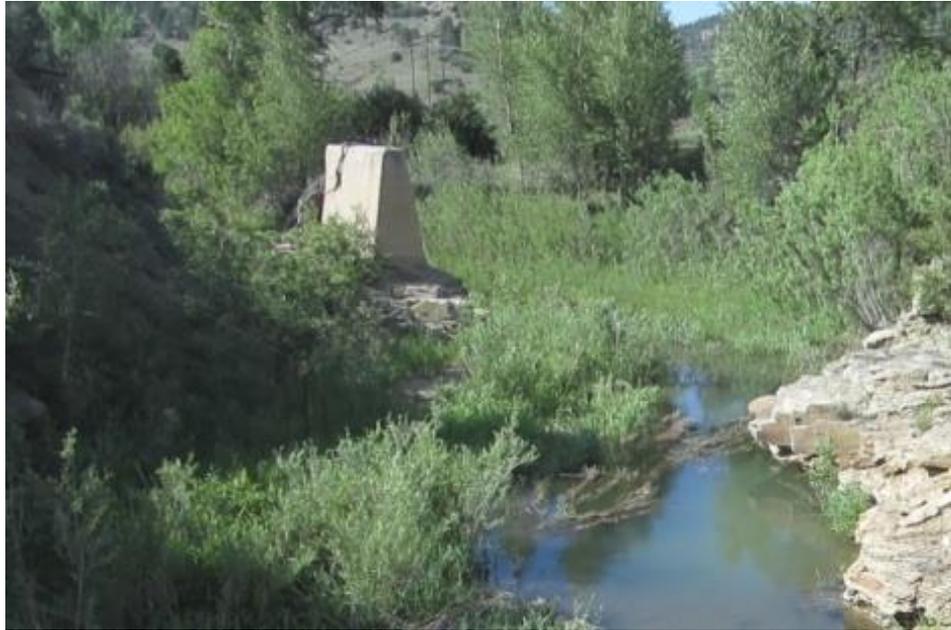
Figure 13. The “oxbow” area.

The design at Swastika sought to preserve a portion of the straightened channel that had been downcut through a sandstone ledge at the base of the hillside. On both sides of the straightened channel in this area, springs and seeps emanating from the fractured sandstone and upstream channel bed were observed to persist throughout the year. Within a small, protected reach of the otherwise degraded channel, diverse mature wetland vegetation and habitat for riparian species had developed. That portion of channel was not backfilled, although the realigned channel meandered away from the hillside at that point. The area was preserved and resembles an “oxbow” (Figure 13) that might develop adjacent to a meandering stream naturally after a meander is severed from the stream path.

The oxbow is separated from the realigned channel on the upstream end by a backfilled section of the channel and a sturdy embankment to prevent the realigned channel from reestablishing flow into the area. A hydraulic connection between the oxbow wetland and the natural springs and seeps was provided by designing a French drain to convey the flow from the backfilled seep and spring locations, thus maintaining the existing water source to the oxbow.

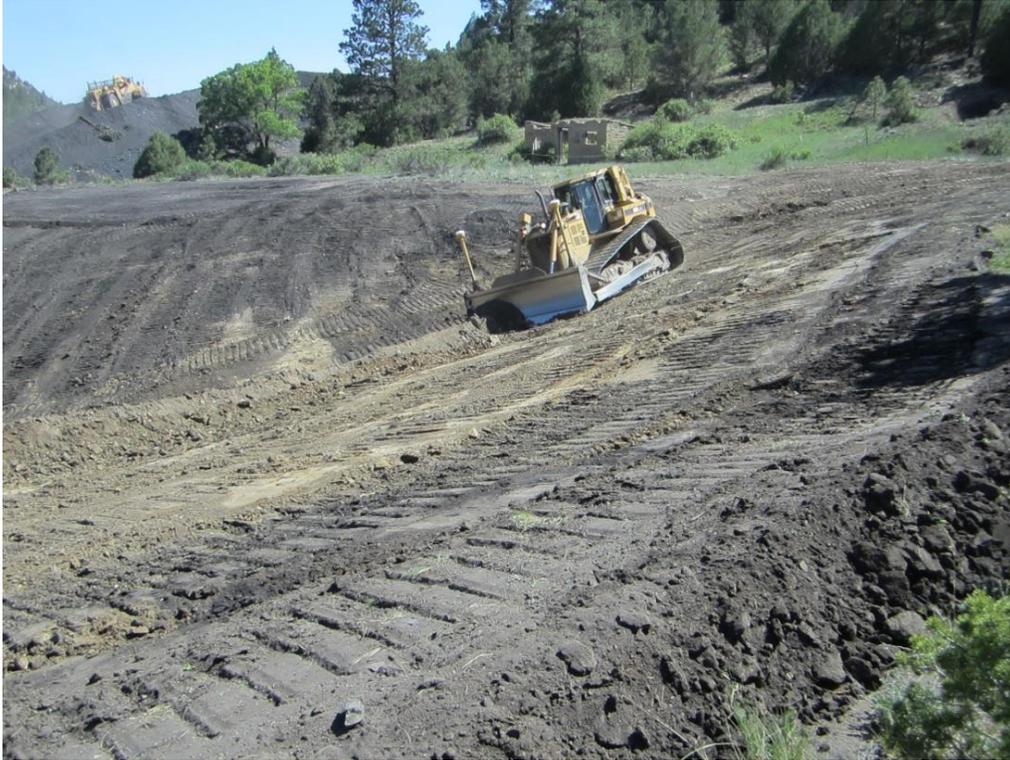
Figure 15. Landforming with GPS machine control.

project from the outset (Figure 15). Digital files were generated in AutoCAD® Civil 3D in an XML format that represented the 3-dimensional design in Triangular Irregular Network (TIN) format. Ridge and valley lines were particularly important and were emphasized when creating the TIN. These XML files were uploaded on the equipment computers so that a precise construction tolerance could be met. Ultimately it was necessary to adjust the topographic contours in the TINs to better accommodate the channel layouts superimposed on the topography by Natural Regrade™ with Geofluv™. The high level of resolution in the TINs allowed the equipment operators to efficiently construct both the geomorphic landforms and their integrated drainage channels.

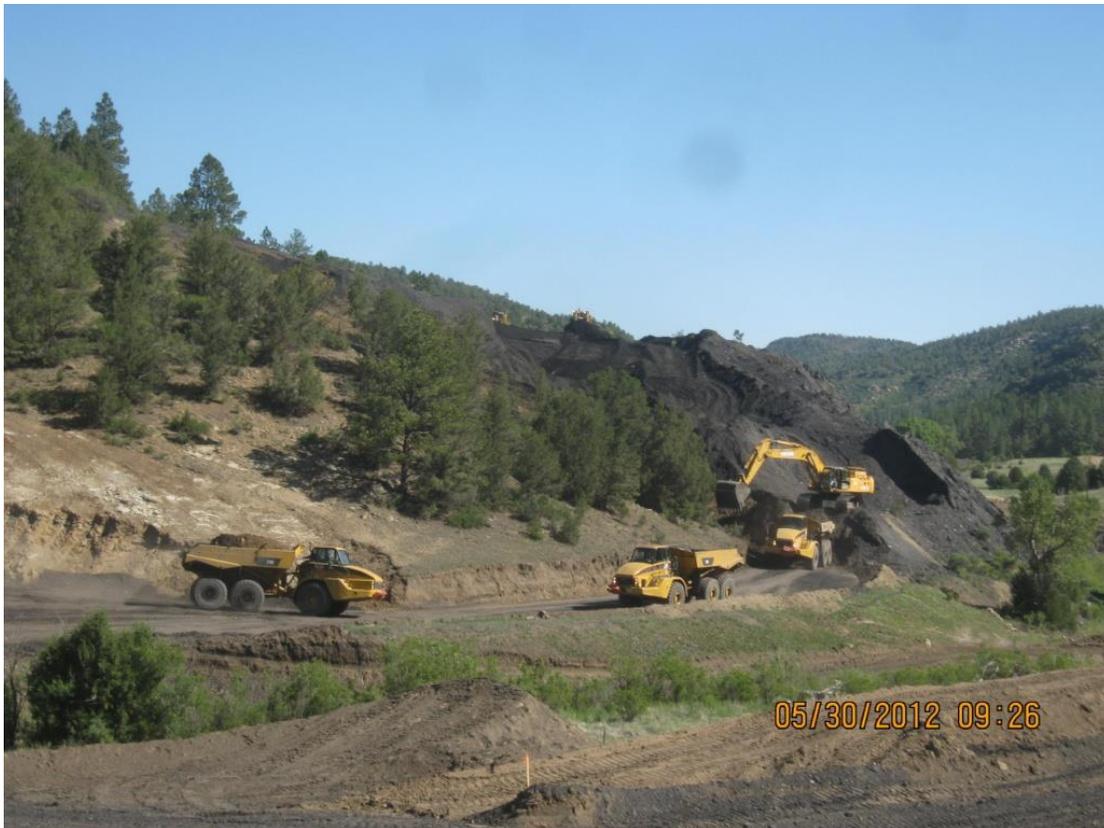
Figure 16. Removing coal waste to combination soil borrow/repository areas.

higher on the pile (Figure 16). Utilizing push construction methods for geomorphic landforming not only reduces the cost of moving material, but has proven to be most effective in achieving the desired landform results as well. Looking at a geomorphic landform design, it is easy to focus on constructing channels to excavate those zigzagging forms first. Subsequent efforts to finalize the surrounding landform, however, are prone to disturbing the channel form and frustrating the operators. A more reliable technique to approximate the final landform is to simply push material from the channel into alternating ridges on either side of the channel, allowing the channel's zigzag shape to emerge from that process and building both the channels and the landform simultaneously.

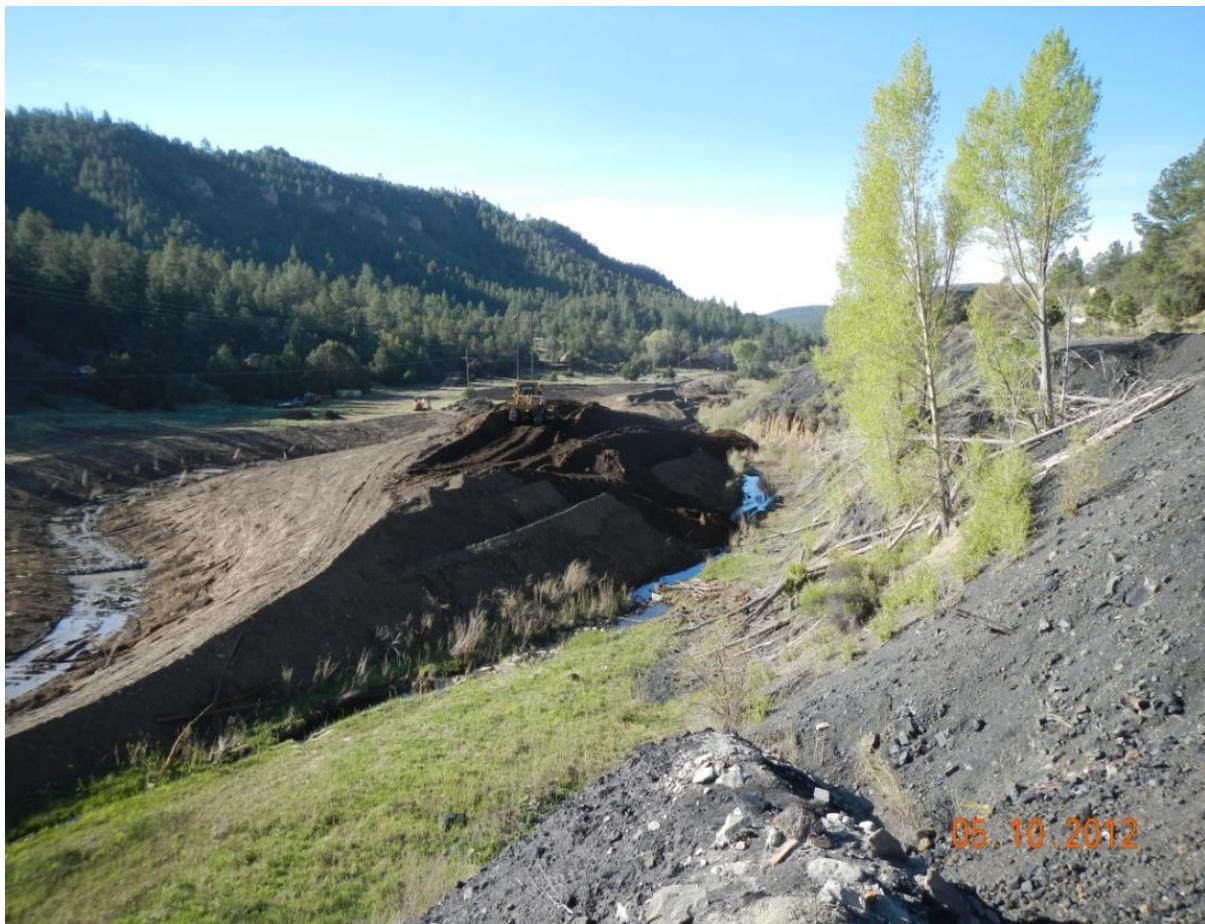
Figure 17. Realigned and restored channel construction.

The channel was built in a direction from downstream to upstream (Figure 17) to facilitate drainage if any groundwater was encountered. Material excavated during construction of the relocated and restored channel was stockpiled to cap coal waste. In several locations bedrock was encountered at channel invert elevations. To allow bedrock grade control to provide extra

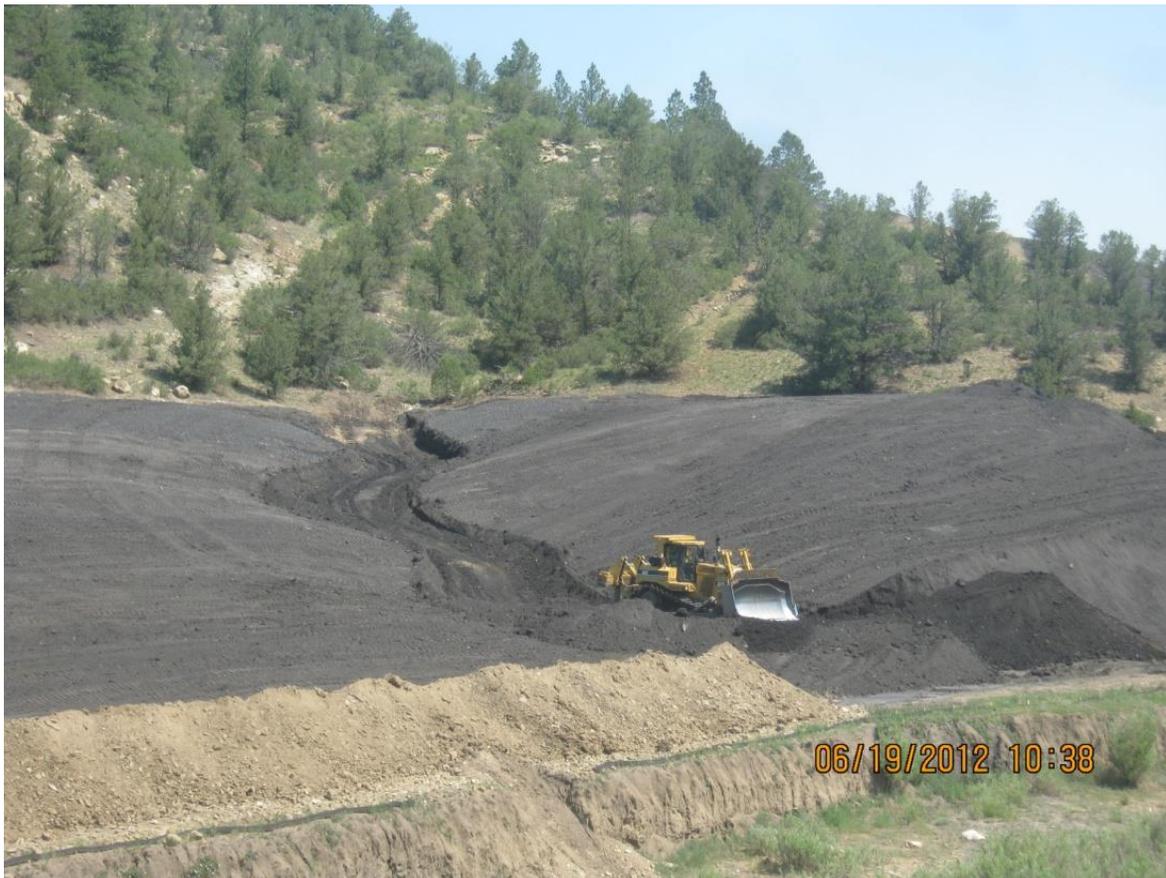
Figure 18. Embankment preventing coal waste fill within the meander belt of the restored channel.

The existing channel was not backfilled until rock and vegetation that could be moved to the new channel was salvaged. Because the geomorphic design relies on dynamic stability rather than engineered structural control with riprap or grouted concrete structures, the meanders constructed for the restored stream may migrate as a result of low-frequency high flow events. To avoid the exposure of coal waste if the restored stream's meanders migrate over time, coal waste was not placed within a meander belt representing the maximum likely extent of meandering for the restored stream, including those locations where the realigned stream meanders approached the old channel. An embankment of clean fill was established to mark the extent of fill with coal waste (Figure 18). Coal waste was also withheld from those locations where substantial tributary drainages were constructed to convey runoff from the hillside across the reclaimed landform to the restored channel.

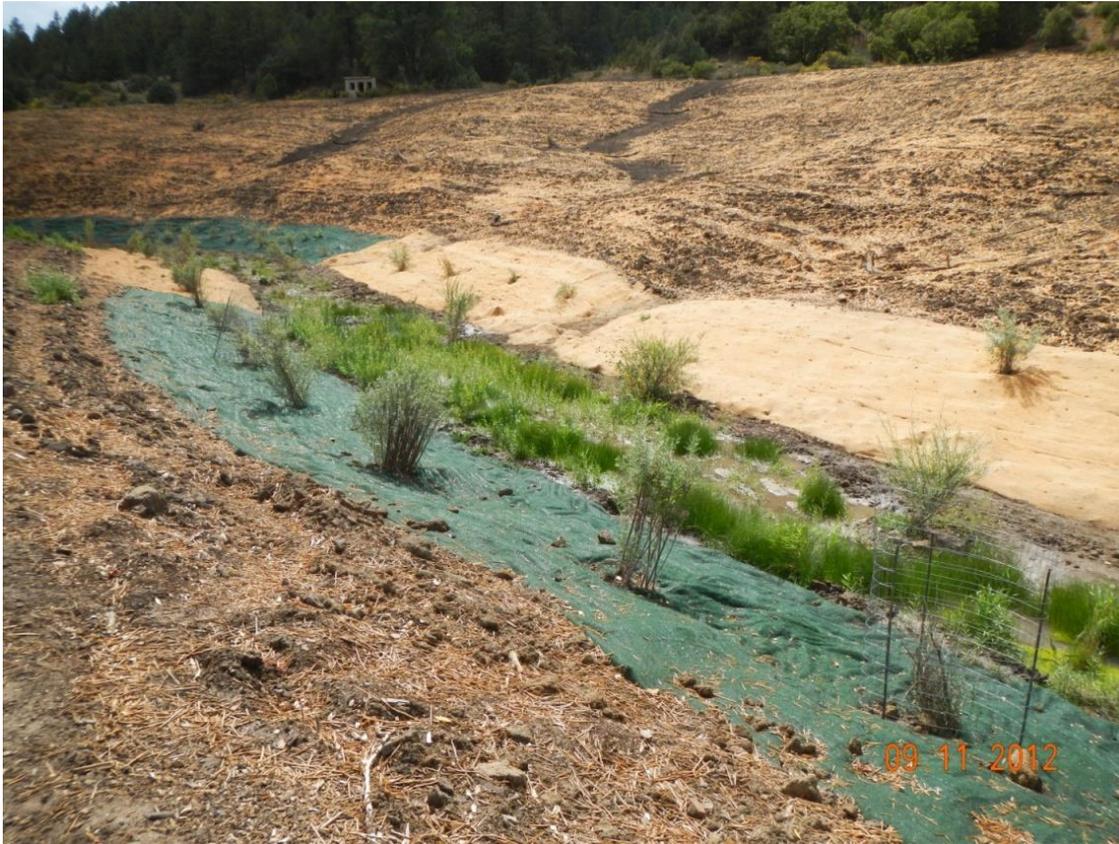
Figure 19. Restored channel with tributary side swales visible in background

The project created an aesthetically pleasing valley, with stable rolling ridges composed of capped coal waste surrounding an ecologically rich riparian corridor (Figure 19). The geomorphic landforms constructed accommodated a total of 200,000 cu. yds. of coal waste (Figure 20). A

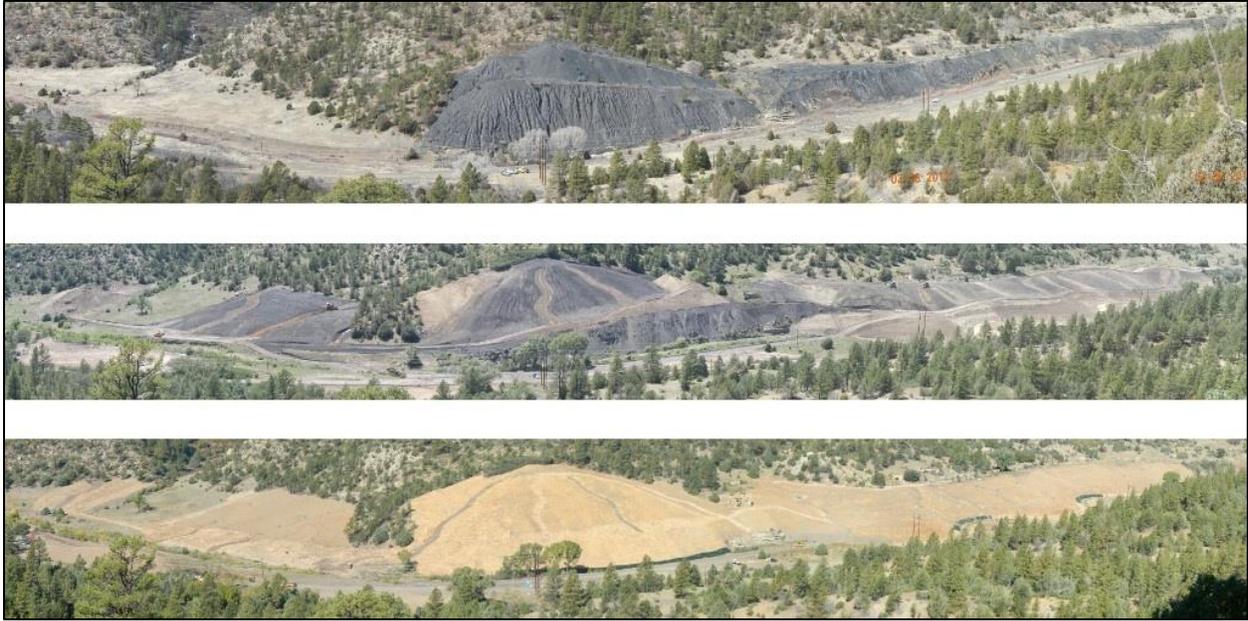
Figure 20. Coal waste reclaimed in geomorphic landforms at Swastika.

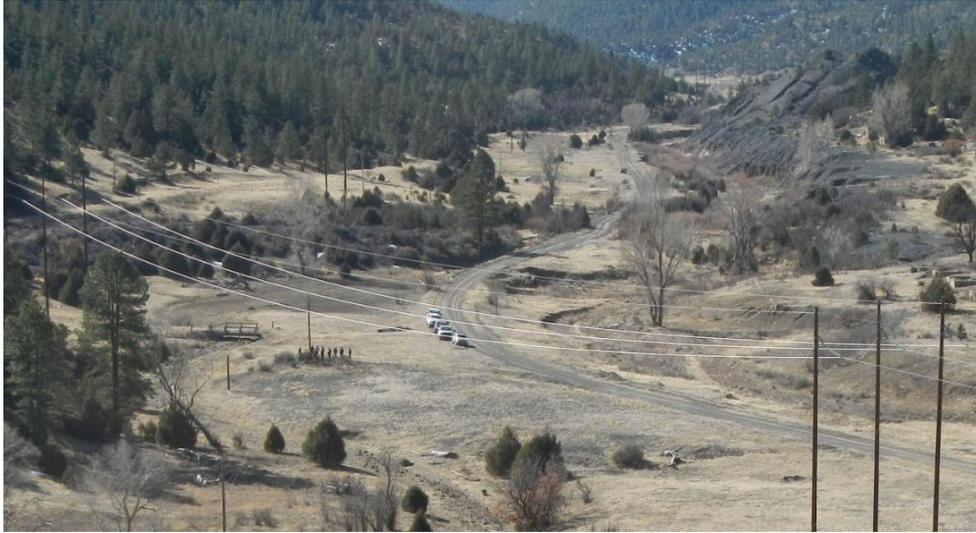
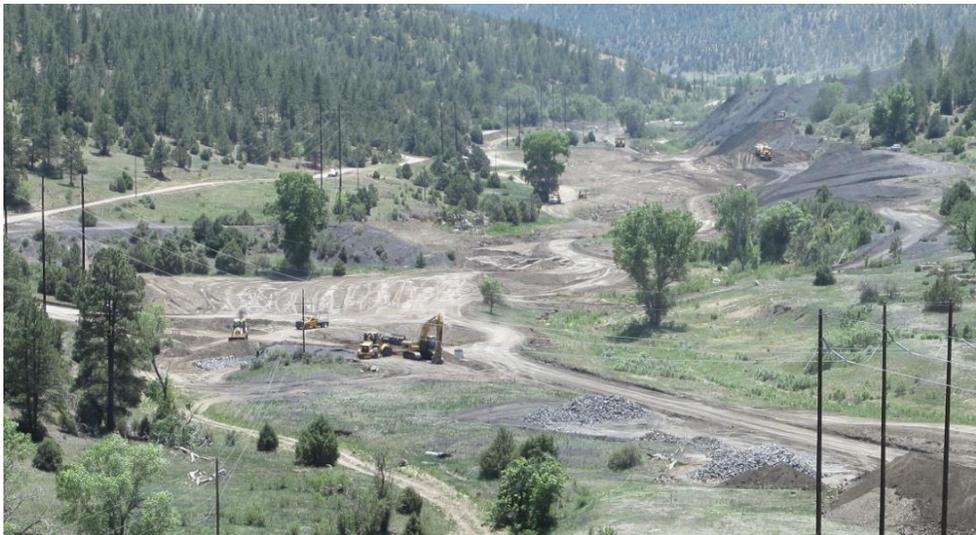
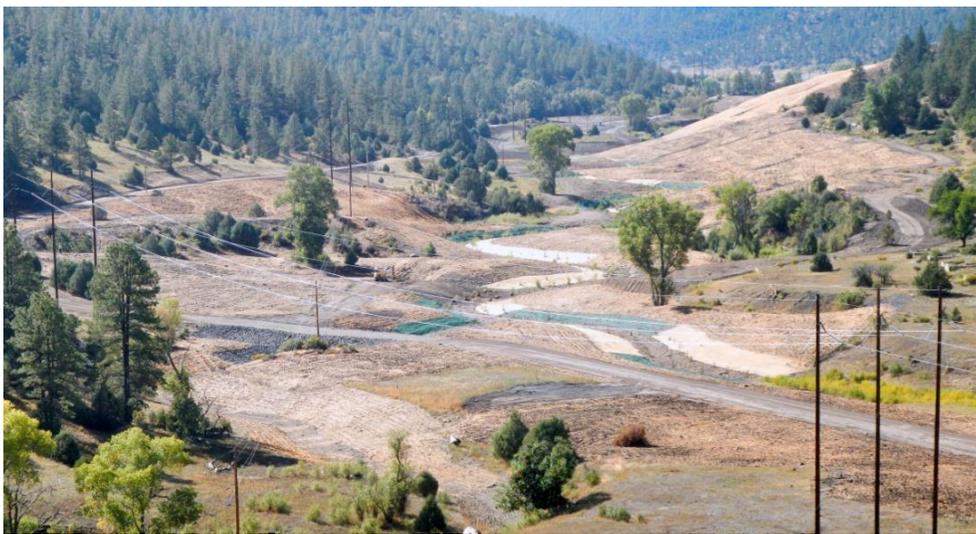
Figure 22. Completed geomorphic reclamation and stream restoration at Swastika.

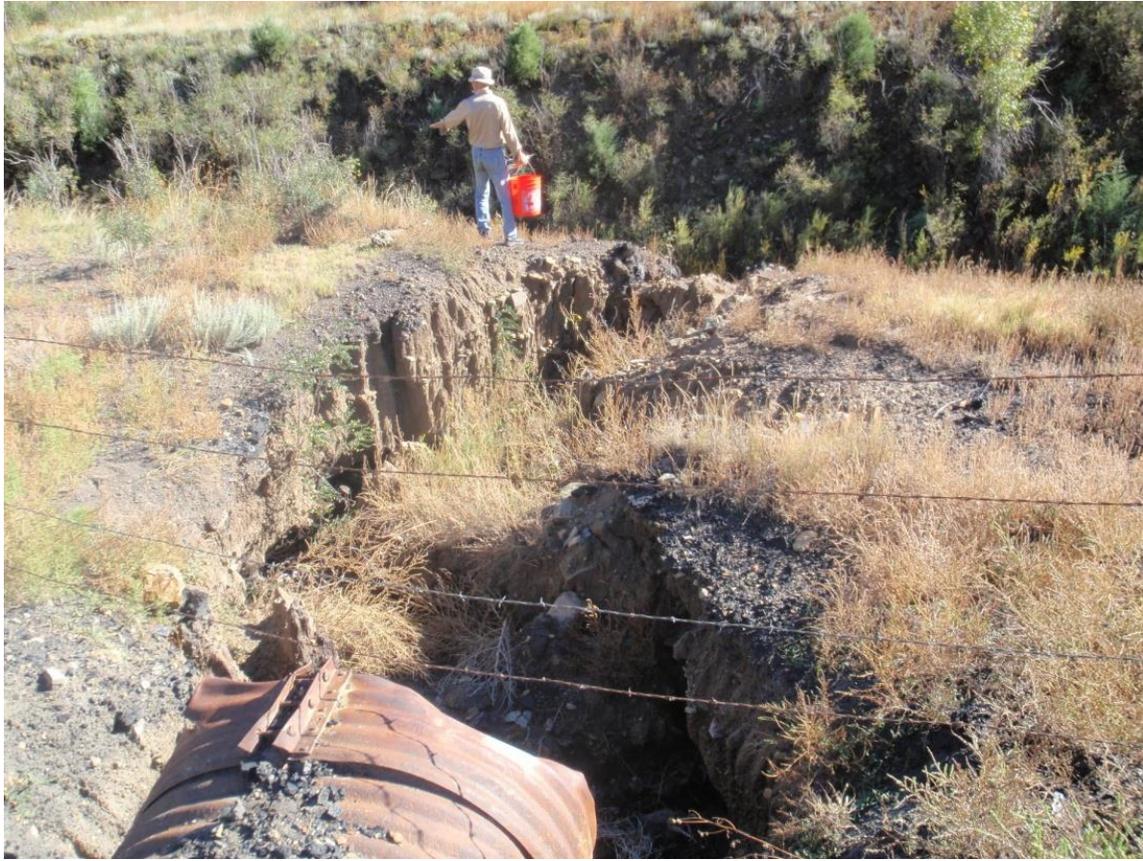
Figure 23. Culvert conveying outflow from the wildlife ponds to the Dutchman Canyon channel.

At Dutchman Canyon, channel head-cutting (Figure 23) was eliminated by redirecting wildlife pond outflow through a constructed spillway to supply water to a new salt-tolerant wetland. An increase in wildlife pond embankment height added a significant factor of safety to prevent overtopping and embankment failure (Figure 24). Better access was provided through road and drainage improvements and vegetative cover was enhanced by treating and seeding remnant coal waste piles.

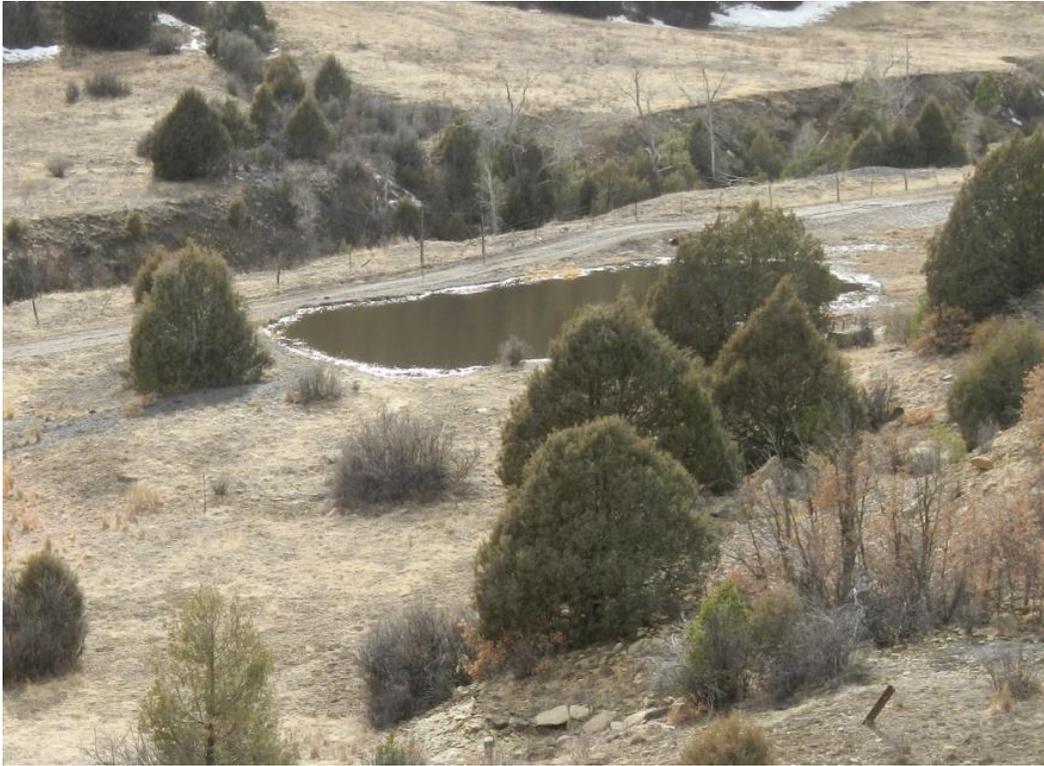
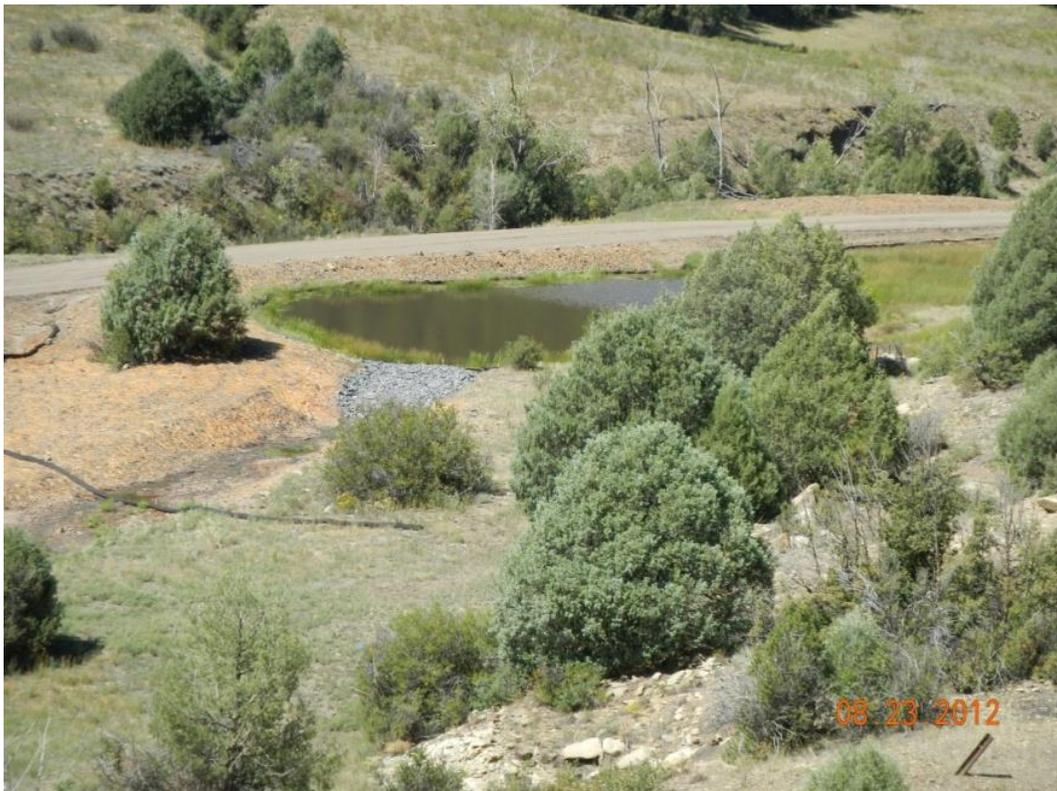
Figure 24. Embankment improvement increases freeboard, provides a spillway, and directs outflow to a new salt-tolerant wetland.
