# NICKLE PLATE ABANDONED MINE POOL “BLOWOUT” WASHINGTON AND ALLEGHENY COUNTIES, PENNSYLVANIA<sup>1</sup>

**Abstract.** On 01/25/05, a 10,000-gpm “blowout” of the century-old Nickle Plate Mine (Pittsburgh coalbed) occurred in a public sidewalk about 12 miles southwest of downtown Pittsburgh, PA. The US Office of Surface Mining, first responder, installed diesel pumps and drain lines along public streets to control and convey the discharge to a nearby stream. On 02/22/05, the Pennsylvania Department of Environmental Protection, Bureau of Abandoned Mine Reclamation issued a 90-day emergency contract to Environmentally Innovative Solutions, LLC to provide a permanent control. With numerous partners (federal, state, local agencies; local residents and businesses), property access, stream and mine pool water quality data, historical mine mapping, and other pertinent site information were acquired.

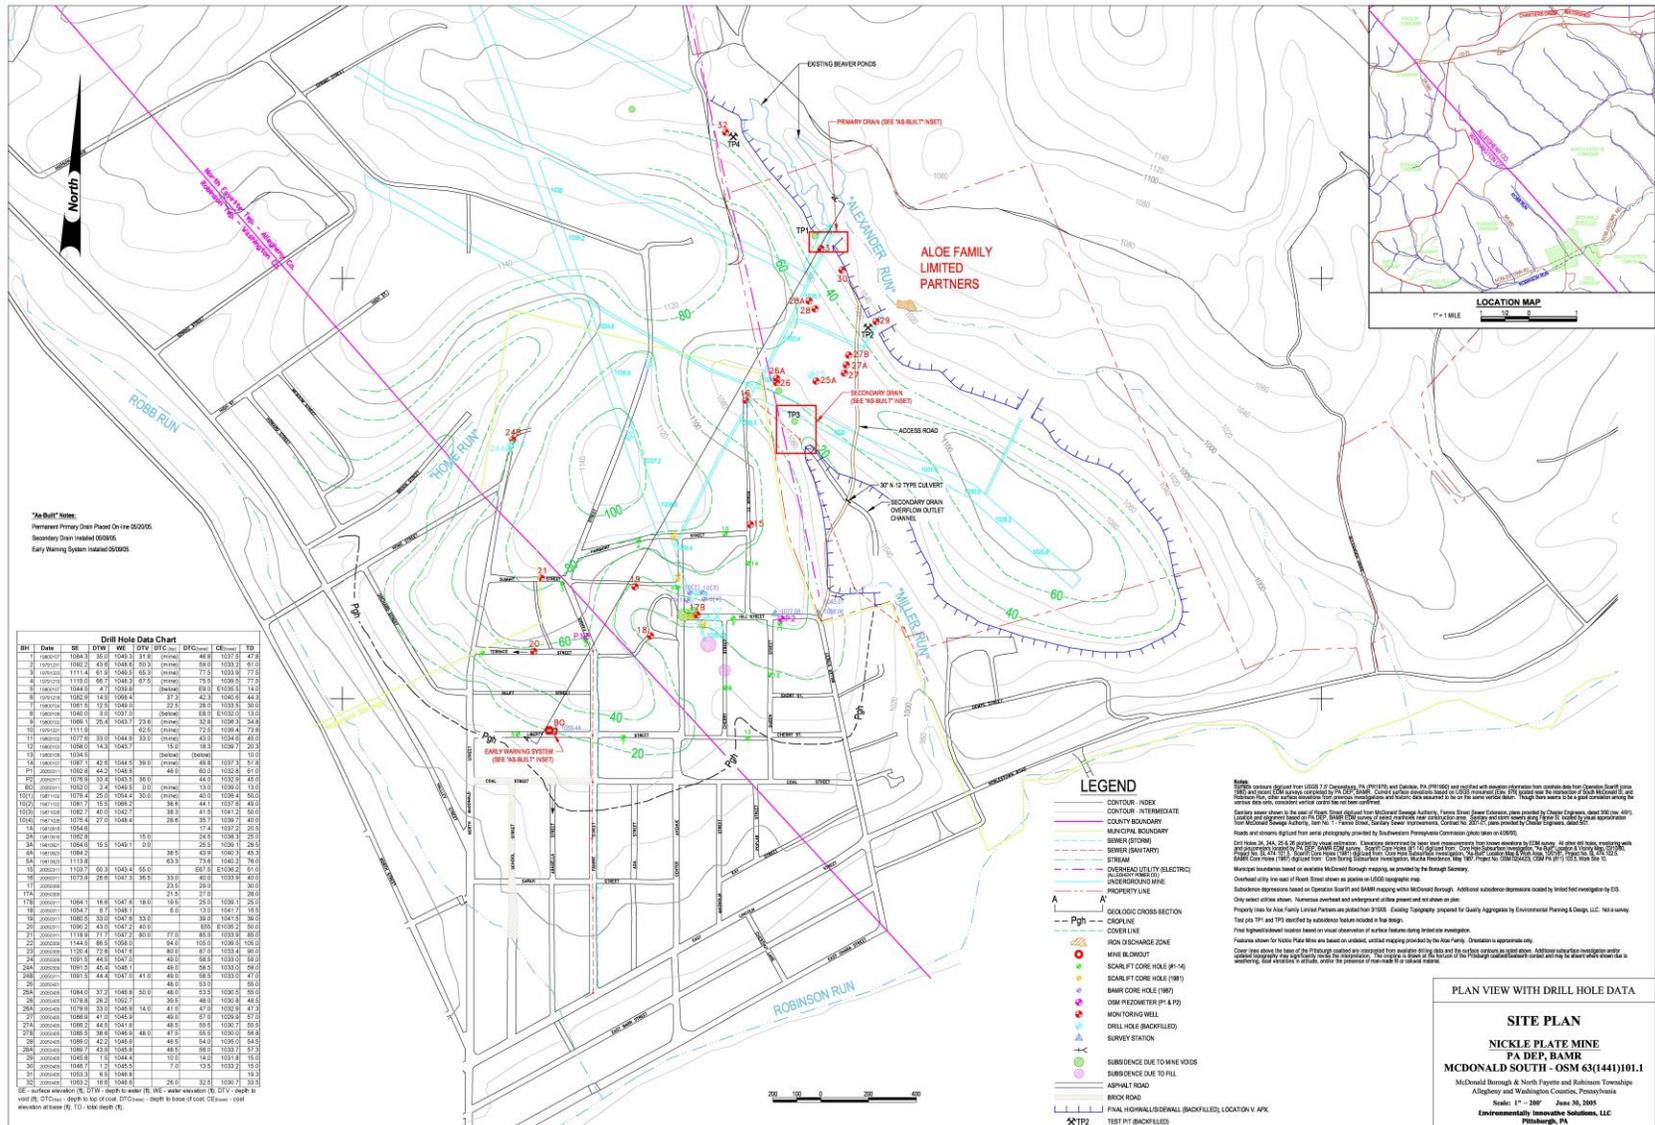
Design. The Primary Drain is installed at the location of Test Pit 1, which was excavated in a subsidence feature. Based on reorienting, revising and interpreting historical underground mapping, Test Pit 1 was in the vicinity of a backfilled drift entry.

\*"As Built" Notes:  
 Permanent Primary Drain On line 802005.  
 Secondary Drain Installed 802005.  
 Early Warning System Installed 802005.
