**ABANDONED DEEP MINE SUBSIDENCE INVESTIGATION
AND REMEDIAL DESIGN,
INTERSTATE 70, GUERNSEY COUNTY, OHIO**

Abstract. A two thousand linear foot, undermined section of Interstate 70 in Guernsey County, Ohio experienced settlements due to pothole type subsidence events within the travel lanes, shoulders and adjacent right-of-way areas. Potholes measured approximately ten feet in depth and width. The subsidence occurred after the dewatering of the abandoned deep mine during auger mining operations west of the site. A two-phase emergency investigation was undertaken by the Ohio Department of Transportation (ODOT) and Gannett Fleming Corddry & Carpenter (GF). The purpose of the investigation was to assess the immediate danger of potholes occurring in the traveled lanes and paved shoulders, to identify the subsidence mechanisms, and to design a remediation program. Phase one investigations involved the review of existing subsurface data, the advancement of shallow borings and the performance of multiple geophysical surveys including ground penetrating radar, seismic refraction and electromagnetic terrain conductivity. The Phase one investigations did not reveal the presence of subsidenc

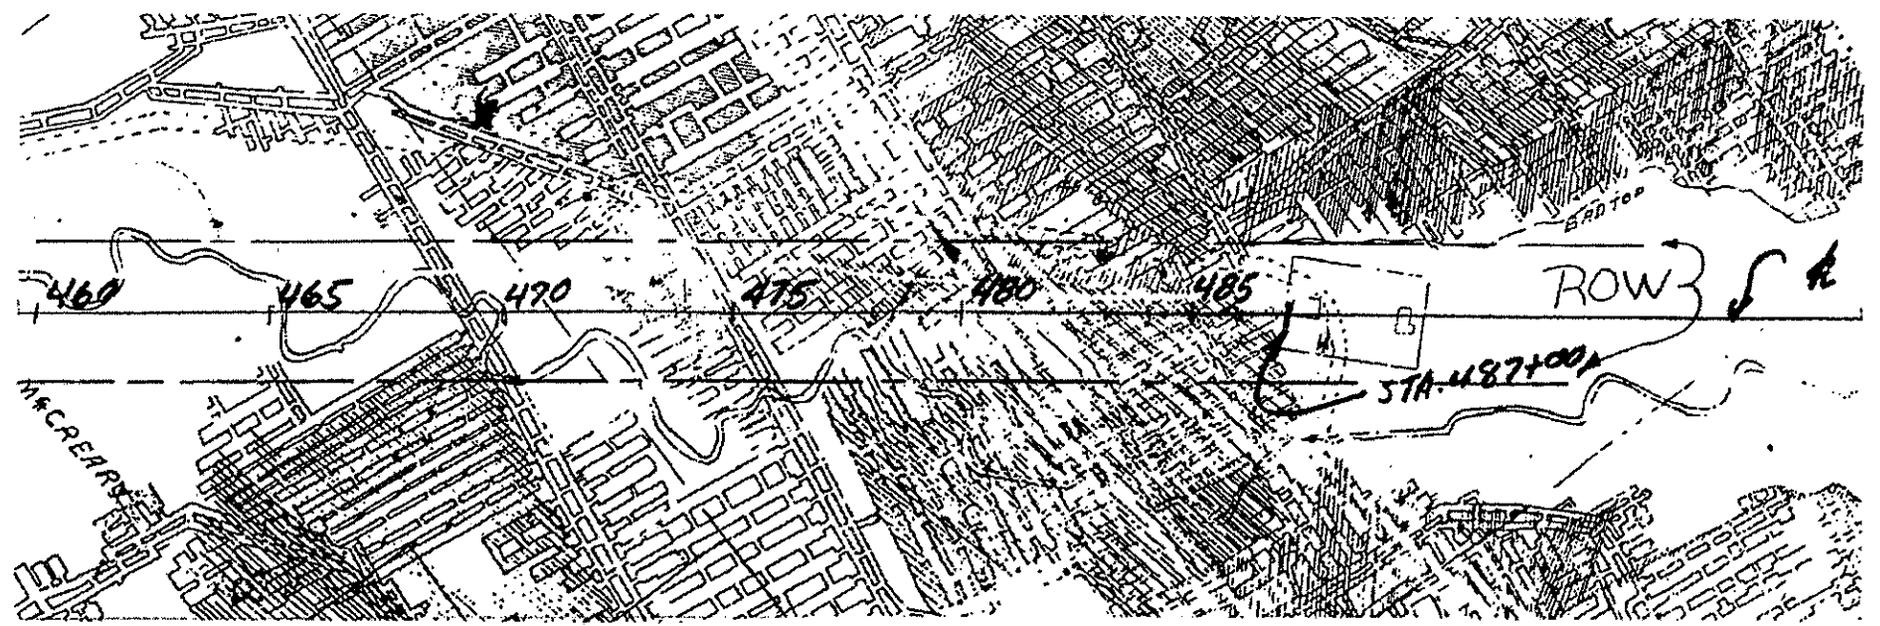
FIGURE 5: MURRAY HILL NO. 2 MINE MAP

extraction). Main and butt entries were oriented at N11E and N79W, respectively, and were generally spaced like typical room and pillar mines. Refer to Figure 5. However, the mine was not developed as most room and pillar mines are. Because of the inconsistent nature of the Upper Freeport Coal in this area, some entries were cut at odd angles and a few rooms were advanced in directions not typical to total extraction mining.

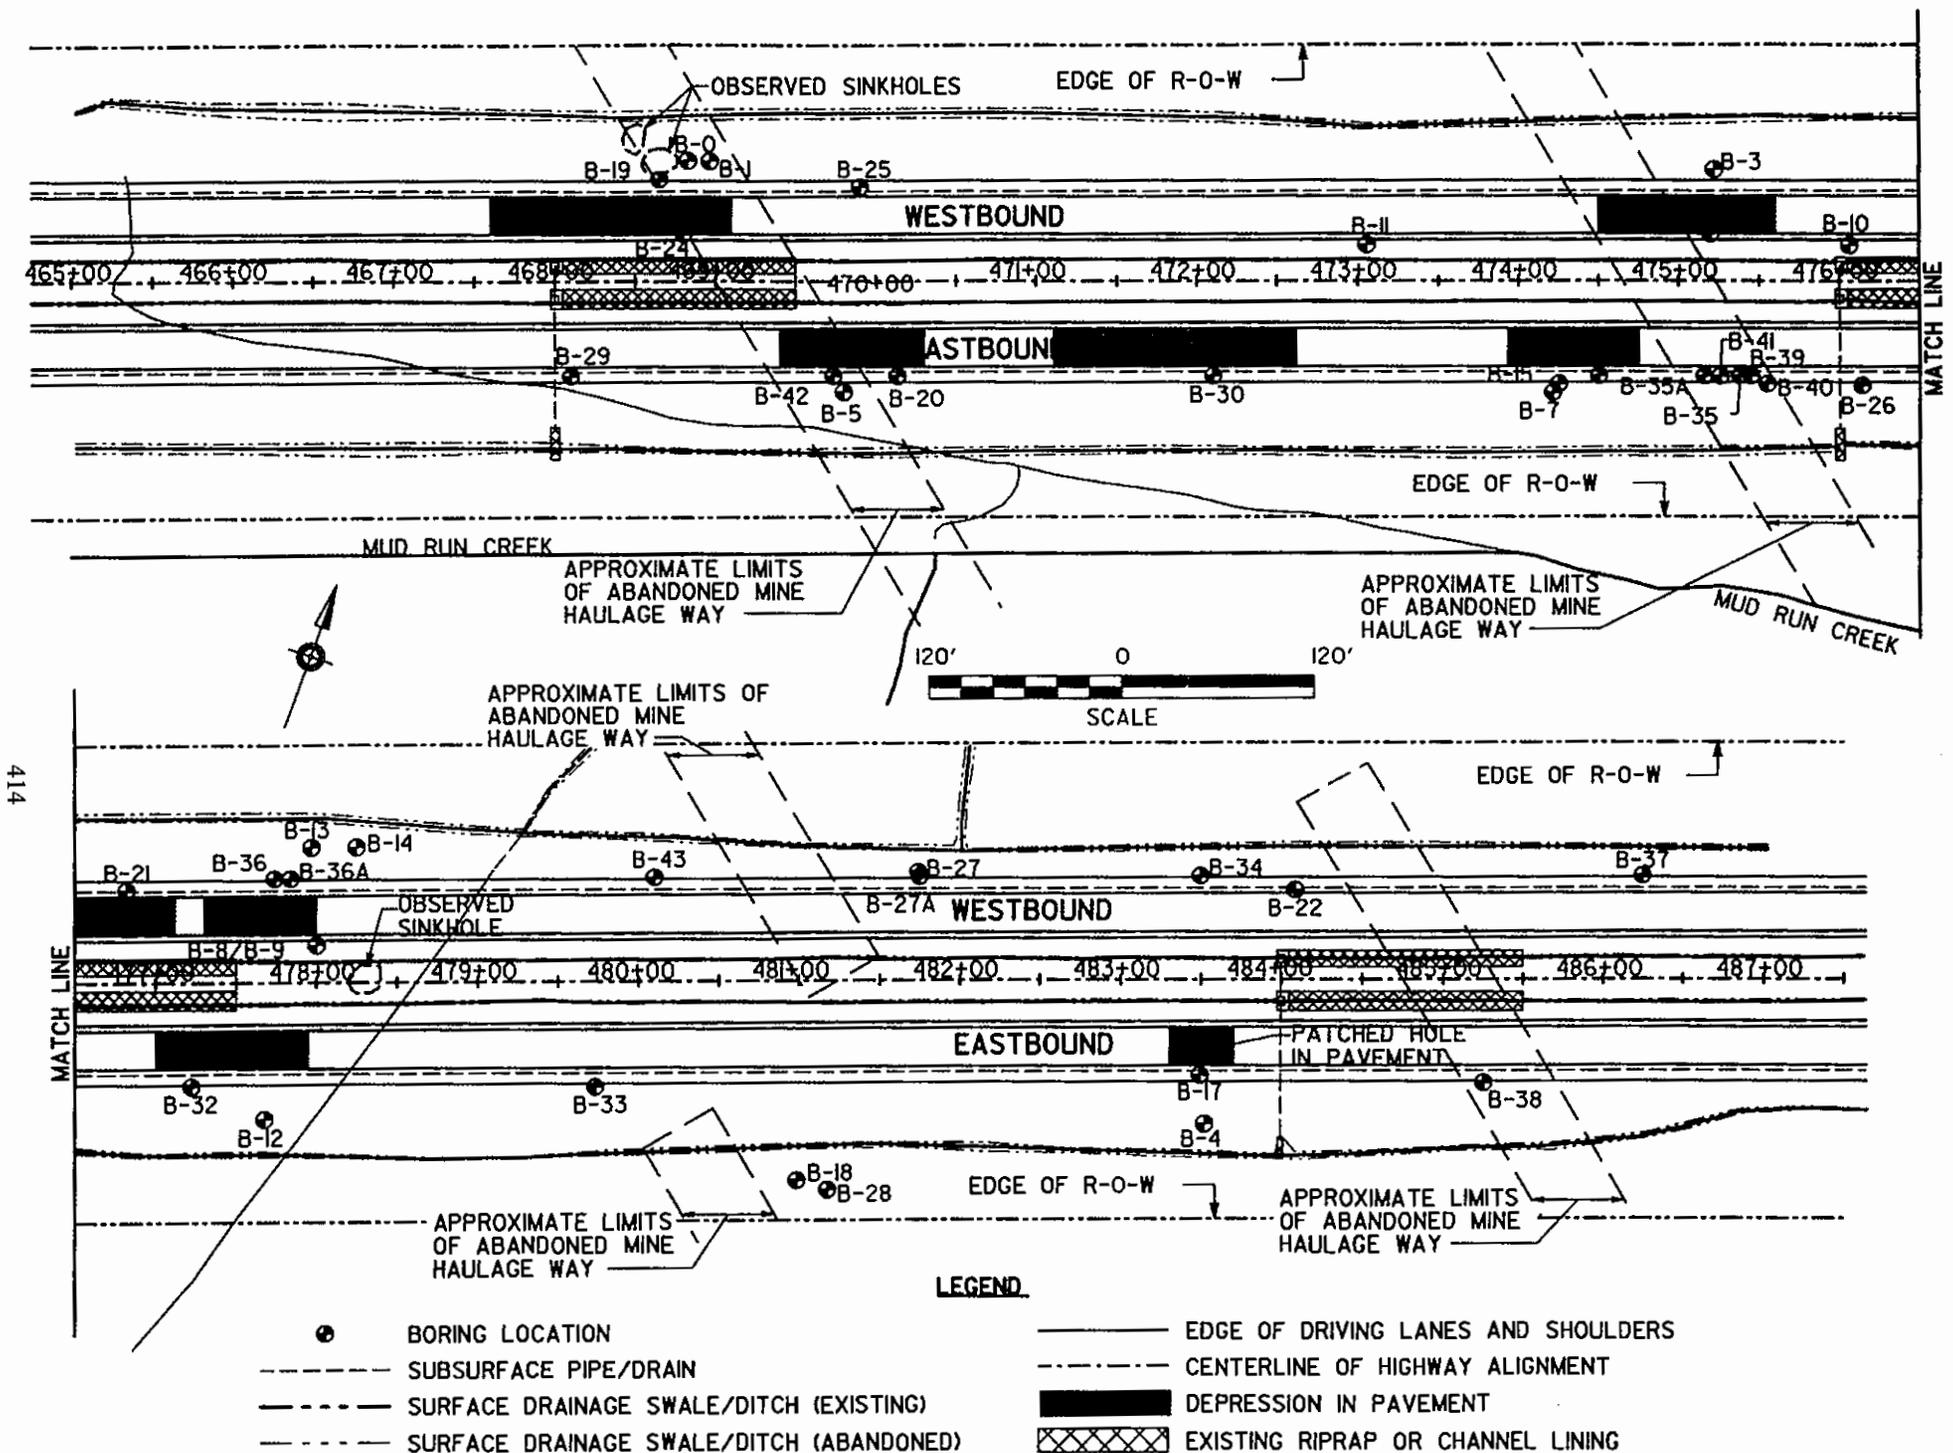
FIGURE 6: SITE PLAN

stream originating north of the new highway was routed into a rock lined drainage swale located north of the traveled lanes. Drainage swales on both sides of the highway are poorly graded, sloping less than one percent in many areas. A site plan is presented as Figure 6.

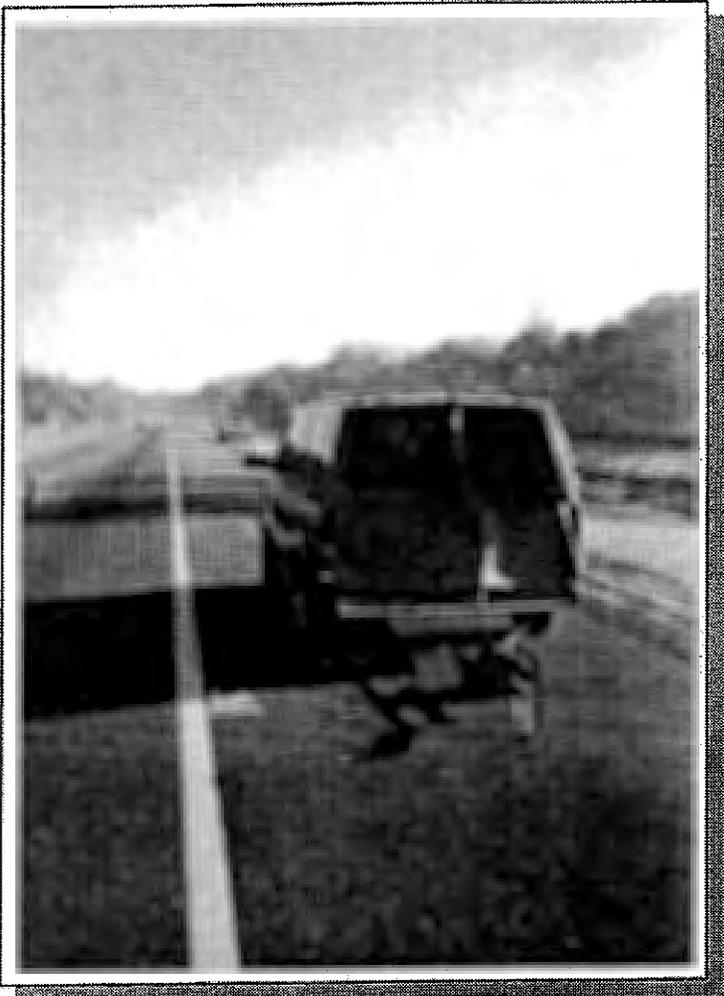
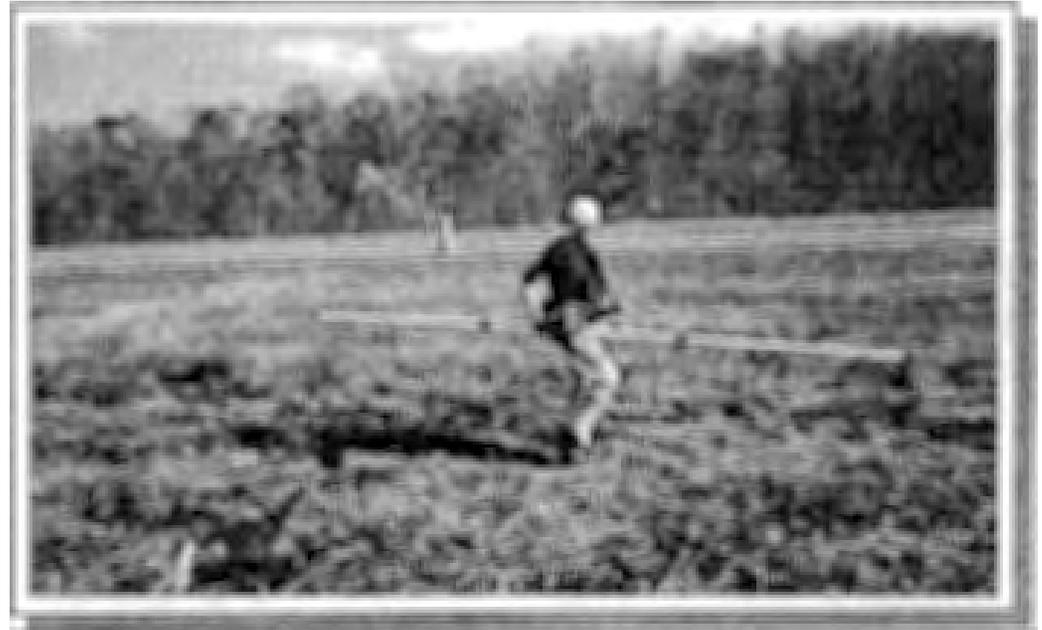
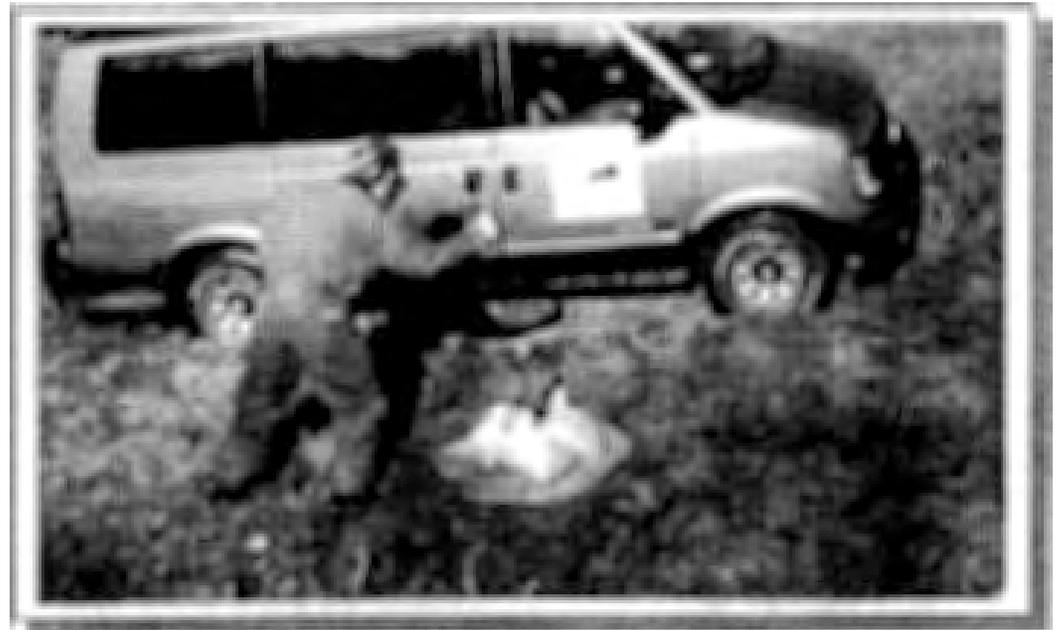
FIGURE 7: GEOPHYSICAL
TECHNIQUES

Geophysical Techniques. Geophysical surveys were conducted to: detect and delineate voids in soil; determine the depth to bedrock; and, to distinguish between generally clayey and sandy subsurface soils beneath the roadway. It was anticipated that such a delineation would be helpful in limiting the required treatment area. GF's geophysics subconsultant, Enviroscan, Inc., of Lancaster, Pennsylvania, utilized ground penetrating radar (GPR), seismic refraction (SR) and electromagnetic terrain conductivity (EM) techniques to perform these surveys. Refer to Figure 7.

Ground Penetrating Radar (GPR) represented the only method with a reasonable likelihood of success for detecting subsurface voids beneath the roadway. Electrical and electromagnetic terrain conductivity/resistivity techniques would have been ineffective for this project due to the presence of the reinforcing mesh and storm and underdrain piping. Seismic techniques exploiting the acoustic resonance of voids would have been difficult to interpret in the expected presence of considerable traffic-related vibration, and interference from high amplitude air blast and ground roll at depths of less than 30 feet.
