CONVERSION OF A TAILING IMPOUNDMENT TO A FRESHWATER RESERVOIR, THE EAGLE PARK RESERVOIR PROJECT, CLIMAX MINE, COLORADO¹

B. R. Romig, J. L. Cupp, and R. C. Ford

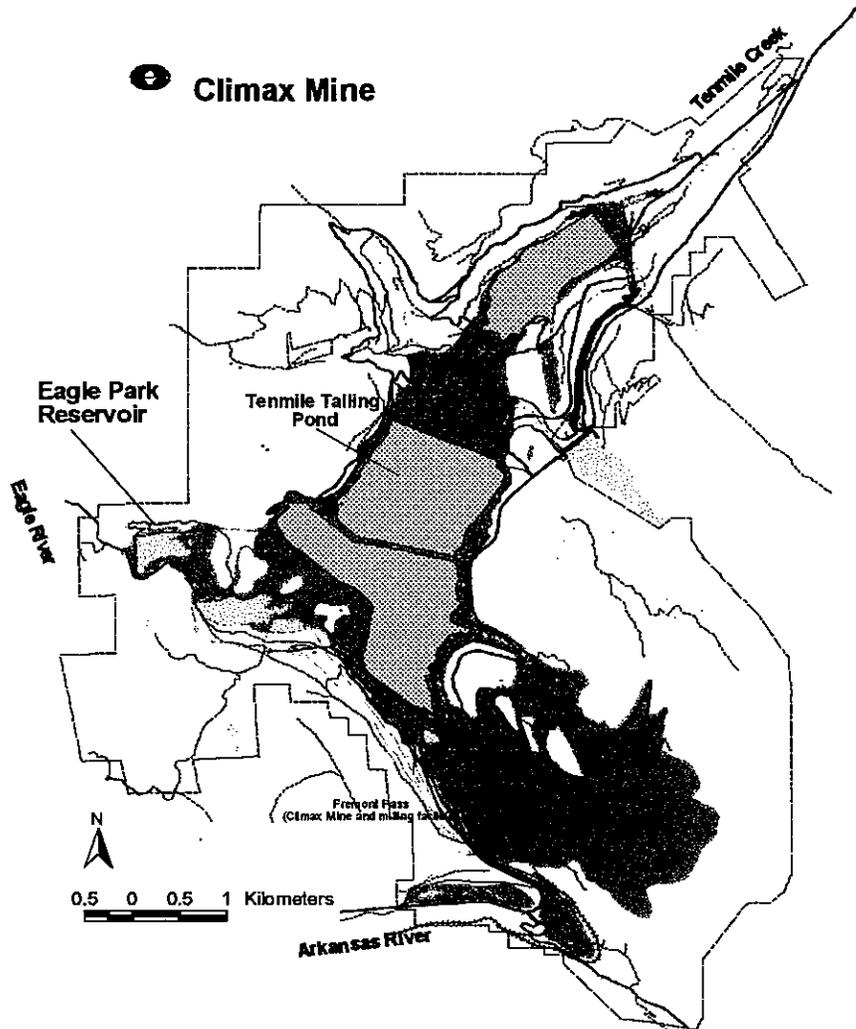
Figure 1. Diagram of the Climax Mine showing locations of the three drainages and the location of Eagle Park Reservoir

(Figure 1), is the largest identified molybdenite orebody in the world. The first processing of molybdenite from Bartlett Mountain occurred in 1918. Climax has since led research and development of molybdenum use in day-to-day products and applications.

Wastes generated from the Molyoxide process required special handling. The silt size fraction of the tailing material prevented their incorporation with the slurried and cycloned sulfide tailings deposited on the Tenmile Tailing Pond (Figure 1). The separate circuits also required separate water handling to prevent poisoning of one circuit in the management of another. At the time, Climax was producing tin, tungsten, and pyrite as well as molybdenum. Implicit in the development of the oxide ore processing circuit was the need to impound the tailing materials from the process in a manner that did not disrupt the handling of other ores and extraction processes at the Climax Mine and Mill. To accomplish this, Climax constructed an earthen core dam at

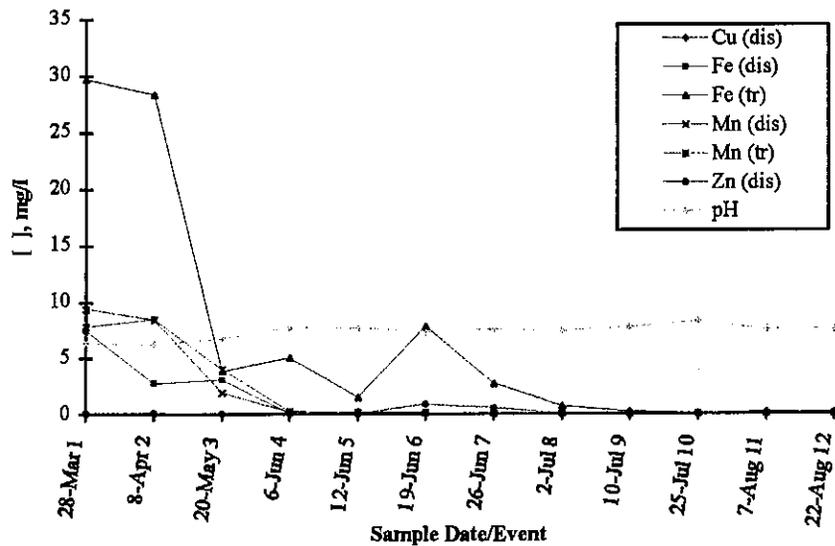
Figure 2. Eagle Park Reservoir Water Quality Trend 1997

SAP sampling of reservoir waters commenced in the spring of 1997. Each sampling event included surface water samples from the north, south and east ends of the reservoir. Initial sampling screened for all constituents for which there were standards. Parameters that were not detected in three screening samples were dropped from the parameter list. Thirteen sampling events occurred between March and September of 1997. During sampling, freshwater delivery to the reservoir amounted to 1.9MM m³ (1500 acre-feet). By July 26, water quality in the reservoir met all standards associated with the Segment 3 of the East Fork of the Eagle River.

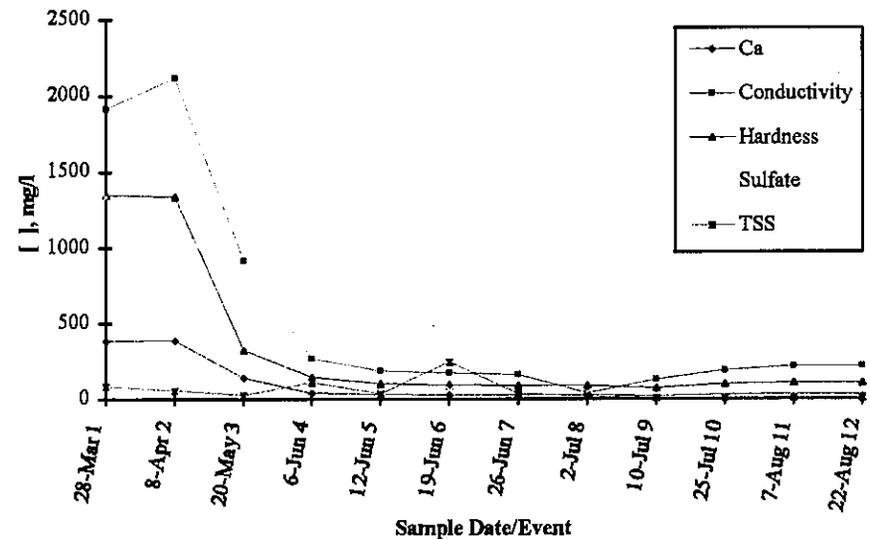
Figure 3. Eagle Park Reservoir Water Quality Trend 1997
