PRESSURIZED GROUT REMOTE BACKFILLING AT AML SITES NEAR BEULAH AND ZAP, NORTH DAKOTA

Edward J. Weiner¹ and William E. Dodd²

Abstract: The Abandoned Mine Lands (AML) Division of the North Dakota Public Service Commission (PSC) is charged with the reclamation of hazardous abandoned mine sites in North Dakota. Several underground lignite coalmines were operated near the cities of Beulah and Zap, North Dakota, from the early 1900's until about 1955. Coal seams in this area were relatively thick and the overburden generally shallow. As these mines have deteriorated with time, deep collapse features, or sinkholes, have surfaced in many areas. These features are very dangerous, especially when they occur at or near residential and commercial areas and public roads. In the past five years, sinkholes have surfaced beneath a commercial building (boat dealership, lounge, and gas station) and beneath a nearby occupied mobile home north of Beulah. Sinkholes have also surfaced near KHOL Radio Station in Beulah and in the right of way of a public road south of Zap. The AML Division has conducted several emergency sinkhole-filling projects in these areas. In 1995-97, the AML Division conducted ex

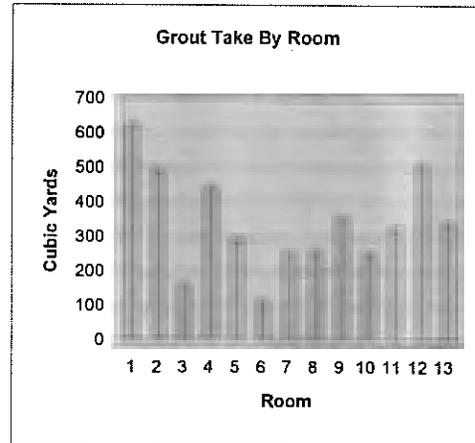
West Side, Beginning at South Fence and heading north

<u>Injection Holes*</u>	<u>Grout (cyd) Notes</u>
1	5,6, 215,263	624
2	8,9, 10,216,217	496
3	201, 202,235-239	166 South edge of building
4	205,205.5,206,C1,C2,C3	444 Interior of building
5	209, 209.5,210,B1,B2	294 Interior of building
6	212,213, 220-225	120 North edge of building
7	14, 15,218	264
8	17,18, 19,219	264
9	21, 22,226	361
10	24,25, 26,227	256
11	28,30,31,230,231, 232	327 Possibly 2 rooms included
12	34,35,233	512
13	37,38,234	344
	Subtotal	4472
	Average	344

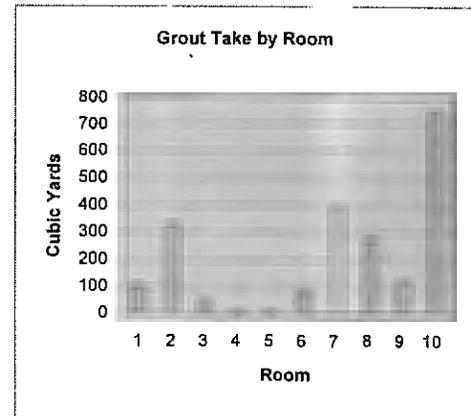
East Side, Beginning at South Fence and Heading North

<u>Injection Holes*</u>	<u>Grout (cyd) Notes</u>
1	50,51,254	110
2	54, 55,255	336
3	58,59,60, 264	56 South edge of shop
4	62, 63,64,S1,S2,S3	14 Interior of shop
5	66,67,258	14 North edge of shop (east of HLS)
6	70, 259,259A,260,265	88 East of HLS, near fuel islands
7	252,257	398 Northeast of HLS, near fuel islands
8	250,249A,266A	280 Northeast of HLS, near fuel islands
9	77,78, 79,248A	126 Northeast of HLS, near fuel tanks
10	82, 83,84,247	754 Northeast of HLS, near fuel tanks
	Total East	2176
	Average	217.6
	Total All	6744
	Overall Average	289.0

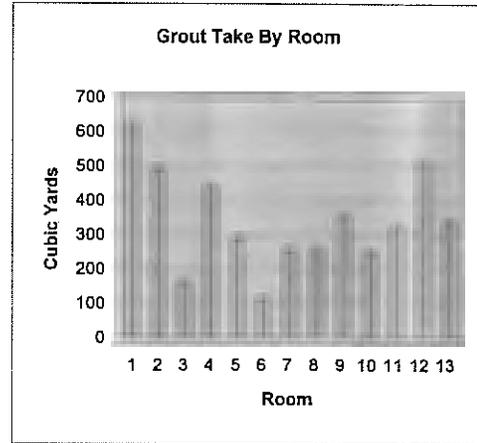
West Side, Beginning at South Fence and heading north

<u>Injection Holes*</u>	<u>Grout (cyd Notes</u>
1	5,6, 215,263	624
2	8,9, 10,216,217	496
3	201, 202,235-239	166 South edge of building
4	205,205.5,206,C1,C2,C3	444 Interior of building
5	209, 209.5,210,B1,B2	294 Interior of building
6	212,213, 220-225	120 North edge of building
7	14, 15,218	264
8	17,18, 19,219	264
9	21, 22,226	361
10	24,25, 26,227	256
11	28,30, 31,230,231,232	327 Possibly 2 rooms included
12	34,35,233	512
13	37,38,234	344
	Subtotal	4472
	Average	344

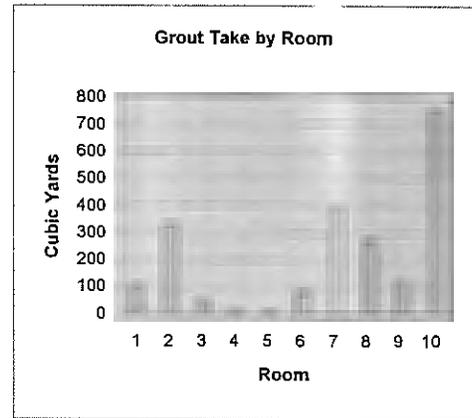
East Side, Beginning at South Fence and Heading North

<u>Injection Holes*</u>	<u>Grout (cyd Notes</u>
1	50,51,254	110
2	54, 55,255	336
3	58,59,60, 264	56 South edge of shop
4	62, 63,64,S1,S2,S3	14 Interior of shop
5	66,67,258	14 North edge of shop (east of HLS)
6	70, 259,259A,260,265	88 East of HLS, near fuel islands
7	252,257	398 Northeast of HLS, near fuel islands
8	250,249A,266A	280 Northeast of HLS, near fuel islands
9	77,78, 79,248A	126 Northeast of HLS, near fuel tanks
10	82, 83,84,247	754 Northeast of HLS, near fuel tanks
	Total East	2176
	Average	217.6
