CHARACTERIZATION AND DESIGN OF THE OLD DOMINION REMEDIAL ACTION PLAN¹

Abstract: The Old Dominion Mine in Arizona's Globe-Miami mining district includes three tailings piles, one slag pile, and numerous waste rock dumps. The mine waste materials were generated from different operations between 1881 and 1931. The Old Dominion Remedial Action Plan (RAP) is an innovative program developed for remediating the impacts of historic mining activities on portions of the Old Dominion property in the Upper Pinal Creek drainage. Agency oversight is jointly provided by the U.S. Environmental Protection Agency and the Arizona Department of Environmental Quality. The goal of the remediation is to stabilize the mine waste materials, mitigating impact to groundwater and surface water to the maximum extent possible. The RAP was recently approved by the agencies and provides for physical and chemical stability of the mine waste materials. Considerations in the design included the high acid generating nature of the tailings and waste rock and the existing erosional and structural instability of the piles. Further, the site is subject to high intensity flows from stormwater runoff during the summer mon

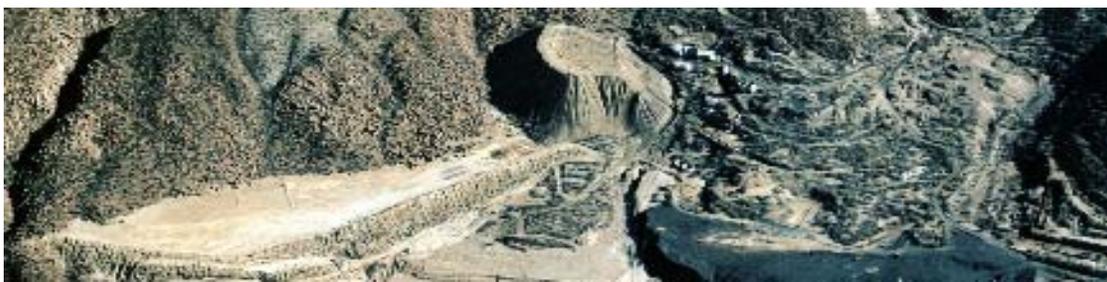
Figure 2. Oblique Aerial Photograph of the Old Dominion Site

The terrain around the Old Dominion Mine is somewhat rugged (see Figure 2). This area of Gila County is comprised of rolling hills and mountains up to 2,400 m high. At these elevations, there is a wide variety of annual climatic changes, ranging from -10°C and snow in the winter months to temperatures exceeding 40°C and intense monsoonal rainstorms in the summer months. Surface runoff leaves the surrounding mountains east of the site primarily in Big Johnnie, Buffalo, Alice, and Copper Gulches and enters Upper Pinal Creek around and through the Old Dominion Site. Portions of the Pinal Mountains to the west also drain into Upper Pinal Creek south and west of the site. Underground water remains confined to the 12th Level (approximately 300 m deep) and below. Water from the underground workings is pumped for operational uses at area mines but is never in contact with the disturbed areas on the surface.

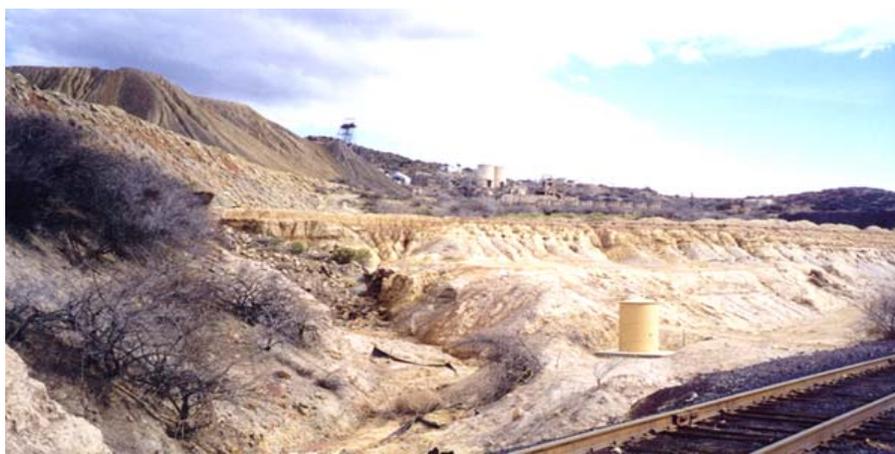
Figure 4. Sample point BG-1 in drainage to left of sampler (right-center) at toe of ODT2.

Four stormwater samplers were installed in three select drainages where stormwater runoff flows at the Old Dominion Site. Three of the four samplers have been placed such that they collect runoff after it has contacted either tailings piles or waste rock dumps (see Figure 4). The fourth sampler was placed upstream from any tailings or waste rock dumps.

BG-1 is in Buffalo Gulch at the toe of ODT2. Storm flow collected at BG-1 comes from two distinct drainages. The first is surface water runoff flowing in No Name Gulch, which flows around the west side of ODW1. The second is surface water flow from portions of the Old Dominion Plant Site. Both sources run onto ODT2 then flow down to BG-1.

There are eleven samples to date that have been collected at BG-1. Values of pH are consistently between 2 and 3; metal species whose concentrations are consistently elevated include arsenic, copper, manganese, zinc, cadmium, chlorine, fluorine, nickel and selenium.

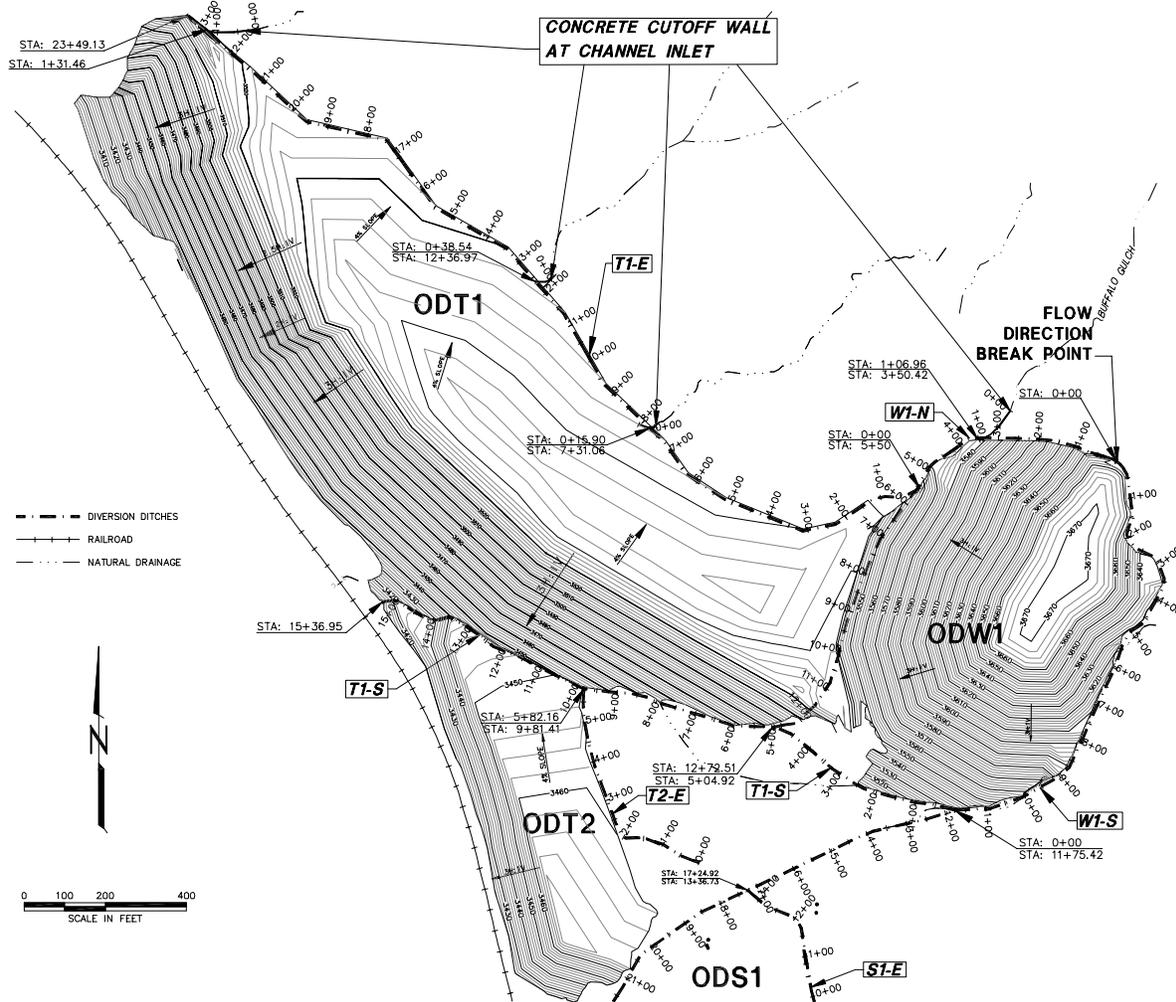
Figure 5. Tailings/Waste Rock Source Control Measures.

The peak discharges for the 100-year 24-hour storm event for the proposed diversion ditches are included in Table 4, some of which are shown on Figure 5.

Side slopes of the facilities will be regraded to an approximately 3H:1V slope where practicable. The exception is approximately 25% of the side slopes of ODT1, which will be regraded to 2.5H or 3H:1V or buttressed to 2H:1V. Where the footprint of ODT1 can be increased, waste rock from ODW1 may be used to buttress and also to flatten the existing slopes to 3H:1V. Where the toe of the pile is restricted by the proximity of the railroad, slopes flatter than 2.5H:1V might expose weak slimes layers resulting in a final configuration that is not as stable as a 2.5H:1V final slope. Therefore, the existing slopes in this location will be regraded to 2.5H:1V and buttressed using rock from a local borrow source. Top surfaces will be regraded to slope away from the pile crests at a grade of approximately 4%. Over 600,000 m³ of mine waste material will be moved in the regrading. Figure 5 provides a general schematic of the remedial measures designed at ODT1, ODT2, and ODW1.
