# RECLAMATION OF AN IN SITU COAL GASIFICATION TEST SITE IN WYOMING<sup>1</sup>

**Abstract:** In the late 1980s, two coal gasification concepts were tested at a 15-acre site in the Hanna Basin of south-central Wyoming. Both tests were conducted in the Hanna No. 1 Coal Seam, which is about 30 feet thick and 365 feet below surface at this site. Approximately 4500 tons and 11,300 tons of coal were burned in the two tests, respectively. The Land Quality Division (LQD) of the Wyoming Department of Environmental Quality (WDEQ) issued Research and Development License No. 15 (RD15) to Stearns Catalytic Corporation (now Washington Group International, Inc.) for the tests. Per the license requirements, ground water restoration and surface reclamation were necessary after the tests. Because of the efficiency of the burns and the effectiveness of venting and flushing the burn cavities after each test, ground water restoration was completed in 1989. Once ground water restoration was deemed complete, the 30+ wells were abandoned and surface reclamation began. The reported seed mix included Wheatgrass (western, thickspike, and slender), Indian Ricegrass, Fourwing Saltbush, and Big Sagebrush. In a

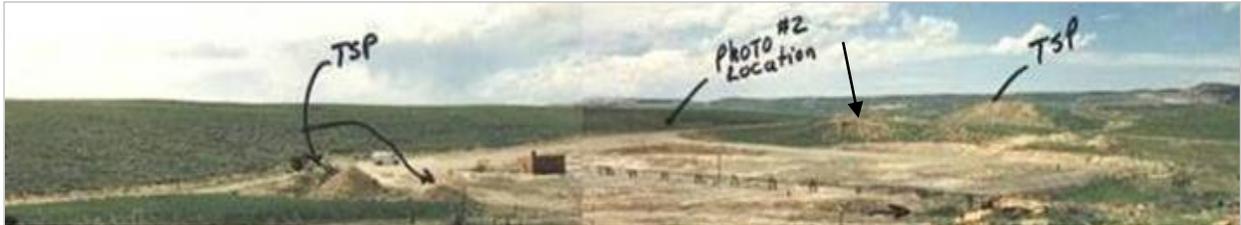
Figure 4a. Facilities Area at the RD15 Site after removal of buildings and most equipment, June 18, 1991, looking northwest. TSP refers to Topsoil Stockpile. The "Photo #2 location" is a reference to another photo, not included in this paper, taken during the June 1991 inspection.

The reestablishment of vegetation at this site proceeded as anticipated, with limited expression of the seed mix in the initial years and then progressive improvement in the following years. Other than control of some patches of Canada Thistle and Whitetop, one-time interseeding on a few spots early in the reclamation period, and occasional fence repair, no additional reclamation work was necessary after the initial seeding. Figures 4a through 4d show the progress in the Facilities Area; Fig. 5a through 5d show progress in the area where many of

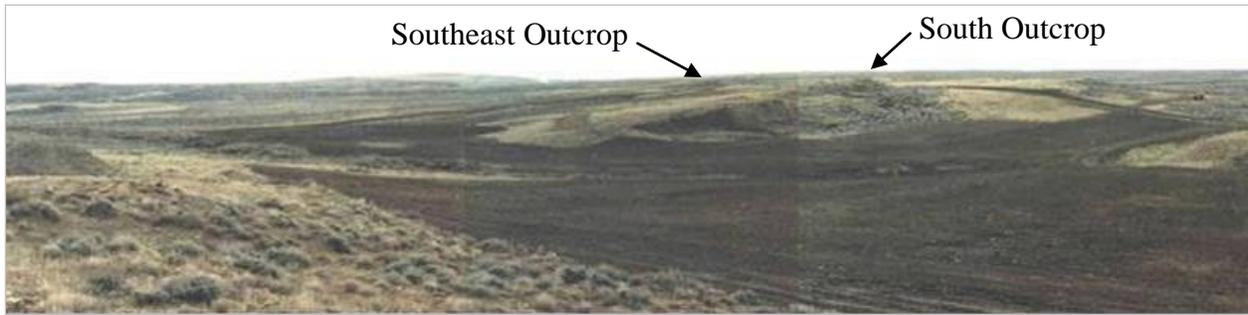
Figure 5a. RD15 Site after completion of grading and application of most of the topsoil, October 12, 1993, looking southeast.

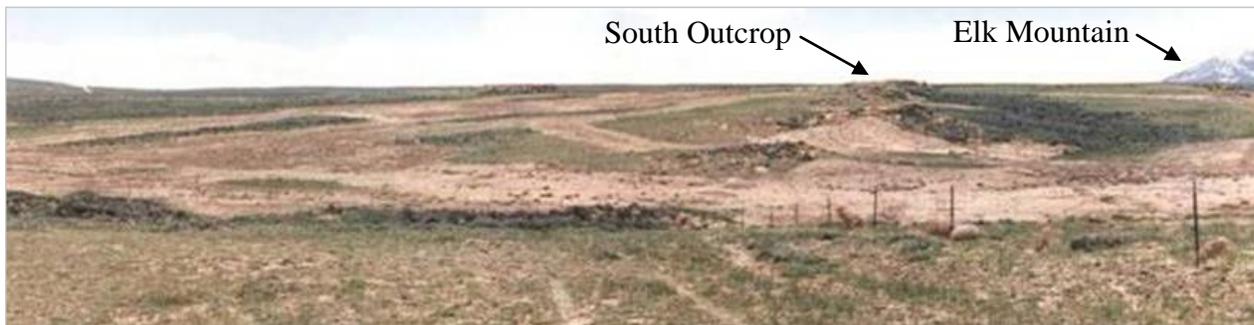
Figure 5b. RD15 Site, June 6, 1995, looking southeast. Site was seeded in the Fall of 1993.

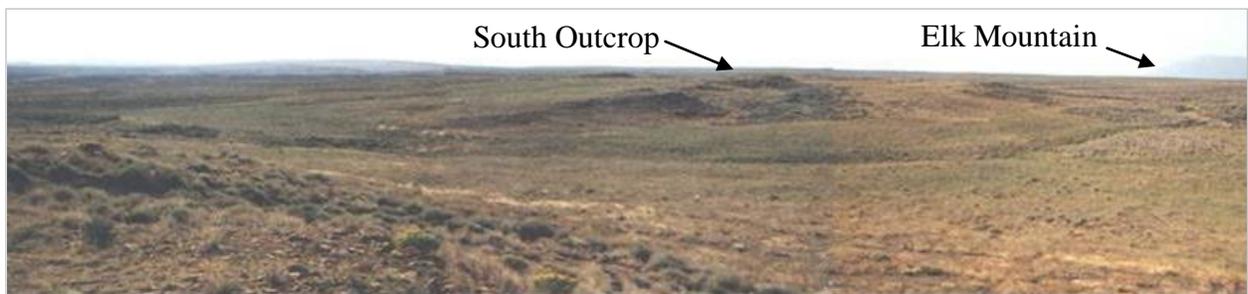
Figure 5c. RD15 Site, August 4, 2000, looking southeast. Site was seeded in the Fall of 1993.

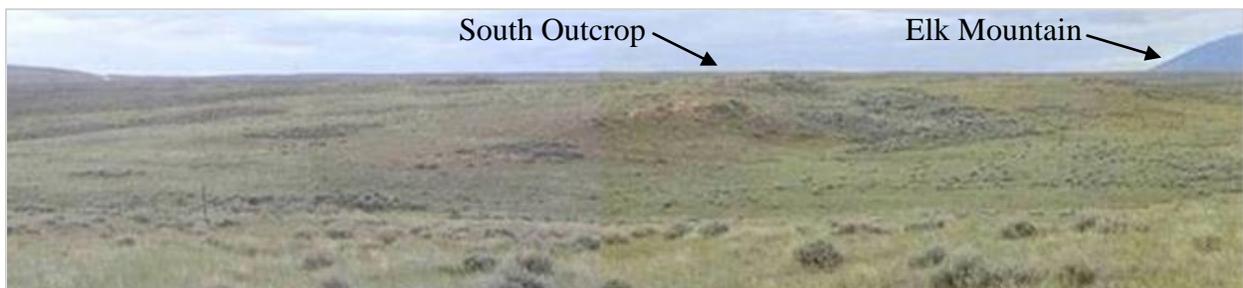
Figure 5d. RD15 Site, June 30, 2004, looking southeast. Site was seeded in the Fall of 1993.

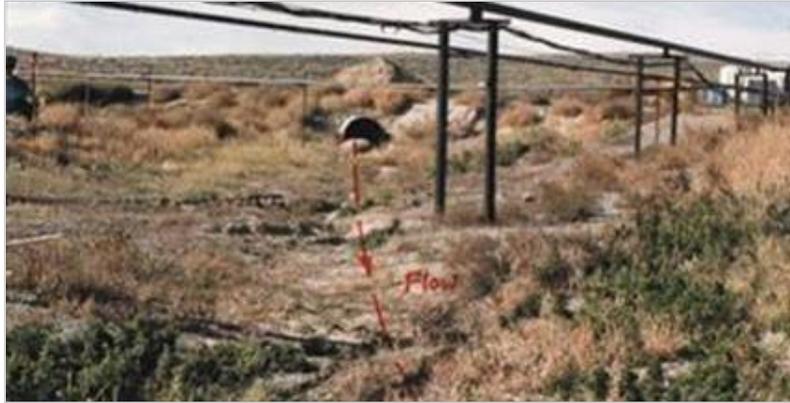
Figure 6a. Drainage through Facilities Area, October 4, 1988, looking west (upstream).

the wells were located; and Fig. 6a through 6c and 7a through 7d show progress along the drainage through the site.

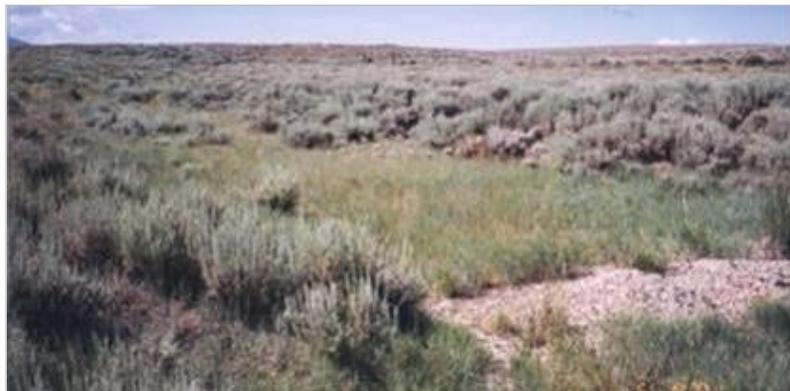
Figure 6b. Drainage through Facilities Area, August 6, 2001, looking west (upstream). Site was seeded in the Fall of 1993.

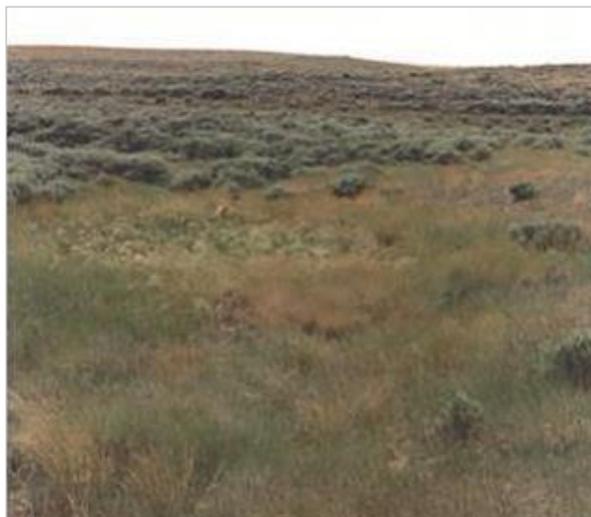
Figure 6c. Drainage through the Facilities Area, July 7, 2005, looking west (upstream). Site was seeded in the Fall of 1993.

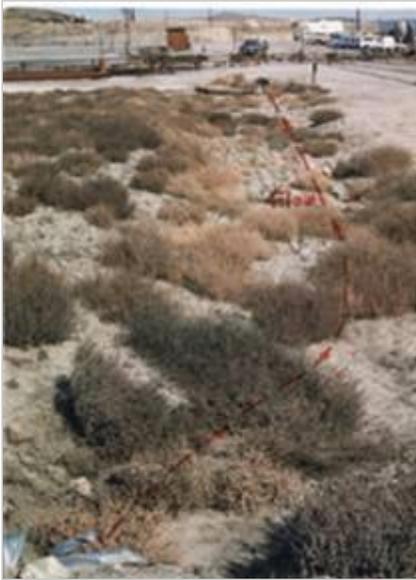
Figure 7a. Drainage through Facilities Area, October 4, 1988, looking east (downstream).

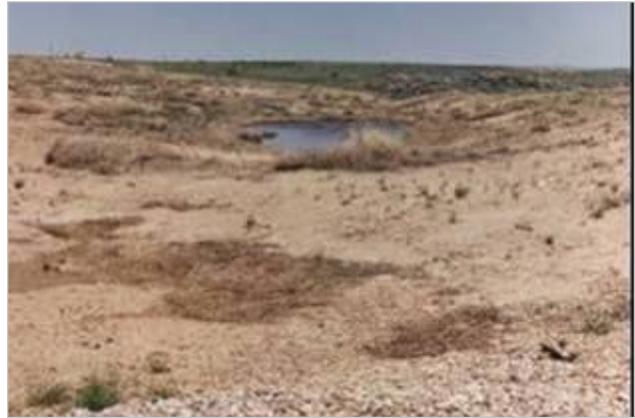
Figure 7b. Drainage through Facilities Area, June 6, 1995, looking east (downstream).

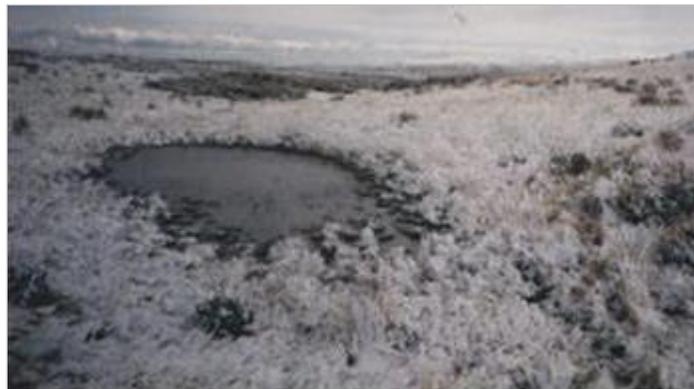
Figure 7c. Drainage through Facilities Area, April 18, 2002, looking east (downstream).

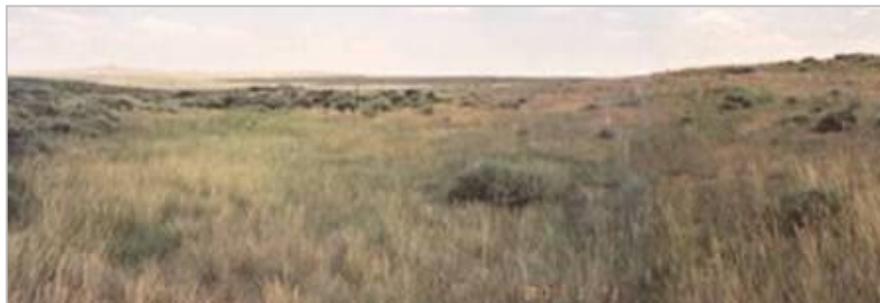
Figure 7d. Drainage through Facilities Area, July 7, 2005, looking east (downstream).

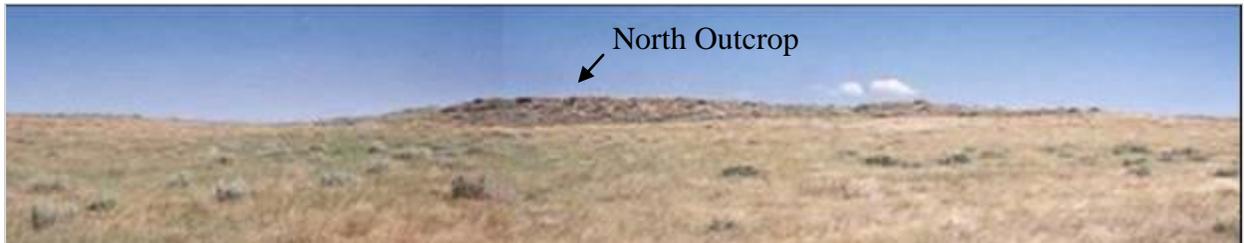
Figure 9a. Reclamation just to the south of the North Outcrop, August 6, 2001, looking north.

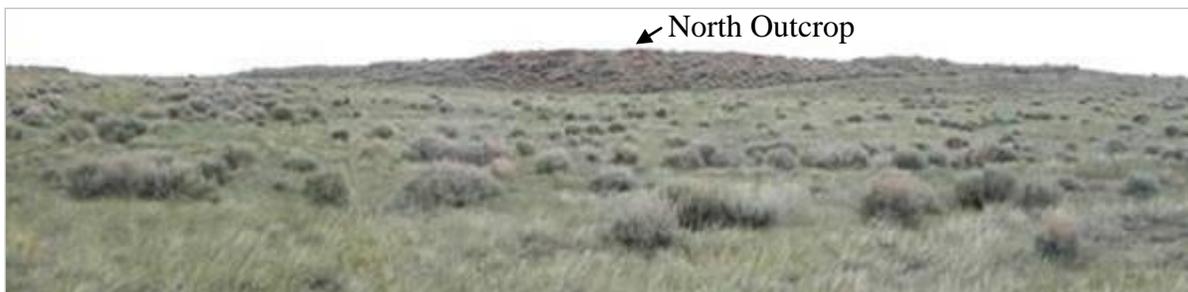
Figure 9c. Reclamation just to the south of the North Outcrop, June 30, 2004, looking north.

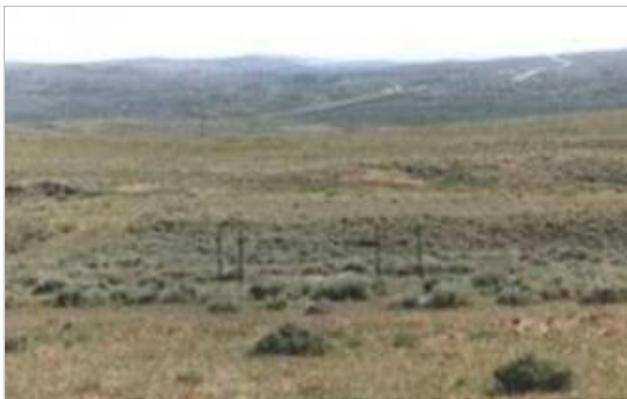
Figure 10a. Upper Comparison Area, July 8, 1997.

In September 1995, two areas were designated within the RD15 Site for comparison of native and reclaimed vegetation to evaluate revegetation success. The area close to the drainage was referred to as the 'lower' comparison area (Fig. 10a), and the area higher on the hillside was referred to as the 'upper' comparison area (Fig. 10b). However, these two areas were subsequently not considered suitable for evaluation of revegetation success for several reasons, including: the reclamation was not differentiated by topography, e.g., there were no separate seed mixes for 'upper' and 'lower' areas; the upper comparison area was in dense sagebrush, even though the approved seed mix resembled an upland grassland community; and the designated areas were too small to provide for adequate sampling. Therefore, in July 1998, an area outside the RD15 Site was designated as the comparison area for evaluation of revegetation success (Fig. 10c). An outside area was considered necessary because the undisturbed areas that were large enough for adequate sampling within the site were primarily rocky outcrops (Fig. 4a and 5a). Selection of an appropriate area was difficult, primarily because of the heavy grazing pressure outside the site, which had been fenced shortly after seeding in 1993 to protect the site from grazing. However, a two-acre upland grassland area was found and fenced in the summer of 1998.

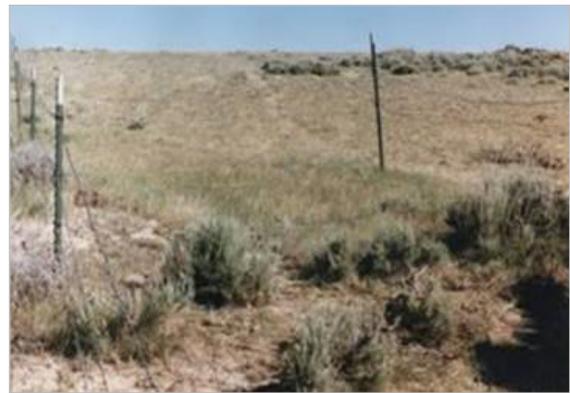
Figure 10b. Lower Comparison Area, July 8, 1997.

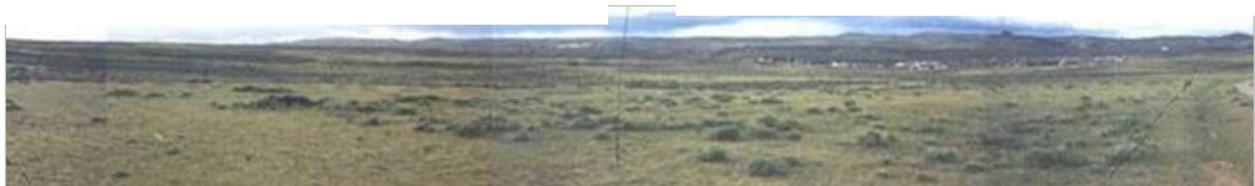
Figure 10c. Off-Site Comparison Area, before fencing, July 17, 1998.

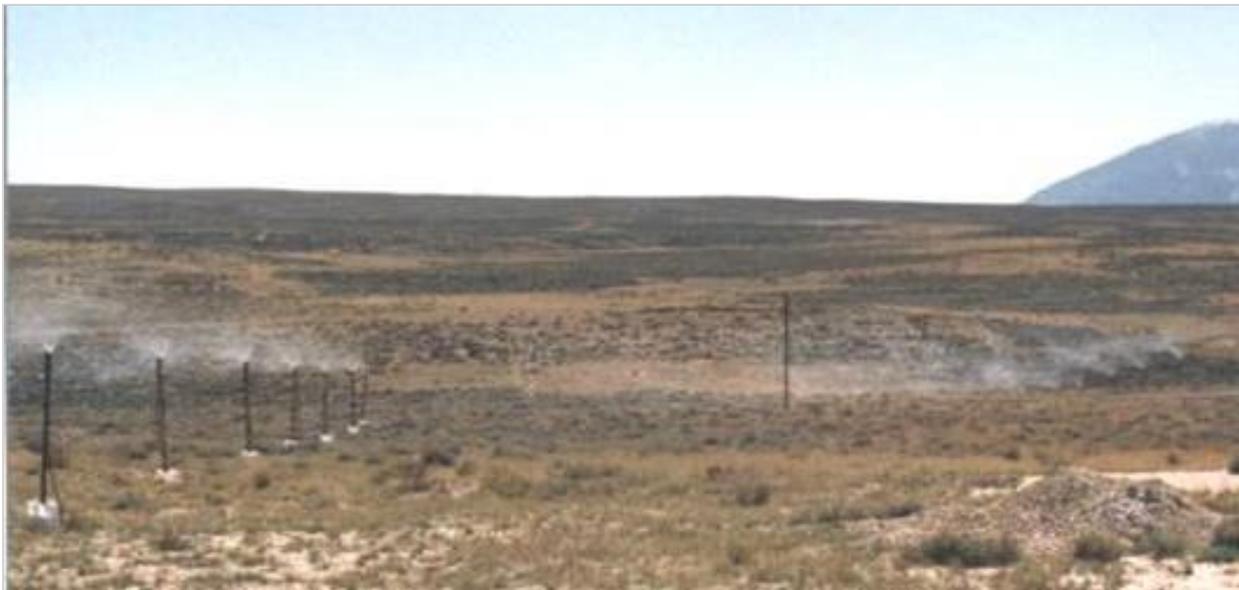
Figure 11. Spray System for Dispersal and Evaporation of Ground Water after Treatment, September 23, 1988.

The ground water treatment system used at the RD15 Site included removal of oils, dissolved metals, dissolved nitrogen, and organic compounds from ground water pumped from the burn cavity and then dispersal and evaporation of the treated water through a spray system. When the WDEQ Water Quality Division approved the ground water treatment system, they did so with the provision that soil sampling would be required in the vicinity of the spray system (Figure 11). The primary concern was the potential accumulation of salts. However, sampling locations were not specified at the time the spray system was in use. Therefore, similar to the mapping of the disturbance at the site, LQD and the operator used available maps and photographs during a field trip 'after-the-fact' to select the required sampling sites.
