BIG HANAFORD CREEK FLOODPLAIN AND WETLAND RESTORATION PROJECT AS MITIGATION FOR A SURFACE COAL MINE PROJECT

Abstract. This paper presents the restoration design process and construction activities associated with the Big Hanaford Creek restoration project. The project was completed as part of required wetland mitigation to compensate for adjacent plant and mine activities requiring state and federal wetland permits. Big Hanaford Creek is a tributary to the Skookumchuck River in Lewis County, Washington, with its headwaters in the foothills of the Cascade Mountains, and with lower reaches in low gradient floodplain valleys. Within its lower reaches, a 4800-meter portion of the creek was straightened and deepened approximately 90 years ago when the valley was drained for agricultural purposes. Most recently, the floodplain surrounding the creek was used for grazing and mowing of pasture grasses for hay production. In an effort to rehabilitate in-stream habitat, reconnect the creek to the floodplain, and return native floodplain vegetation to the valley, a 61-hectare restoration project is underway. The project includes excavating 63,460 cubic meters of soil to relocate 2,286 linear

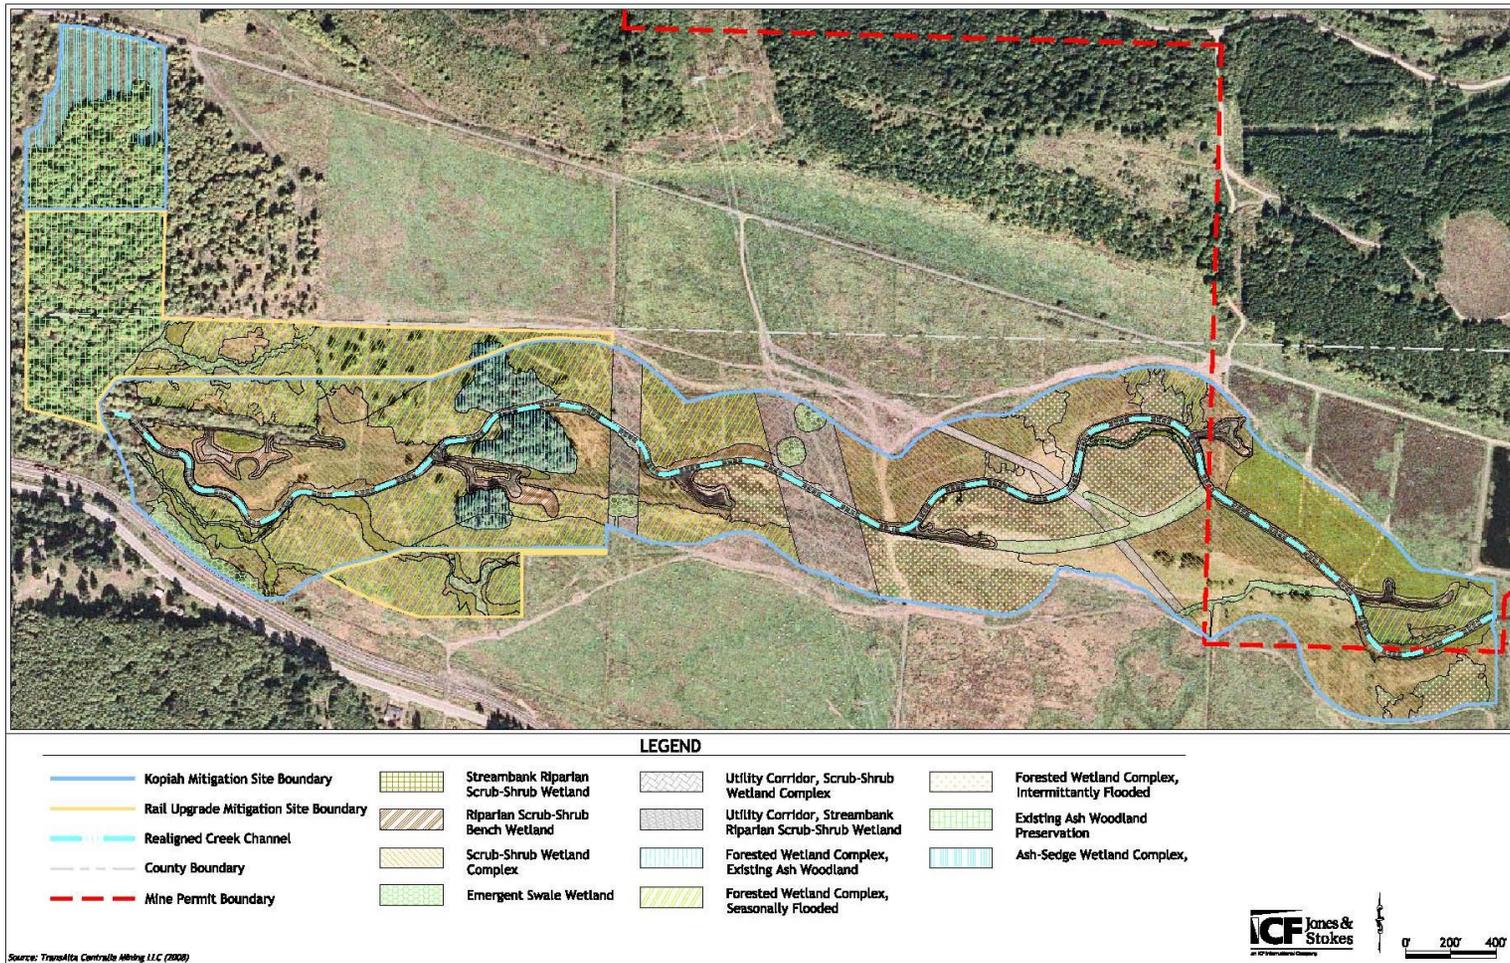
Figure 1. Mitigation site showing stream realignment and associated plant communities.

The primary components of the restoration design were the realignment of 2,286 meters (7,500 linear feet) of Big Hanaford Creek and the planting of native wetland vegetation along the channel and adjacent floodplain. Figure 1 shows the project site's restoration design with the alignment for the constructed channel and the associated vegetation communities.

Locations of the plant communities were based on the anticipated hydrologic conditions on the floodplain using Mike 11 modeling of flooding scenarios. Although the floodplain is generally featureless with respect to obvious topographic changes, subtle differences in topography create areas that are more seasonally flooded vs. areas not as wet and are less frequently flooded or flooded/ponded for shorter periods. Scrub-shrub wetlands and intermittently flooded wetlands were considered the “drier” plant communities.

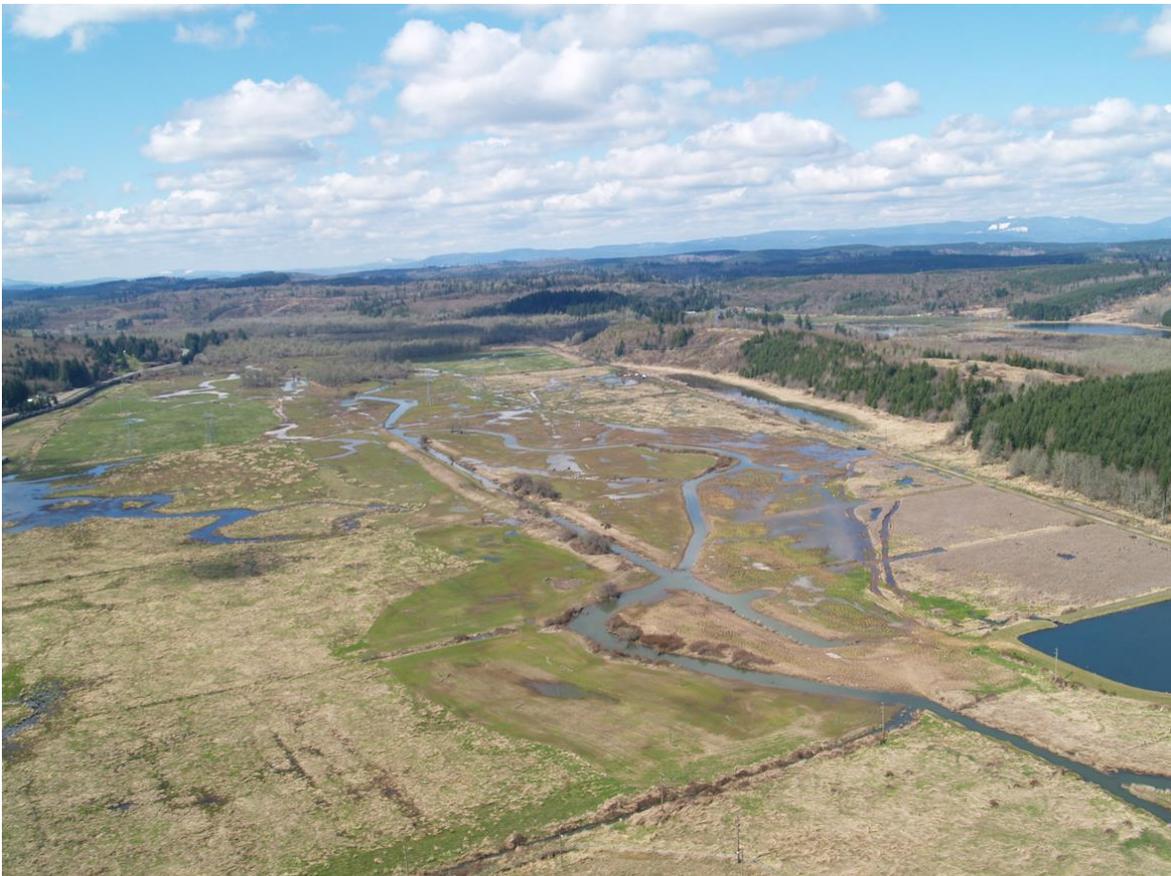
Figure 2. Aerial view showing localized flooding still remained after high flows receded back into the creek.

During periods when heavy rainfall is constant for three or more days, the creek has exceeded its banks and spills out onto the floodplain as designed. This occurred twice during the 2007–2008 winter and has already occurred once during 2008–2009 rainy season. The basic process of flooding on site starts as the floodplain soils become saturated and ponding occurs in

depressions and low areas. Surface flows in the stream rise and floodwaters encroach on the valley from the creek through gentle overbank flooding via the swales and alcoves that were constructed and disperse onto the floodplain (as opposed to the past condition when there was more of an immediate overbank flooding once the sidecast berm was topped adjacent to the channel and via several linear ditches). Floodwater gradually receded in approximately 7 to 10 days via the created swales and alcoves constructed along the length of the constructed channel. In addition, there have been several periods when the floodplain did not entirely flood, but localized flooding occurred adjacent to the channel in the lower areas where the constructed channel has a broad general gradation toward the floodplain and around the six constructed alcoves. Figure 2 shows a portion of the floodplain several days after a high spring flow that exceeded the top of channel, spread out onto the floodplain, and has begun to recede back to the channel. High water can still be seen in the channel and alcoves and swales connected to the channel along with surface water present in depressions.

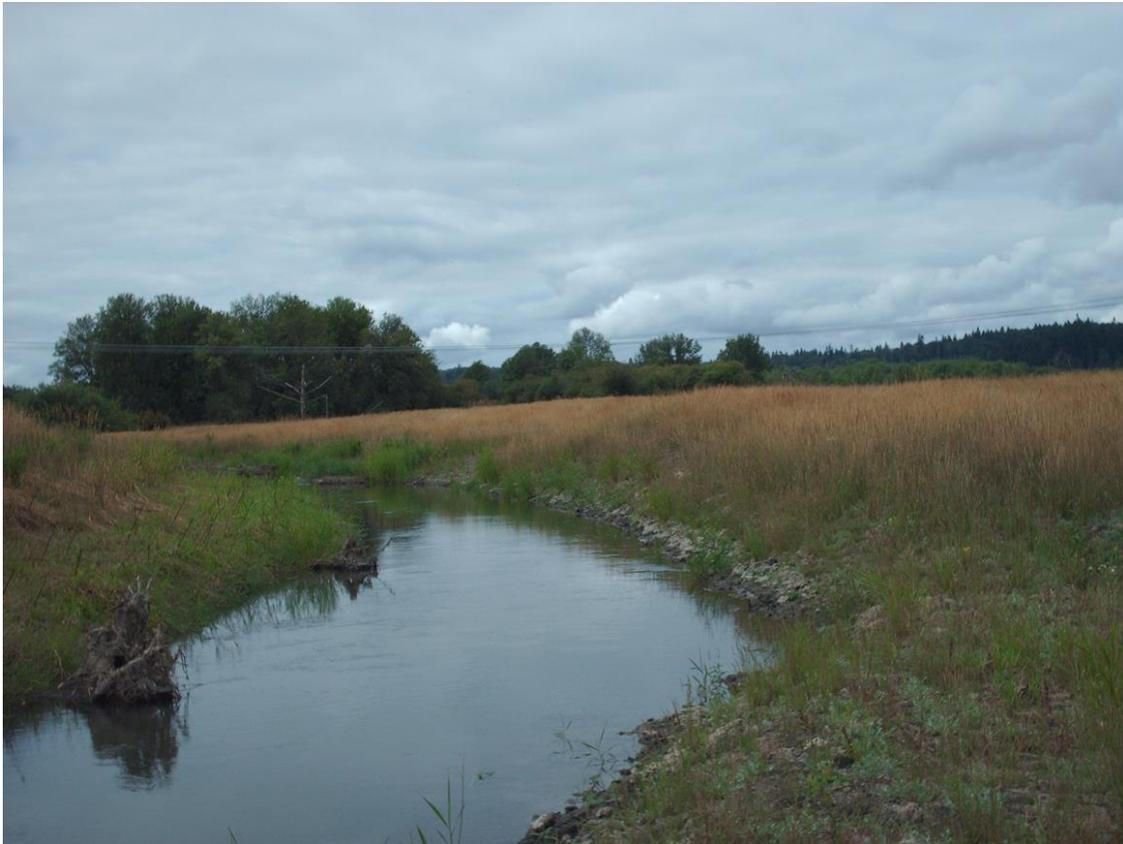
Figure 3. Planting bench on left side of creek will provide location for riparian willow growth.

Cross sections of the newly constructed channel with the riparian planting bench appear to be providing the function as designed. The riparian planting bench along the inside bends of the creek channel is approximately 0.3 meter (1 foot) above the low flow summer elevations. This bench is expected to provide an excellent location for willow growth as a source for aquatic shading. Figure 3 shows a typical section of the constructed channel during summer conditions with a planting bench on one side where willows will be planted.

Some sloughing along the low flow channel banks has occurred but has not changed the course of the stream or created a loss of planting bench area. Low flow summer velocities are approximately 0.3 meter per second (1 foot per second) and depths are approximately 0.9 meter (3 feet). Based on visual observations from qualitative site visits after construction there has been minimal erosion from channel flows. No slumps or bank failures in the constructed channel have been observed and only in several places have small rills formed along the channel banks where ponded water drains back into the creek. During the winter months flow depths are great enough to submerge the planting bench by 0.6 to 0.9 meter (2 to 3 feet) with flow velocities of

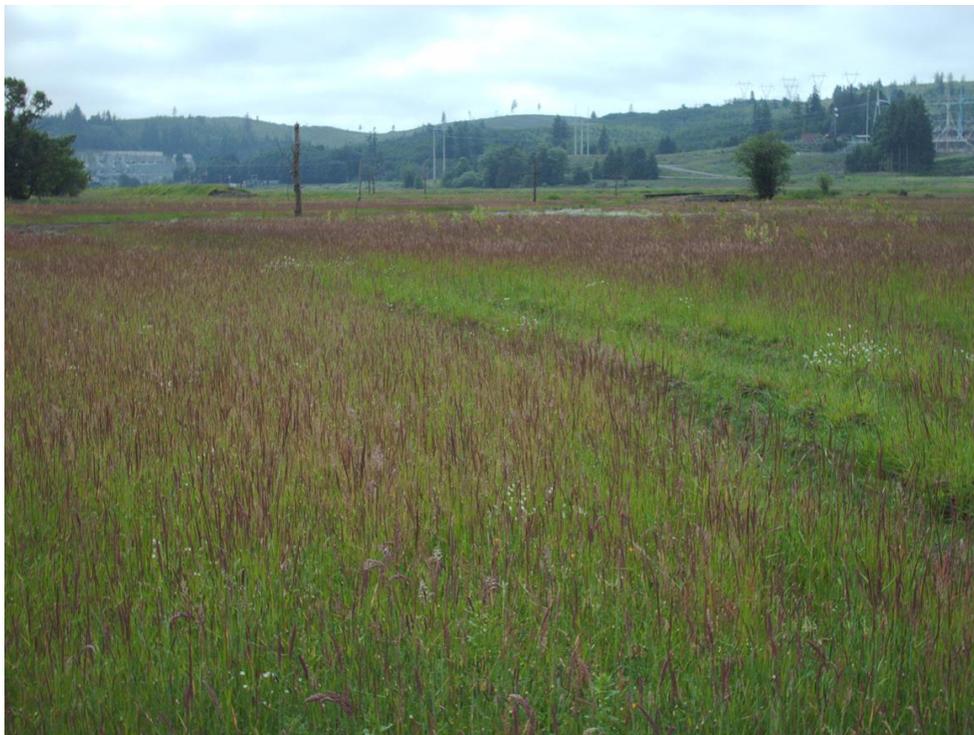
Figure 4. Successful establishment of native grasses on floodplain one season after seeding.

Native grass seed formed dense stands with cover values ranging from 65-90% absolute cover on the majority of the floodplain the first growing season after application (Fig. 4). Native grasses included *Agrostis errata*, *Deschampsia caespitosa*, and *Hordeum brachyantherum*. However, native grasses did not establish well in narrow swales where other weed control efforts were more difficult to implement due to prolonged wetness. Monitoring of vegetation as required by agency permits is scheduled to begin in summer 2009 to determine how well the native grasses continue to establish in subsequent growing seasons, as well as monitoring survival of planted trees and shrubs. Plant installation was just completed in spring 2008 and monitoring in 2009 will assess how plants are responding to the site conditions.
