WATERSHED REHABILITATION IN REDWOOD NATIONAL PARK¹

David L. Steensen and Terry A. Spreiter²

¹Paper presented at the 1992 National Meeting of the American Society for Surface Mining and Reclamation, Duluth, Minnesota, June 14-18, 1992.

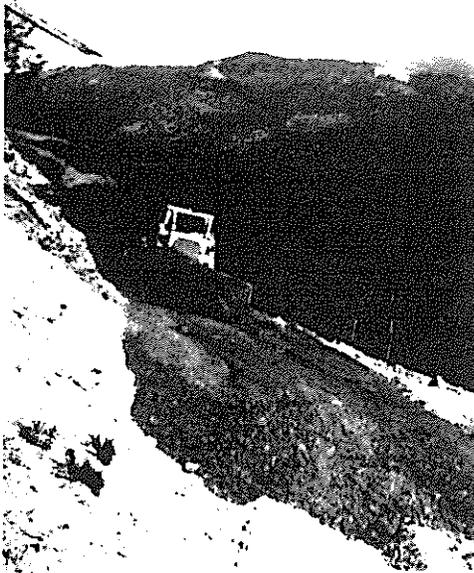
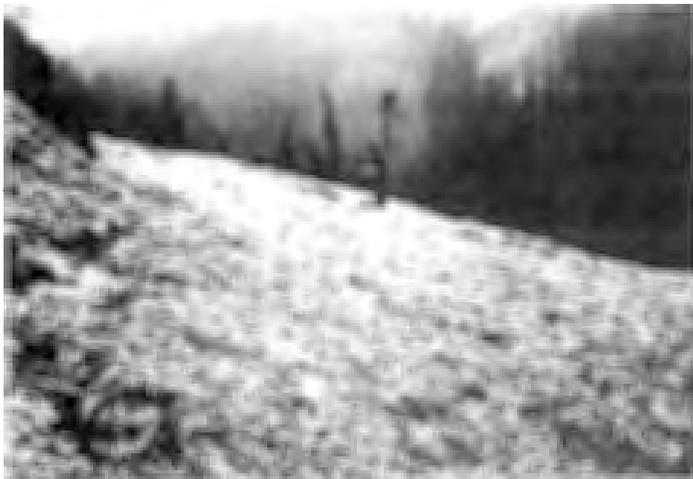
Figure 2. The sequence of three photographs below show the before, during, and after of an outsloped road section.

Observations made over a ten-year period indicate that restoring soil depth along the inboard edge of the road prism (cut void) is the most effective way to enhance revegetation potential. Changes in techniques in the past few years have been made to include more outsloping in areas where revegetation potential would be enhanced by restoring soil depth (Hektner and Reed 1991) (see Figure 2). This more complete treatment adds between 5-10% in cost to a typical project in RNP. The actual percentage varies depending on disturbed area size, erosional problems, and location relative to streams.

1. A standard array of treatments is as follows:
 - a) Outsloping (fill against cutbank) avgs. \$10,000/mi., or \$1.00/yard³ along a road 30 ft. wide, 8 ft deep cut along the outboard edge, finished slopes of 3:1, that removes 1.7yd³ per linear ft. of road.

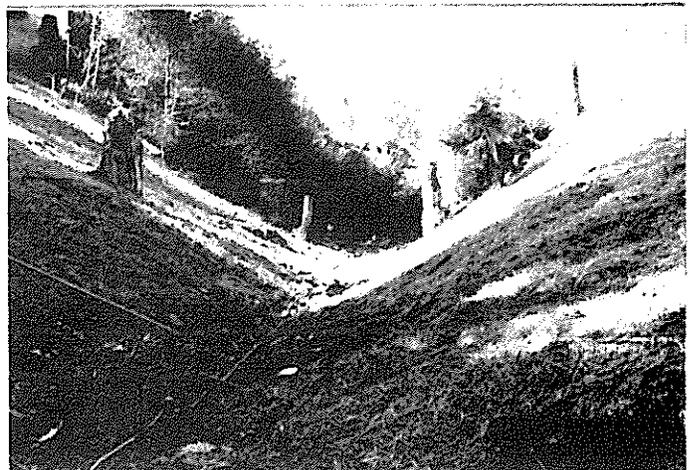
Figure 3. The sequence of three photographs below show the before, during, and after of a haul road stream crossing excavation.

These treatments include removal of road fill from stream crossings, removal of unstable materials from landslide areas, replacement of road fill back into the cut (outsloping), decompaction of road surfaces, and cross-road drain construction (large waterbars intended to disperse runoff onto hillslope areas).

- f) Haul road stream crossings vary with size, amount of organic debris, amount of stream flow, fill saturation, etc. Relatively straight forward crossings average \$1.00 to \$2.00/yard³.
