# LIME TREATMENT EXPERIMENTS GOB REVEGETATION IN ILLINOIS

## A TWENTY-FIVE YEAR RECORD

**Abstract.** In 1971 and 1972, an attempt was made to achieve direct coal refuse revegetation on an Illinois coal refuse (gob) pile by testing six lime application rates and six grass and legume species. Following achievement of some initial success, a larger plot employing "best" treatment was established. Additionally, a small test was installed using "best" treatment and six-inch thick soil cover. In 1976, early results were published, in which short term success was presented. At that time, the prevailing question seemed to be, how long will the vegetation persist? In 1984 and 1985, the gob pile excluding the research plots, was lime-treated and revegetated, but the research plot area was left undisturbed. In 1997, after a 25-year time lapse, the original plots were re-staked from original records, and plot-by-plot, existing vegetation on the plots was evaluated. Data is presented correlating for each treatment (each treatment repeated three times), sulfur analysis, vegetation status and lime adequacy. Related research is discussed. Ramifications concerning relevant acid mine drainage is a

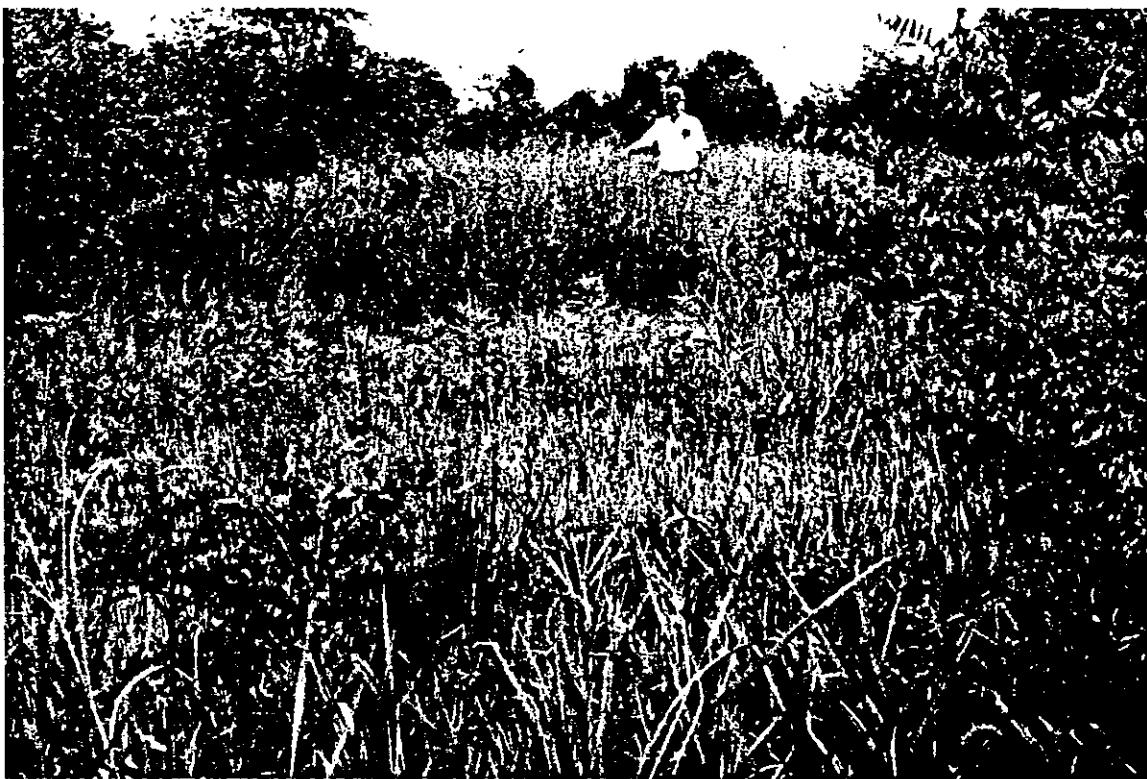
**Figure 3.** View of revegetation plots from north end looking south. The entire plot tract is visible from left to right. To the right and left of the research plots, black locust trees, planted by Peabody in 1984, are visible. Some trees are encroaching on the plots. Person in the photograph is resting his hand on a wooden lath which is four feet long.
