INNOVATIVE PLANTING TECHNIQUE FOR RIPARIAN AND WETLAND SITES¹

Leonard J. Ballek ²

Additional Key Words: mine reclamation, salmon recovery, mine tailings, Stibnite Mine.

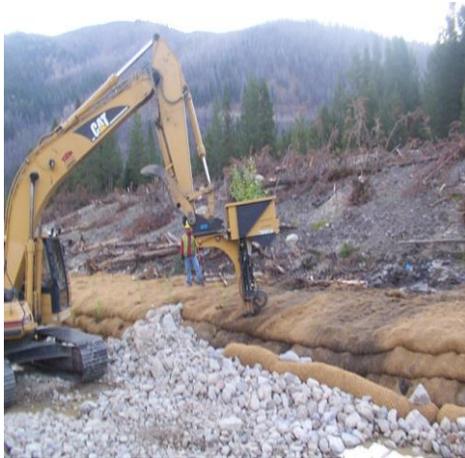
Figure 1. Planting container plants.

BRI utilized patented equipment mounted on an excavator arm to plant both the rooted plants and the cuttings. We were able to access the site by walking the excavator down the new stream channel before the old channel was abandoned. With the reach of the excavator, we were able to plant both sides of the stream without damaging the constructed banks. Plants were delivered to the planting equipment with a small tractor and all terrain vehicles. The operation included an excavator operator, one to two people supplying plants and two people loading plants into the rotary planter and cuttings into the expandable stinger. (See Fig. 1 and Fig. 2)

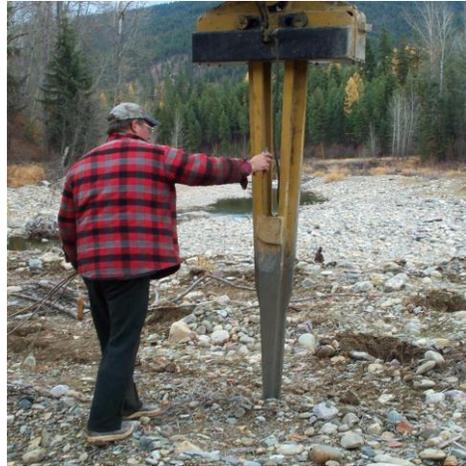
Figure 2. Loading cutting for planting.
