A QUALITATIVE RECLAMATION ASSESSMENT HANDBOOK FOR ABANDONED HARDROCK MINE LANDS¹.

Pamela S. Blicker², Dennis R. Neuman, and Stuart R. Jennings

¹ Paper was presented at the 2009 National Meeting of the American Society of Mining and Reclamation, Billings, MT, *Revitalizing the Environment: Proven Solutions and Innovative Approaches* May 30 – June 5, 2009. R.I. Barnhisel (Ed.) Published by ASMR, 3134 Montavesta Rd., Lexington, KY 40502.

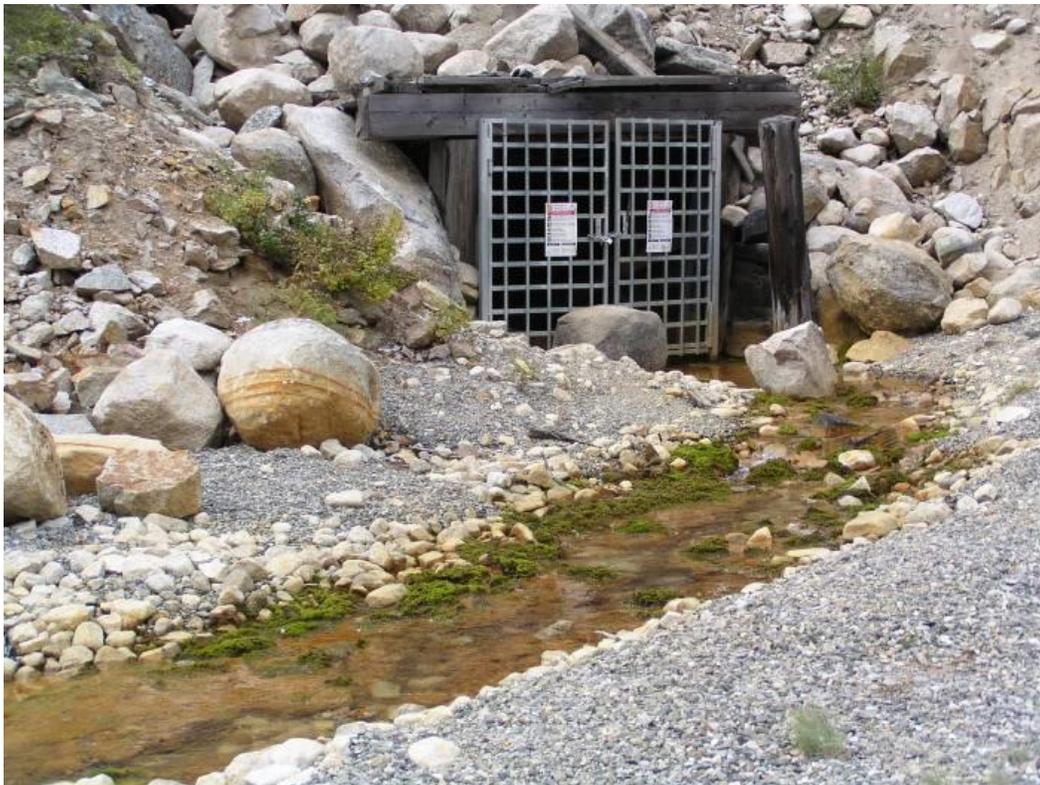
Figure 1. Gated adit protecting public safety, untreated water is a source of acid mine drainage.

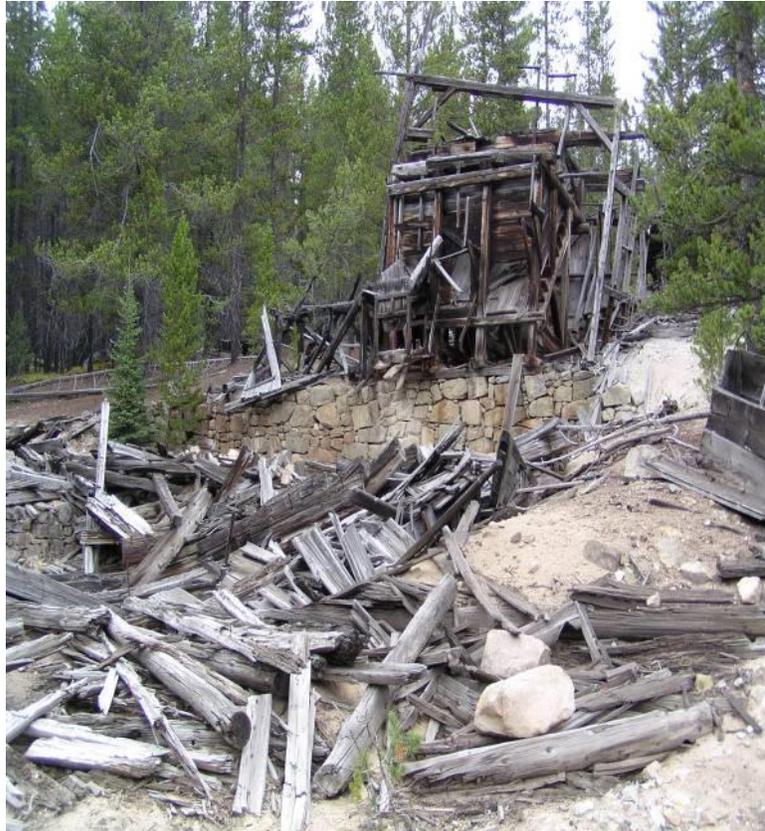
Figure 2. Dilapidated historic structure poses risk to public safety.

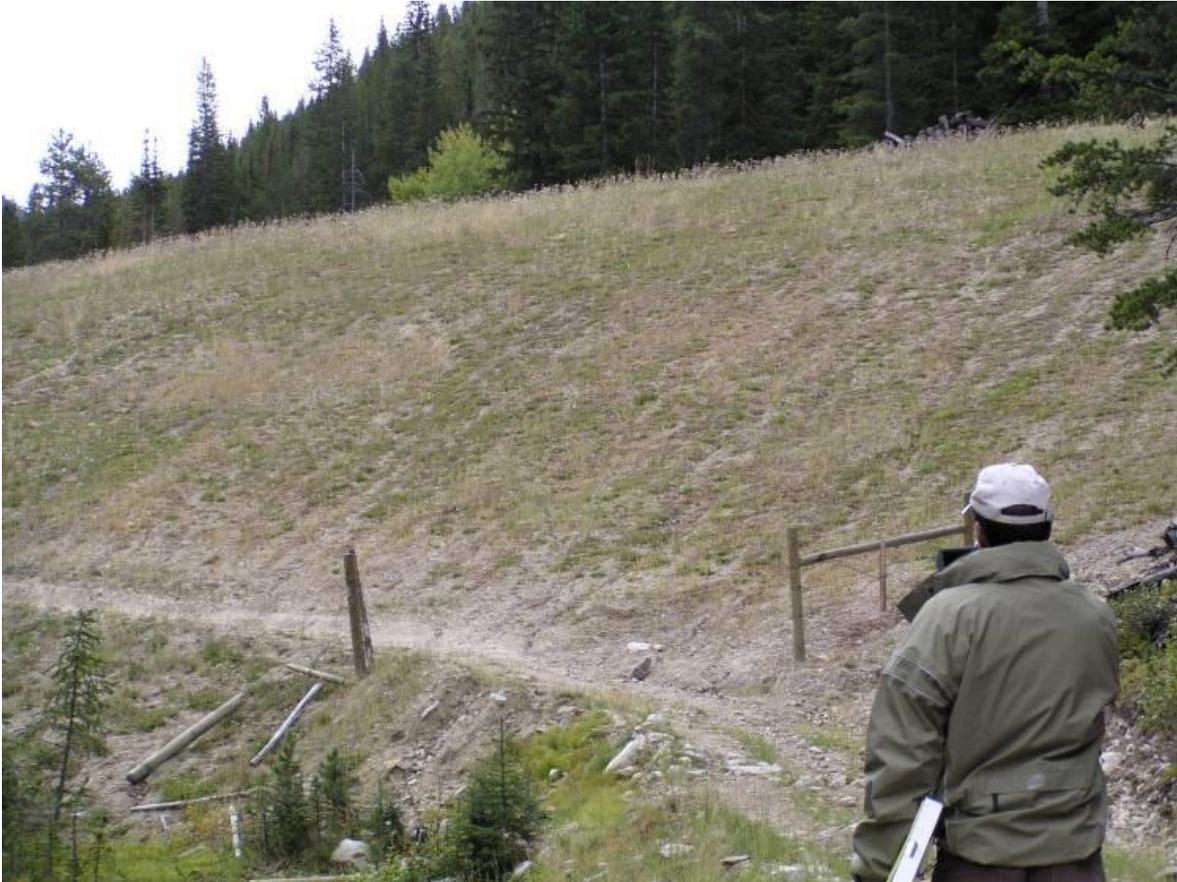
Figure 3. Repository with poor vegetation cover and rills and gullies caused by erosion.

A repository is an engineered disposal cell similar to a landfill (Ford and Walker 2002). Many abandoned mine cleanup activities include the construction of a repository either at the site or nearby. Design of a repository depends largely on site conditions but should remain stable in the long-term and prevent migration of contaminants into the environment (Lottermoser, B. 2003). Repository concerns include; vegetation community and cover, condition of diversion structures, drainage or seepage, erosion, and stability including signs of slope failure or

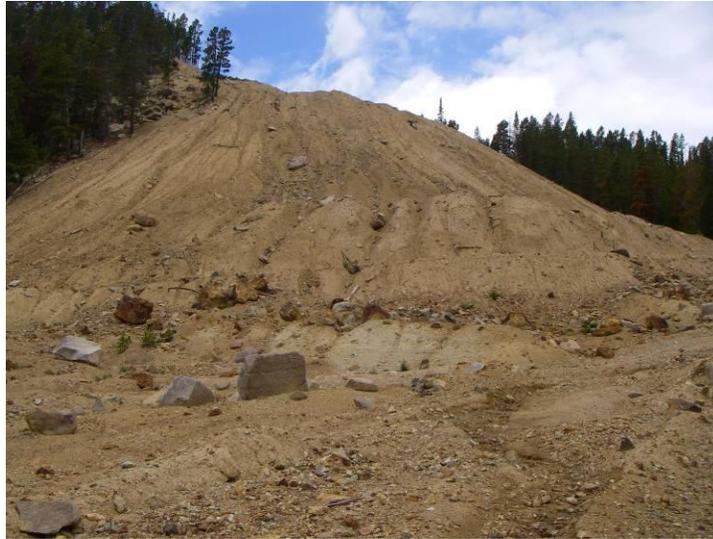
Figure 4. Waste rock and other material were dumped down the side of a steep slope. Erosion and surface water runoff quality are of concern at this site.

A waste rock dump is typically a historic pile of overburden that may be environmentally innocuous or contain contaminated materials and produce runoff water of poor quality. Waste rock dumps are generally not highly engineered, rather unwanted (of low economic value) rock was simply dumped in a convenient location that often included steep slope areas. The type of reclamation work occurring on waste rock dumps is variable and can range from no action to installing a constructed cap.

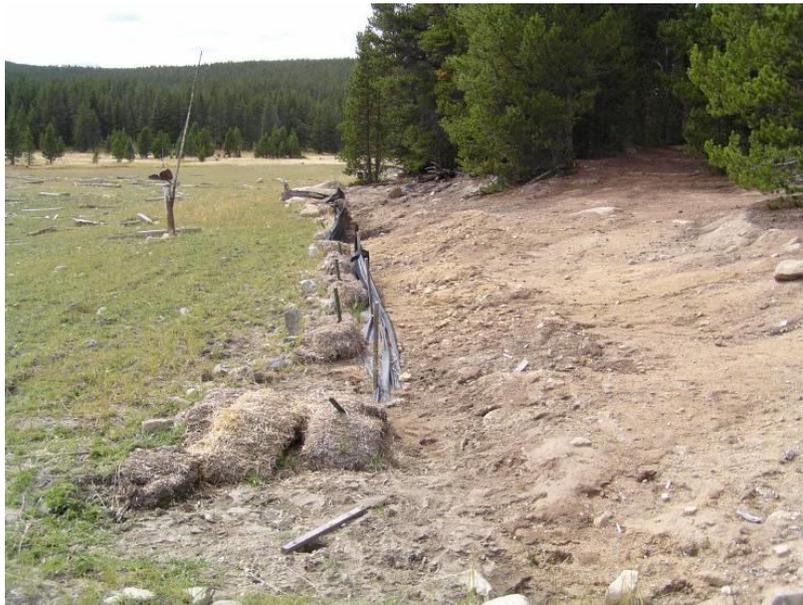
Figure 5. Waste material left in place adjacent to removal area. Run-on from the contaminated area is affecting the reclaimed area.

This form is used to assess locations where mine waste has been removed. These areas are generally covered with borrow soil and revegetated, but not always. Several attributes are assessed in removal areas, examples include: vegetation community, remaining waste, erosion, water diversion features, acid mine drainage, metal salts, seeps, and impacts of/to adjacent land.

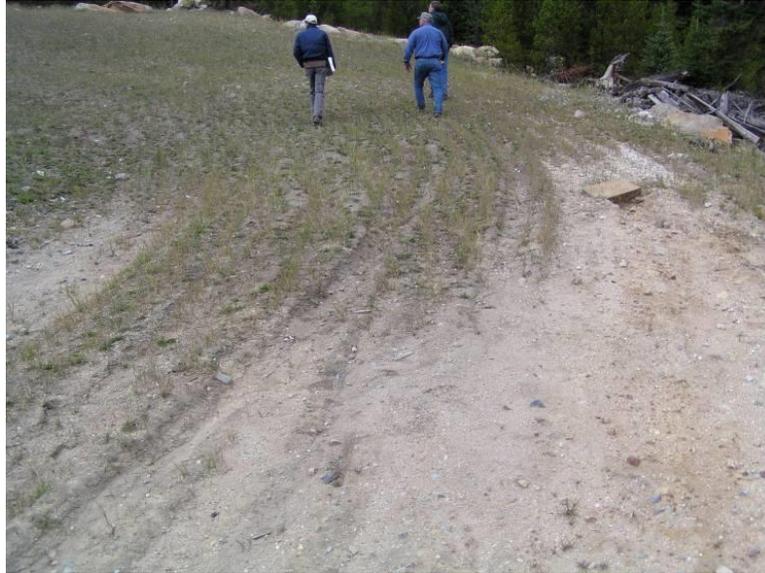
Figure 6. Poor vegetation establishment in removal area.

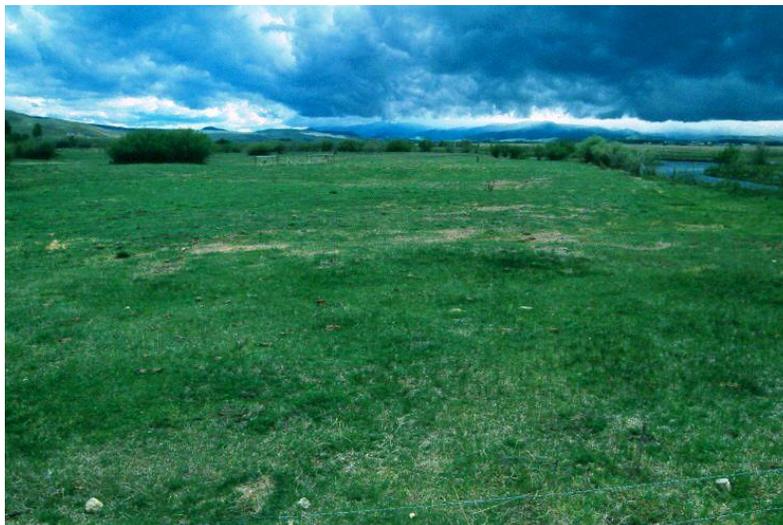
Figure 7. Area treated in-place (in-situ) remediation. Lime and organic matter were tilled into the contaminated soil and the area was revegetated.

General remediated areas refer to reclaimed areas within the site that are not assessed using the other feature-specific evaluation forms. These areas may have been treated in-place, graded, revegetated, or had other reclamation activities occur. This form asks the evaluator to assess attributes that include, but are not limited to; vegetation community, erosion, weeds, instability of slopes, acid mine drainage, exposed waste, and impact of/to adjacent land.

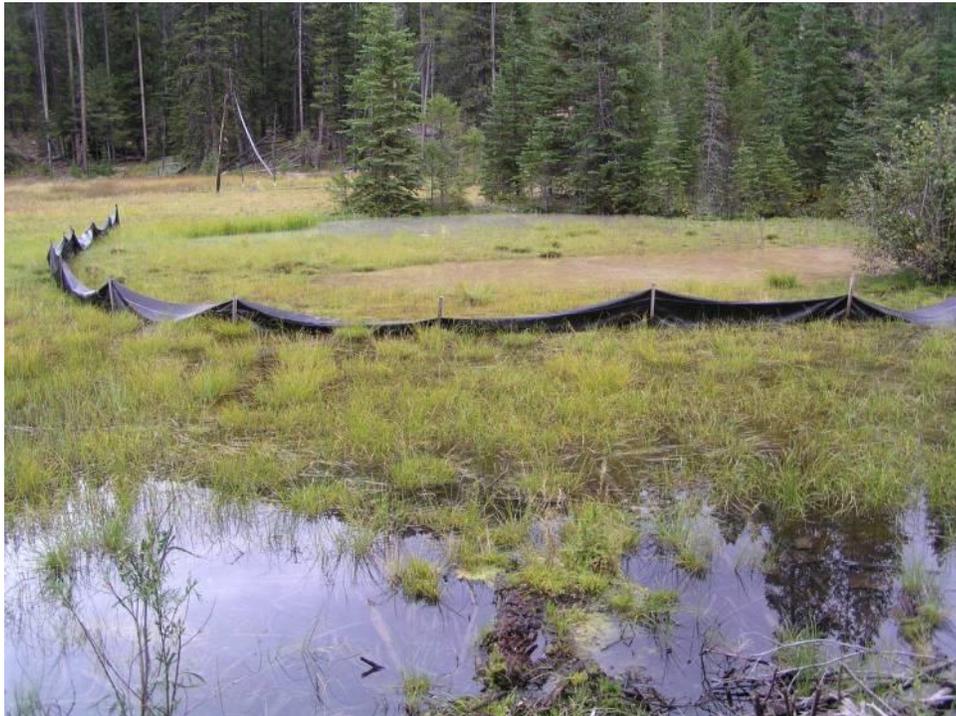
Figure 8. Wetland in a reclaimed area; silt fence needs maintenance or removal depending on erosional characteristics of adjacent area.

Wetland areas may be original to the site or may have been constructed as part of the reclamation design. Assessment attributes include looking at the seasonal water level of the wetland, determining if acid drainage discharges into the wetland, plant community health, sedimentation, water diversion features, and more.

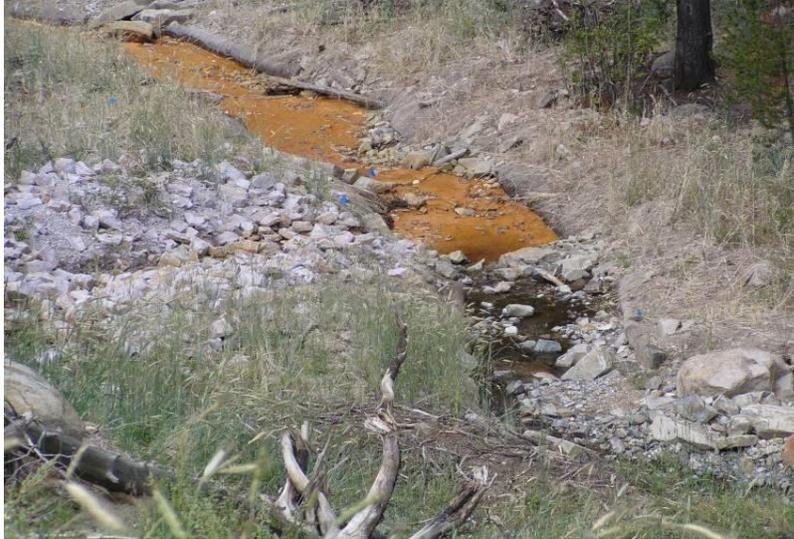
Figure 9. Acid mine drainage discharging into a clear stream. Notice vegetation is poorly established on the streambank near the acid water.

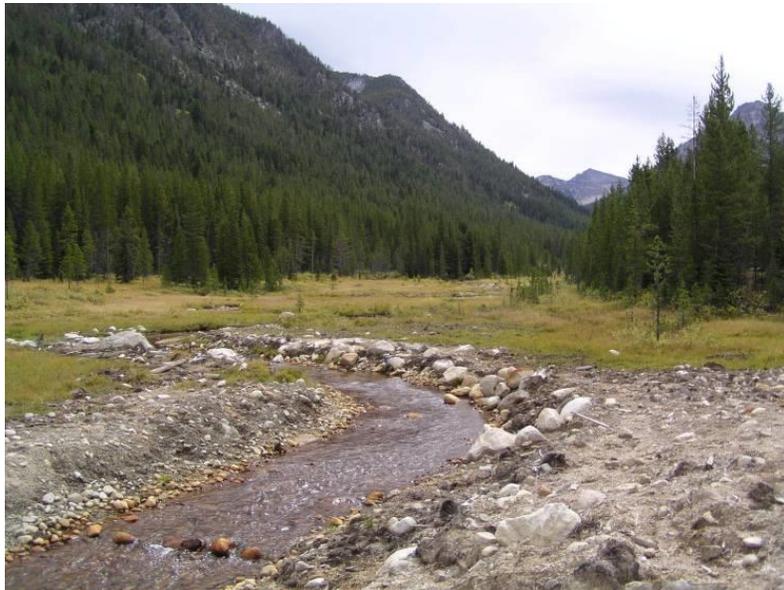
Figure 10. Dead and dying streambank vegetation in reclaimed area.

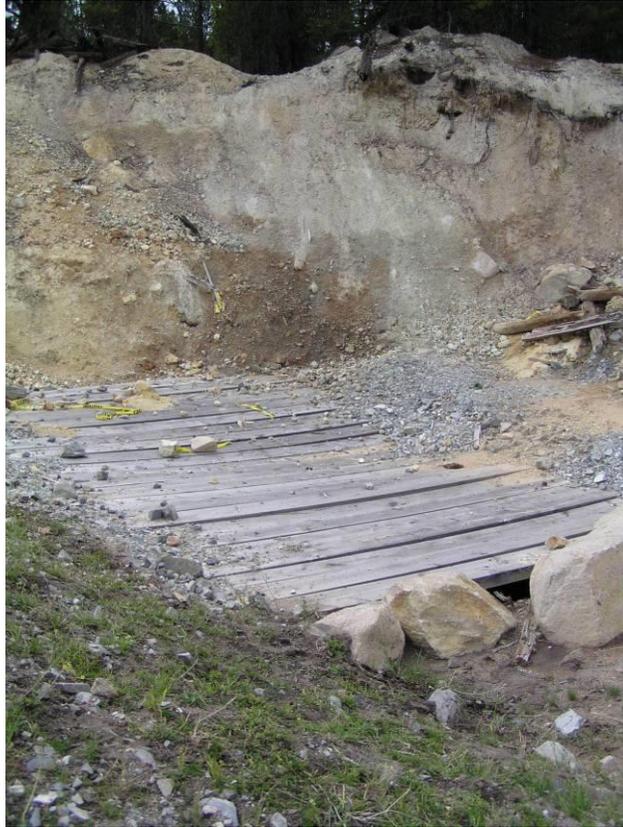
Figure 11. Temporarily closed mine shaft.

Abandoned mine sites require the closure of unsafe mine adits and shafts. These mine features can pose a serious risk to the public. Additionally, adits and shafts commonly discharge water from the old mine workings. Assessment attributes include the condition of the water being discharged, the path of the discharged water, and condition of the device used to close the adit/shaft.

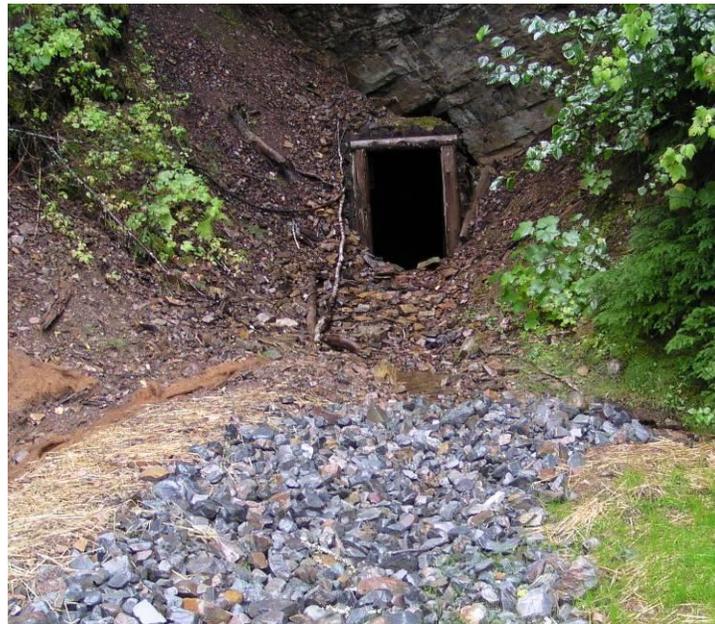
Figure 12. The mine adit closure bulkhead at this reclaimed site is located several feet inside of opening creating an attractive nuisance and risk to site visitors.

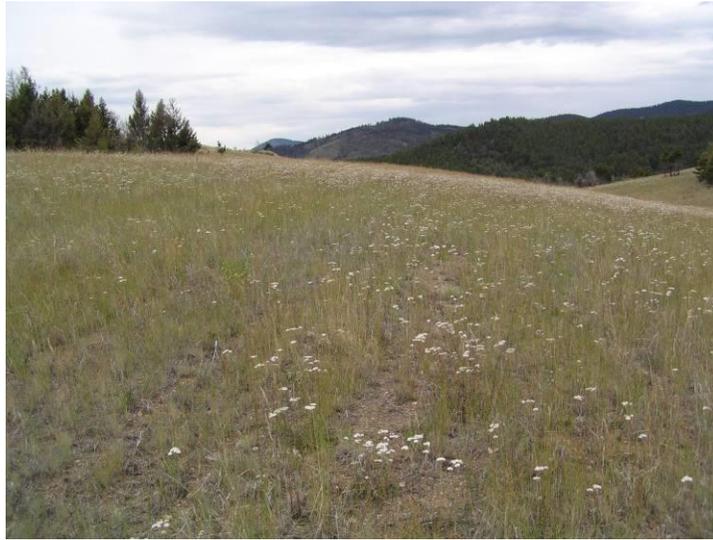
Figure 13. Revegetated borrow area.

Borrow areas are evaluated using Form No. 10, these are areas where uncontaminated soil or fill material was removed, creating a pit that generally requires recontouring and revegetation. Borrow sites may be located some distance from the abandoned mine site. In some cases following removal of borrow material, the pit may be used as a repository. Attributes addressed at borrow areas include vegetation conditions, erosion characteristics, impacts of or to adjacent land, water diversion features and slope stability. If the pit was filled with waste material, the borrow pit would then be assessed using the repository or waste rock dump form.
